IFA Technical Conference

SHAFT OIL BARRIER SEALS CAN CAUSE HIGH VIBRATION. DO YOU KNOW ? (a)

(A Case Study of High Vibrations in Syn Gas Compressor, its Diagnosis and Correction)

Arun Kumar National Fertilisers Limited, Panipat Unit, India

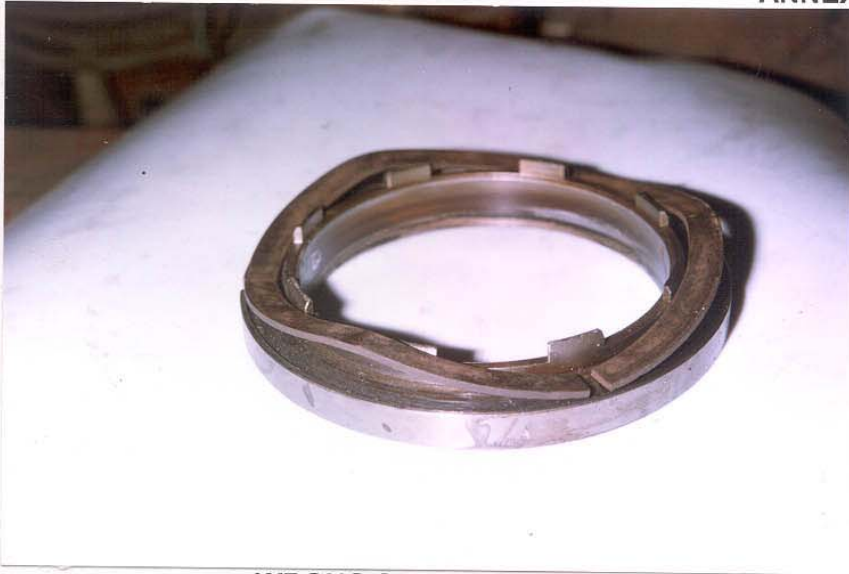
ANNEXURE-IV

It is generally observed that the rotating machinery users, in case of low frequency vibrations doubt oil whirl at the journal bearings. But it is important to know that ‘Oil Whirl’ can set in any continuous shaft constraint, which is lightly loaded. (i.e., not necessary at only journal bearings). It is what the subject case study was about. The seal rings were acting as lightly loaded bearing and causing oil whirl, as the babit metal in seal rings acts as continuous constraint without any break or lobe in it. The probable reasons were tight clearance of HP seal ring, lack of flexibility in seal rings due to digging of leaf spring end edges (Refer Annexure V).

WRONG SEAL ASSEMBLY
(Edge of the Leaf spring resting on seal ring face)

To prevent the restricting of floating action of HP seal ring, all concerned areas were taken care of as follows: a)The journal bearings were replaced with new bearings with lower clearance. b) The new HP seal ring with higher clearance of 0.09mm to 0.1mm was fixed. A chamfer of 45 degrees was provided at oil inlet ends of HP seal ring. c)The assembly of seal rings were made with leaf spring positioning in such a way that slot on leaf spring did not rest on face of seal ring,(i.e., it was set in air). Kindly refer Annexure IV for correct and incorrect position of leaf spring.
