# IFA Technical Conference

## CORROSION PROBLEMS AND REMEDIAL MEASURES IN FERTILIZER PLANT

M.S. Al-Rassi

SAFCO/IBN AL-BAYTAR, Saudi Arabia

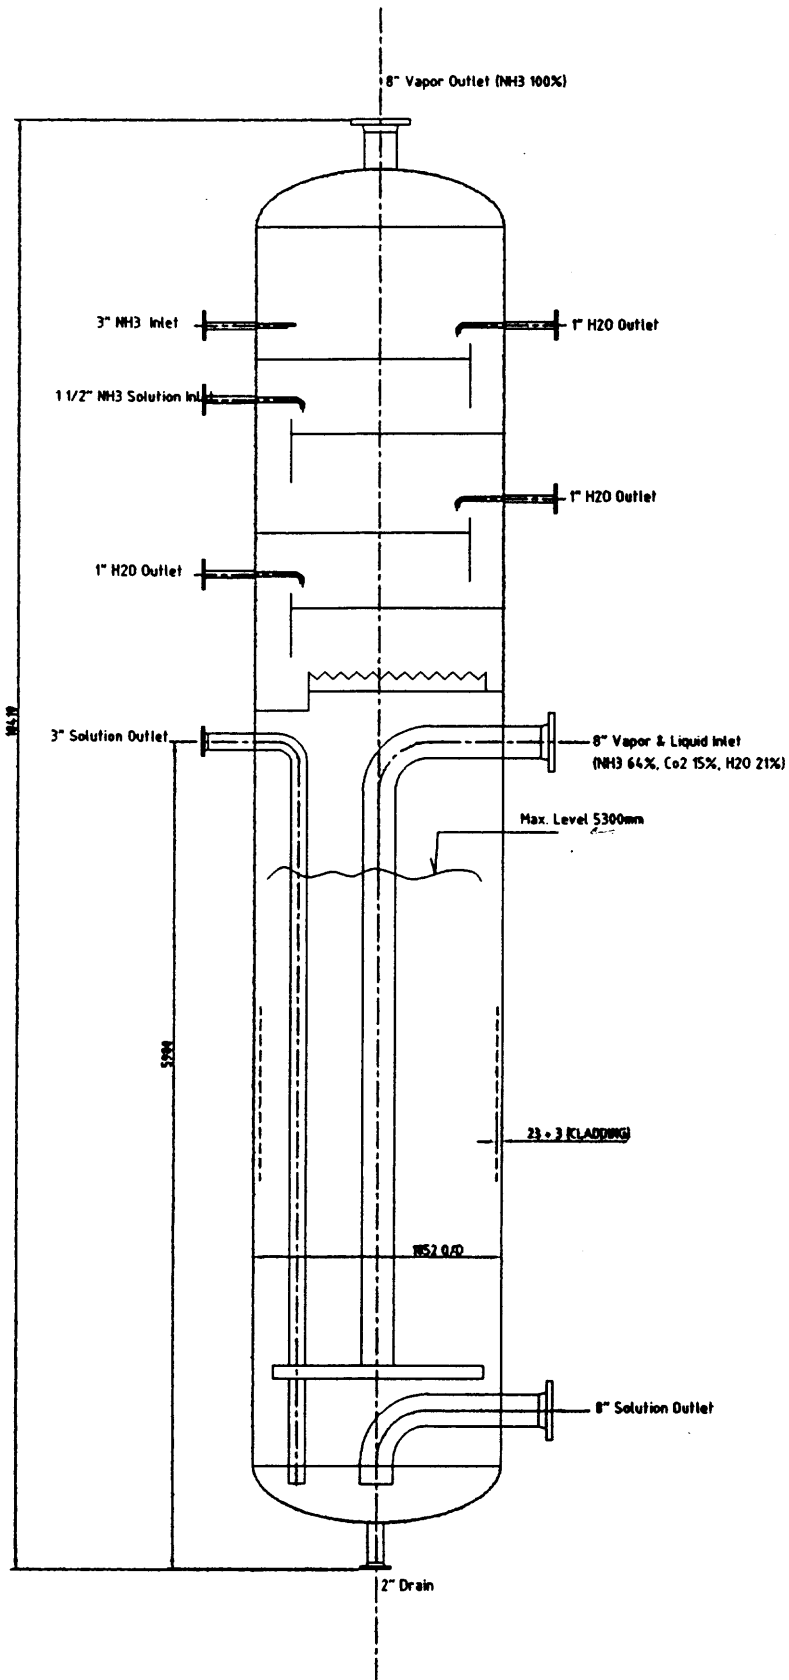
Fig.1

## Medium Pressure Absorber ( MPA ) (Figure 1)

MEDIUM PRESSURE ABSORBER ASSEMBLY DRAWING

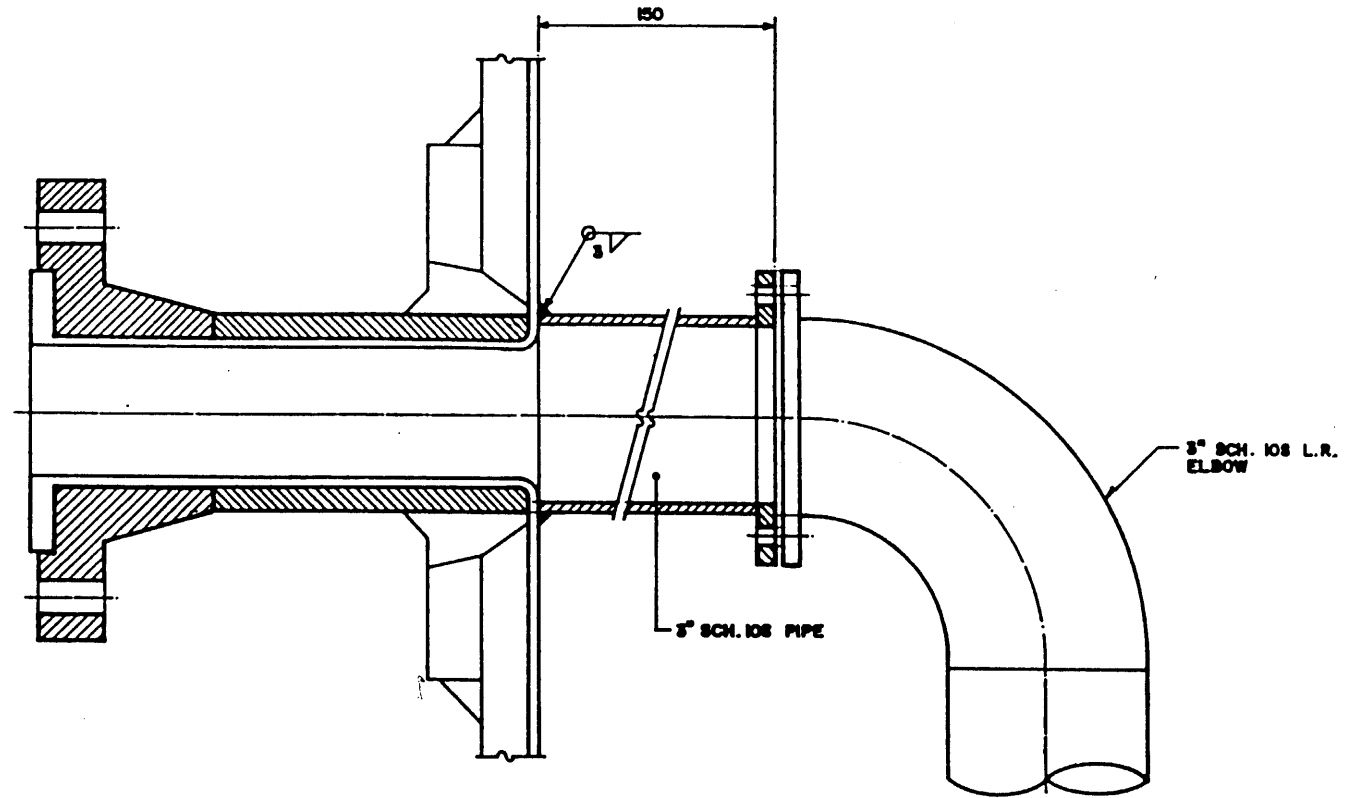
FIG. 2

1. Nozzle material is carbon steel 3" SHC.160 A-106 Gr. B., 10 mm thick (Figure 2)
2. Nozzle lining material is SS 316L, 3 mm thick
3. Shell material A-106 Gr. B., 23 mm thick
4. Shell lining SS 316L, 3 mm thick

1. From flange side, nozzle was visually checked. Liner was found punctured at six places near the weld.
2. From shell side, the nozzle was visually checked at the location where it joins the vessel. The carbon steel nozzle was found exposed and corroded at three locations. It became very clear that the weld joining shell liner to nozzle liner has failed and caused the whole problem.
3. Ferrite content reading were taken on this weld. It was found 3-4% which is beyond limit (.2% max).
4. The condition of the C.S nozzle was assessed after grinding both sides of the SS316 liner. The C.S nozzle was found severely corroded (4-7 mm) deep grooves covering 45 mm of nozzle length from shell side. Corrosion grooves continued along nozzle and nozzle liner until it reached the flange weld where it failed.

As can be understood from the incident, corrosion attack of lined C.S. nozzle was attributed to wrong electrode selection which had excess ferrite content. Practically, this means poor corrosion resistance and less service life of weld in ammonium carbonate service. After weld failure, ammonium carbonate attacked the C.S and propagated along liner / nozzle span until it reached the weld. The corrosion then diverted its path along the HAZ and leaked outside.

OLD NOZZLE ARRANGEMENT

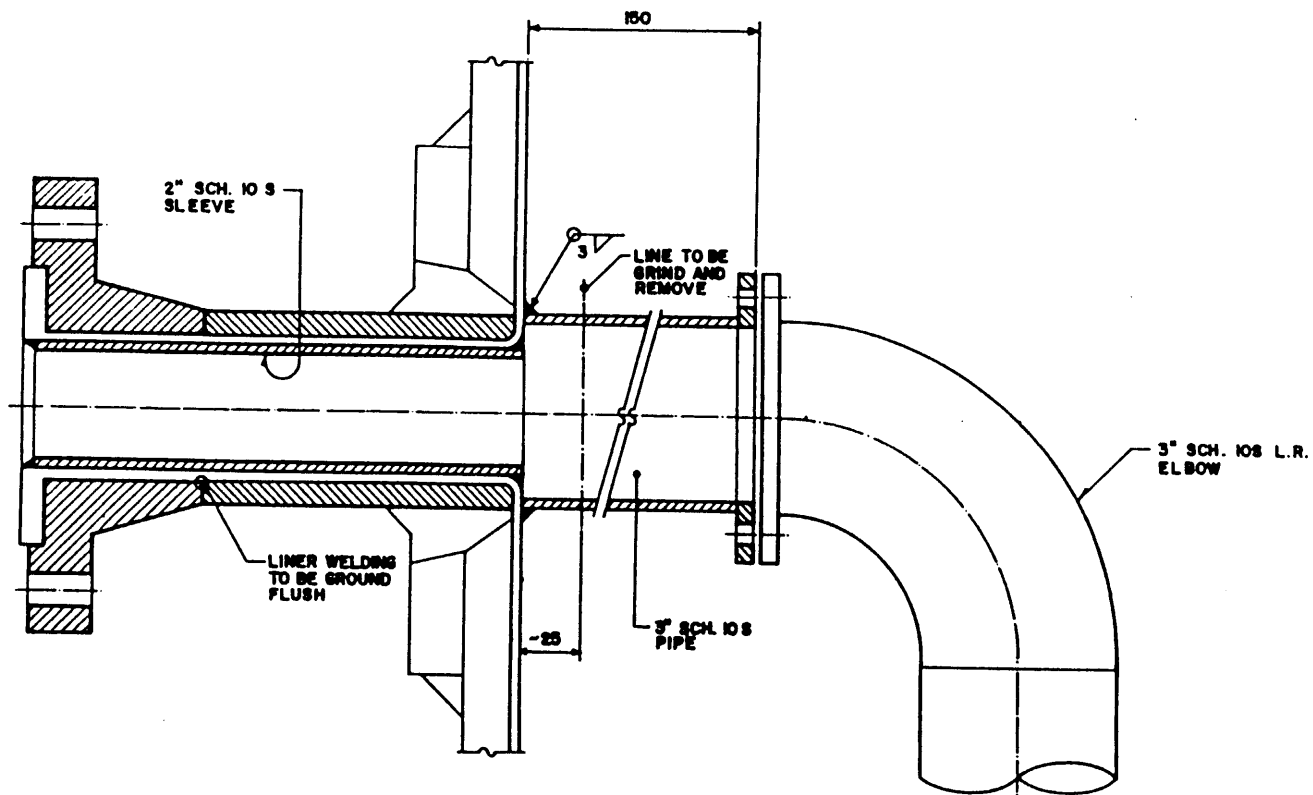
FIG. 3

MODIFIED NOZZLE ARRANGEMENT

1. Corroded nozzle was overlay welded where deep grooves were noticed at its end using Inconel 182 electrodes. Final layers were made with Thermanit 25/22/H filler wire.
2. Sleeve pipe (2" schedule 10 SS 316L) was inserted and welded at both ends to vessel liner & flangeliner using Thermanit 25/22/H (urea grade). (Figure 3)
3. DP check and leak test was made after repair and found O.K.

During April, 1993 Turn Around, permanent repair was done. Repair was nothing but replacing the existing C.S. nozzle with new SS 316L nozzle. Following is the procedure for replacement:

3. Beveled surface of compensating pad plate and shell was ground finished
4. External welding of new nozzle to carbon steel shell was done using AWS E-309-MO electrode.
5. Internal welding of new nozzle to shell liner was done using Thermanite 25/22/MO electrode.
6. DPT & leak test were made on the new joint and found O.K.

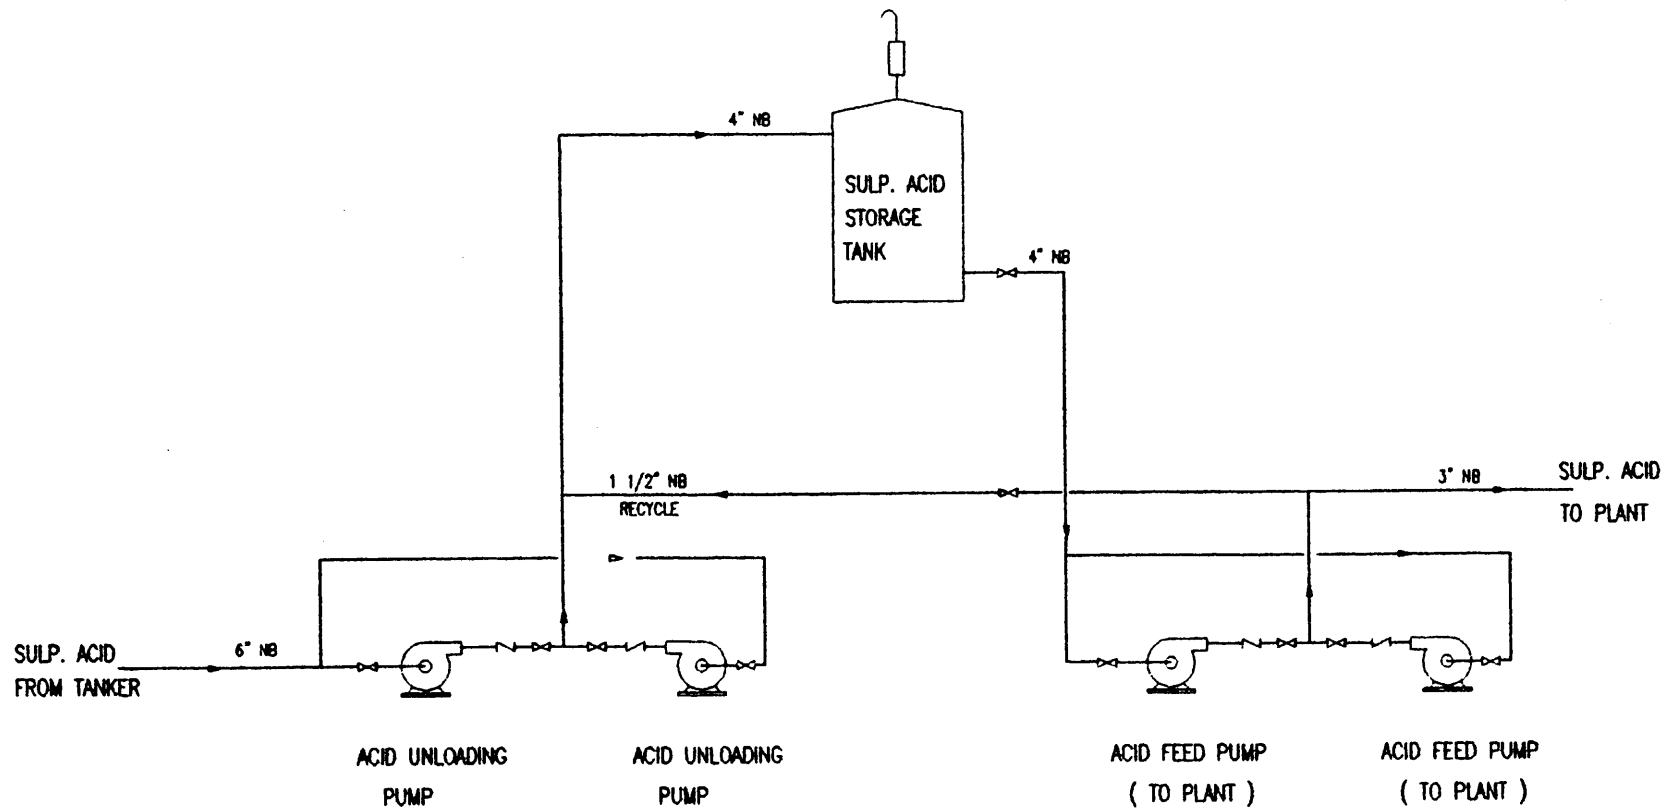
Fig. 5

Even though carbon steel pipes rendered good service life in  $H_2SO_4$  handling in NPK plant, discharge and recycle lines of  $H_2SO_4$  unloading / transfer pumps experienced frequent leaks on account of high velocity flow.

As plant draw rate of sulfuric acid is normally much less than pump capacity (5 ton/hr against pump capacity of 18 ton/hr), discharge valve was throttled. So the following phenomenon took place:

1. Erosion corrosion on casing inside due to acid recirculation and high liquid velocity.
2. As 13 ton/hr was recycled back to sulphuric acid tank, liquid velocity inside the discharge line and the minimum flow line become more than the tolerable limit (3ft/sec). This caused erosion-corrosion and consequent leakage especially at elbows where fluid changes direction.

# SULPHURIC ACID UNLOADING / FEED SYSTEM (OLD ARRANGEMENT)

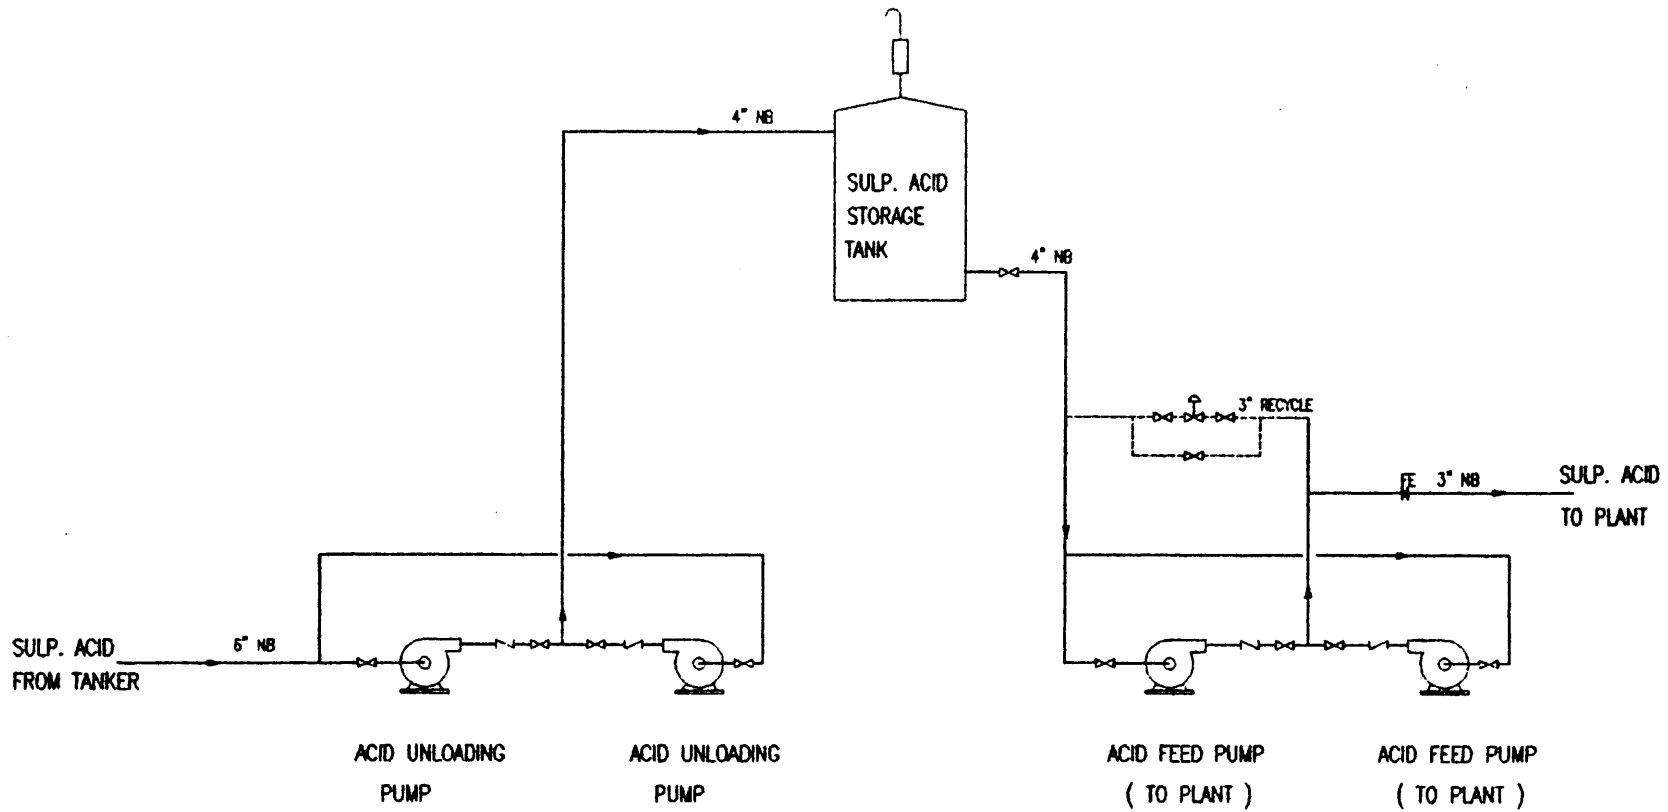
Fig. 6

# SULPHURIC ACID UNLOADING / FEED SYSTEM ( NEW ARRANGEMENT )

- Existing pumps of 18 MT/hr were replaced by three pumps with lower capacity of 6.3 MT/hr to suit the normal demand of the plant. The spare pumps can be used in case of high sulphuric acid demand.
- Minimum flow line was modified to be leading to pump suction instead of going to tank to avoid overload on unloading line. (Figure 6)
- Discharge line thickness was increased from 3" Sch 40 to 3" Sch 80.
- Welding was carried out by TIG welding process for high quality welds.
- It was recommended to provide insulation on all piping to protect the pipe from high temperature exposure during summer.

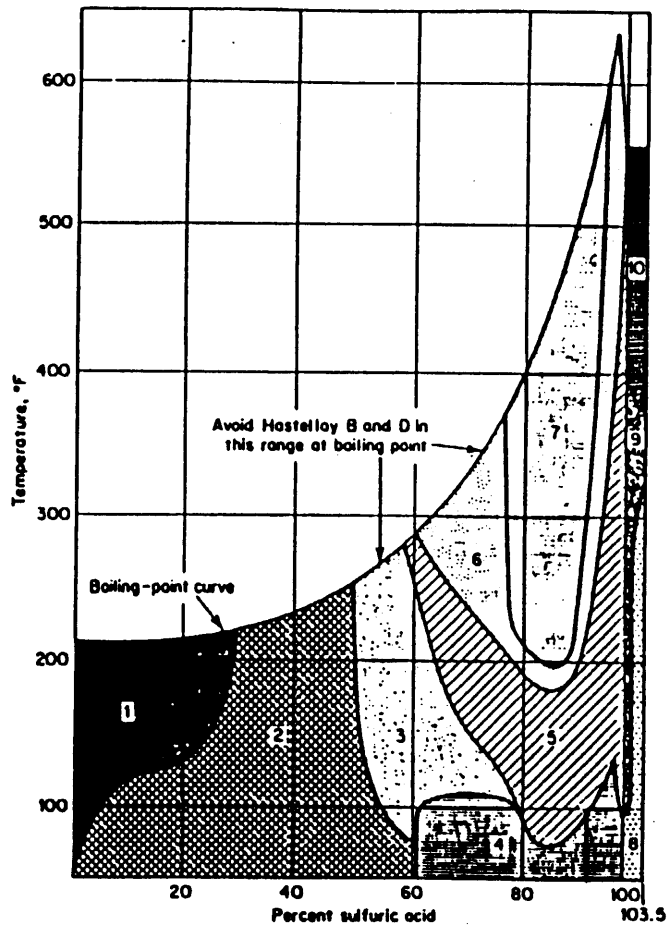
1. High capacity pump selection was the main reason for pump and related piping problems.
2. Although C.S. is a proven material for sulfuric acid service, it should be used within its allowable limits (See graph).

Figure 7-12 Corrosion resistance of materials to sulfuric acid—corrosion rate less than 20 mpy. (Courtesy G. A. Nelson, Shell Development Co.)
