IFA Technical Conference

MODIFICATIONS DONE ON SYNTHESIS GAS COMPRESSOR DRIVE TURBINE

A.B. Tipnis, V.B. Waghulde, T.M. Bhagwat and H.N. Gakhar

Rashtriya Chemicals & Fertilizers Ltd., India

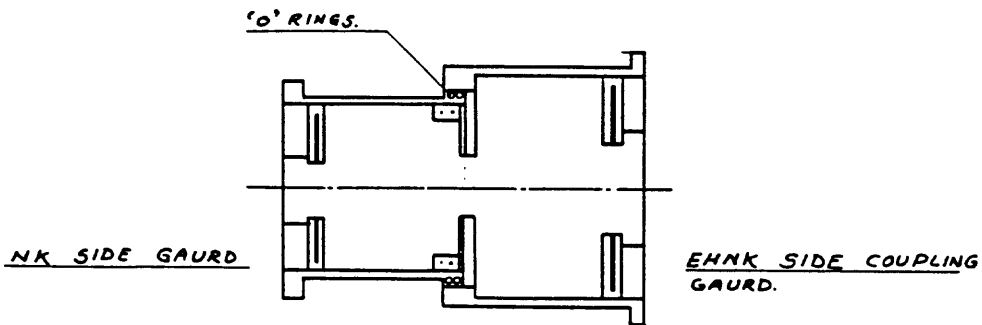
Figure 2 A - OLD COUPLING GAURD

The coupling guard design between HP and LP turbines was having overlap on each other with « O » ring as sealing medium. Both the turbines are coupled in such a way that their front sides face each other and so during operation the casings expands towards each other. This inevitably resulted in oil leakage from coupling guard. Being front side these always posed fire hazards. Similarly this design was not flexible enough and limited the bearing housing travel from travelling equally. This contributed to vibrations. A new type of coupling guard was then installed having flexible bellow between both front coupling guards. Due to this oil leakage is completely stopped. Additionally due to flexible bellow axial travel of both bearing housings improved and disturbance of centering in skew fashion reduced. This resulted in lowering vibration level to some extent. Both old and new coupling guards are shown in the Figure 2.

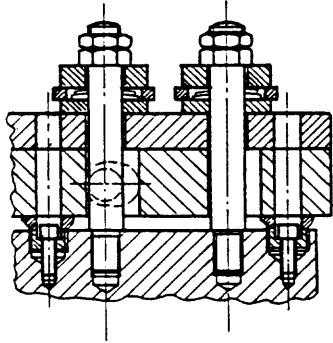
Figure 3 - FRONT HOUSING HOLDING DOWN BOLT MODIFICATION

During running we observed that the front bearing housing is having a tendency of lifting up. All the spherical washers were not getting loaded. Due to this unstable housing condition we were unable to increase the speed of the machine above 10,000 rpm. After 2 or 3 start-ups we were hardly able to maintain 9800 rpm giving plant load limitation. Frequent disturbance in centering due to poor holding down arrangement was resulting in high vibrations. M/s Siemens suggested modification of the front housing holding down arrangement. In earlier design there were two bolts on both left and right side keeping 0.03 mm clearance with bearing housing. Due to convection heat from casing the holding down bolts were

expanding and resulting into increase in clearance. This provides room for movement of housing and disturbs the centering. New type of design employs two disk springs in back to back arrangement with 0.80 mm initial compression. Both design are shown in Figures 3 and 4. This provides a constant holding down force on the housing and gives stable condition.

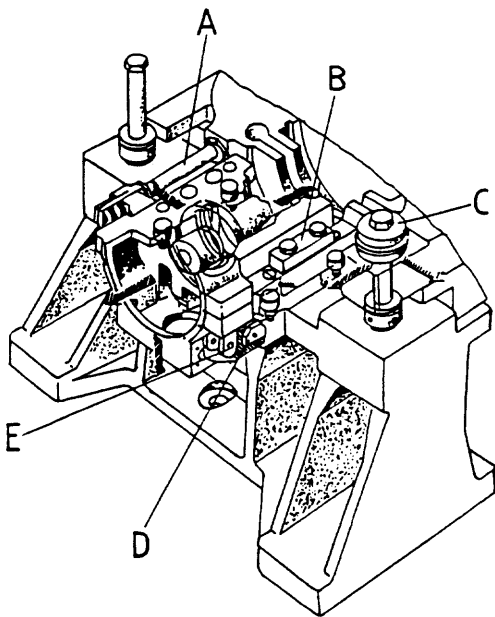
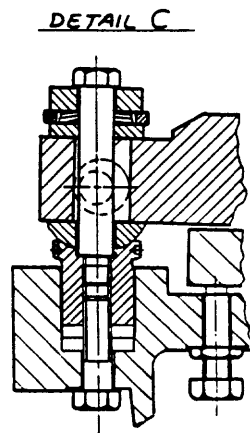
Figure 4

Details of the front bearing housing and pedestal of original design is shown in the Figure 4. It can be seen from detail « A » that front bearing housing is resting on four spherical washers which are mounted on the threaded cups fixed on the bearing pedestal. Similarly at detail « B » it can be seen that bearing housing is connected to casing with tie rods. At detail « D » it has been shown that centering guide key is the part of bearing pedestal, where as spherical washers and adjustable bushes are installed in bearing housing.

The tie rod facility is provided only in front bearing housing to take care of axial housing movement with respect to casing expansion /rotor expansion, so as to maintain bearing node point and centering of the rotor. Thus the tie rods push the front bearing housing equally in forward direction during turbine expansion. Bearing housing slides on four spherical washers due to the pushing force of tie rods. This action maintains the vertical elevation of the rotor during expansion. Similarly sideways movement of the bearing housing as well casing is controlled by spherical washers located at guide block of bearing pedestal as shown under detail D.

1. Centering was getting disturbed maximum in up down and sideways fashion.
2. Deep grooves were observed on the seating face of the front bearing housing at the spherical washer points.
3. Deep grooves were also observed on sliding faces of the center guide key of front housing.
4. Front steam gland sealing fins were getting damaged unevenly.
5. Some rotor fins were also found damaged.

Material of construction of bearing housing is softer than spherical washer. During running and in frequent start-ups and shutdowns (including those for process reasons also) vibrations resulted in pitting at contact surface. Continuous pitting results into formation of grooves. Once these grooves are formed travel of the bearing housing is not uniform. Due to this rotor center is always disturbed. The threaded supports are also prone for sinking and disturbs the rotor center. Running the machine in this condition resulted into damaging the bearings and the fins of front steam gland. Due to leakage steam hitting on the bearing housing, the problem aggravates. Turbine shaft vibrations and casing velocities remain on higher side and result into rpm limitation and less production.

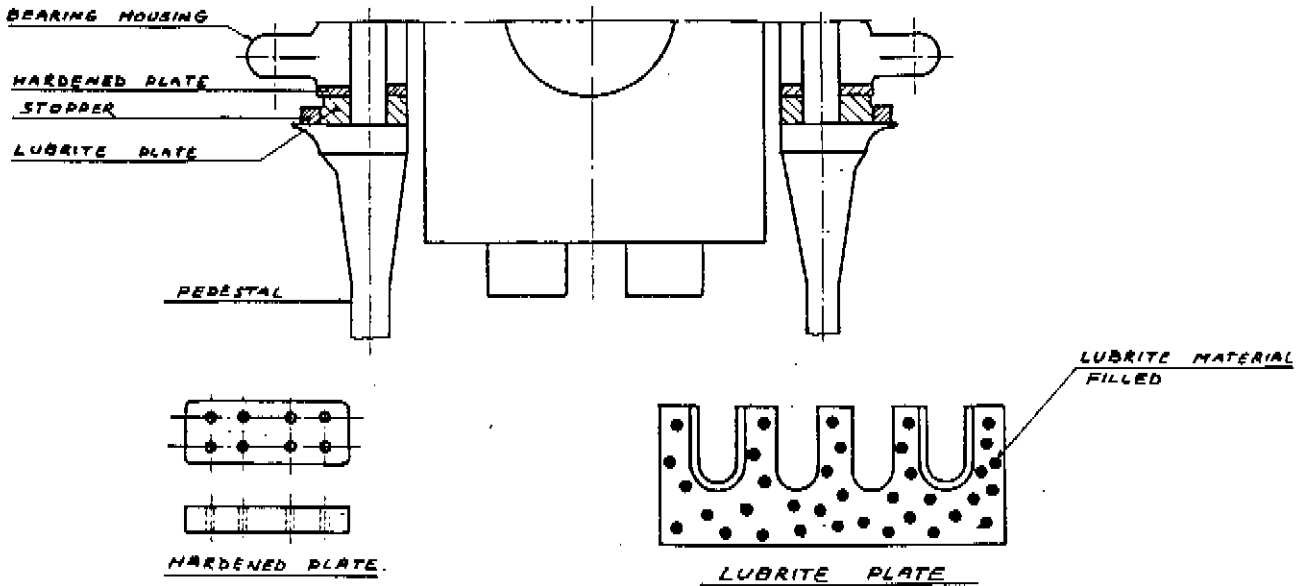
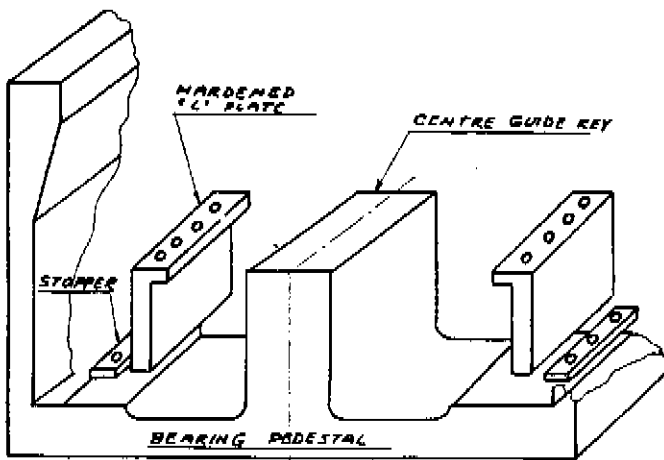
Figure 5

1. Fixing of hardened plates on the seating surface of front bearing housing to increase the wear resistance. Replacement of spherical washers by lubrite plates to increase the load carrying area.

Lubrite plates are plates having graphite pockets in it. Graphite being a solid lubricant helps smooth travel of the bearing housing during running. With the modified holding down bolts, the rotor center is maintained.

2. Fixing of hardened « L » shape plates on the center guide key to increase the wear resistance and to help easy guide. The required spares were obtained from M/s Siemens in time and we waited for the opportunity to implement it. Similar machine in train-II is by M/s BHEL. During November 1989 it had high vibration problem and it was decided to overhaul the same. As we were having modification spares in hand we decided to implement it on this machine. The modifications are shown in Figure 5.

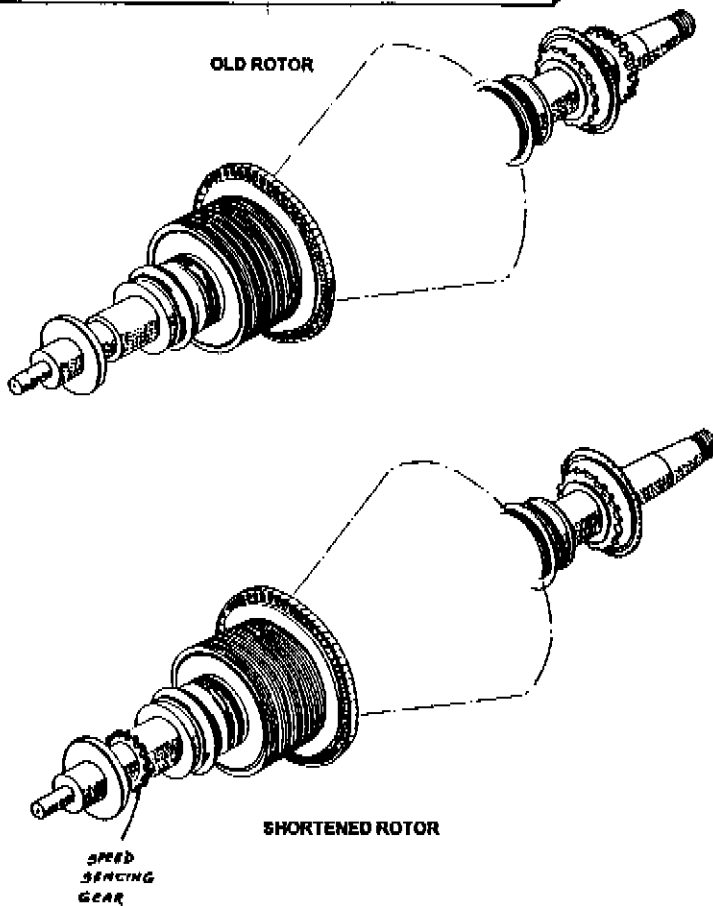
The old design of HP turbine rotor was having more overhang on both side of the journal bearings. As torque transmission point was quite away from journal bearings, the turbine was unable to take high rpm continuously as after some period bearings started to damage. This often resulted in damage to front steam gland sealing fins too. Increasing the mechanical stability without disturbing the blading and casing was only possible by reducing the overhang portion of the turbine rotor. Hence the shortened rotor concept was suggested by M/s Siemens.

The difference between old and new shortened rotor is shown in Figure 6 and these differences are as follows:

1. Length shortened at front side is 63.79 mm
2. Length shortened at rear side is 73.68 mm
3. Total reduction in length of the rotor is 137.47 mm
4. Old rotor was having speed pickup probes on the rear side. Due to shortening of the rear side that area was removed; so this gear along with probes was shifted to front side.

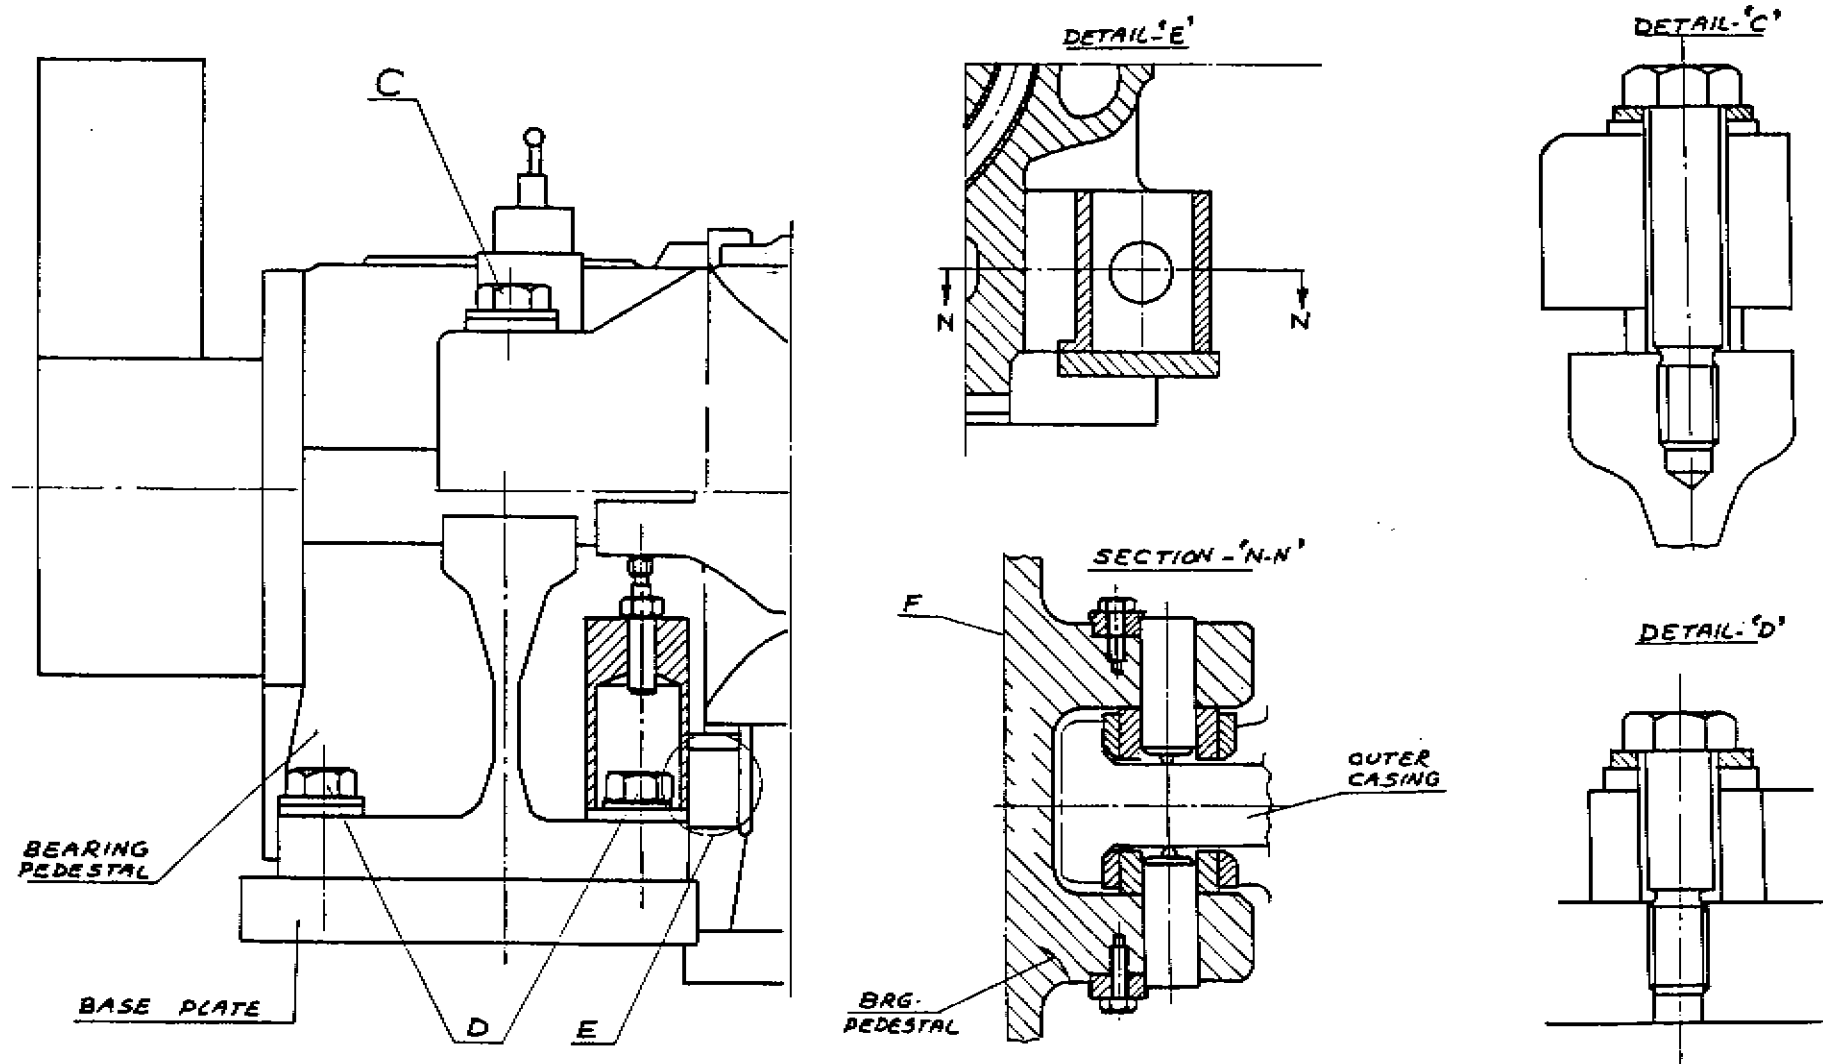
Figure 7 - DETAILS OF FRONT SUPPORTING SYSTEM

In earlier designs, the casing expansion is transmitted to the bearing housing through tie rods. Non-uniform heating of these rods causes uneven expansion in both the rods, ultimately resulting in misalignment of the rotor bearing system. New design is proposed to adopt tongue and groove locking arrangement between casing and the front bearing pedestal.

Designs in the past incorporated spherical washers through threaded cup back-up for guiding the front bearing housing during axial movement. The new design would incorporate a key. The front bearing pedestal of the new design slides over frictionless lubrite plates as shown in Figure 7.
