IFA Technical Conference

**New Orleans, Louisiana, USA
1-4 October 2000**

Ammonia Plants : Past Accidents and Lessons Learnt

R.M.Chopde and K.M.Patel
Krishak Bharati Cooperative Ltd., India.

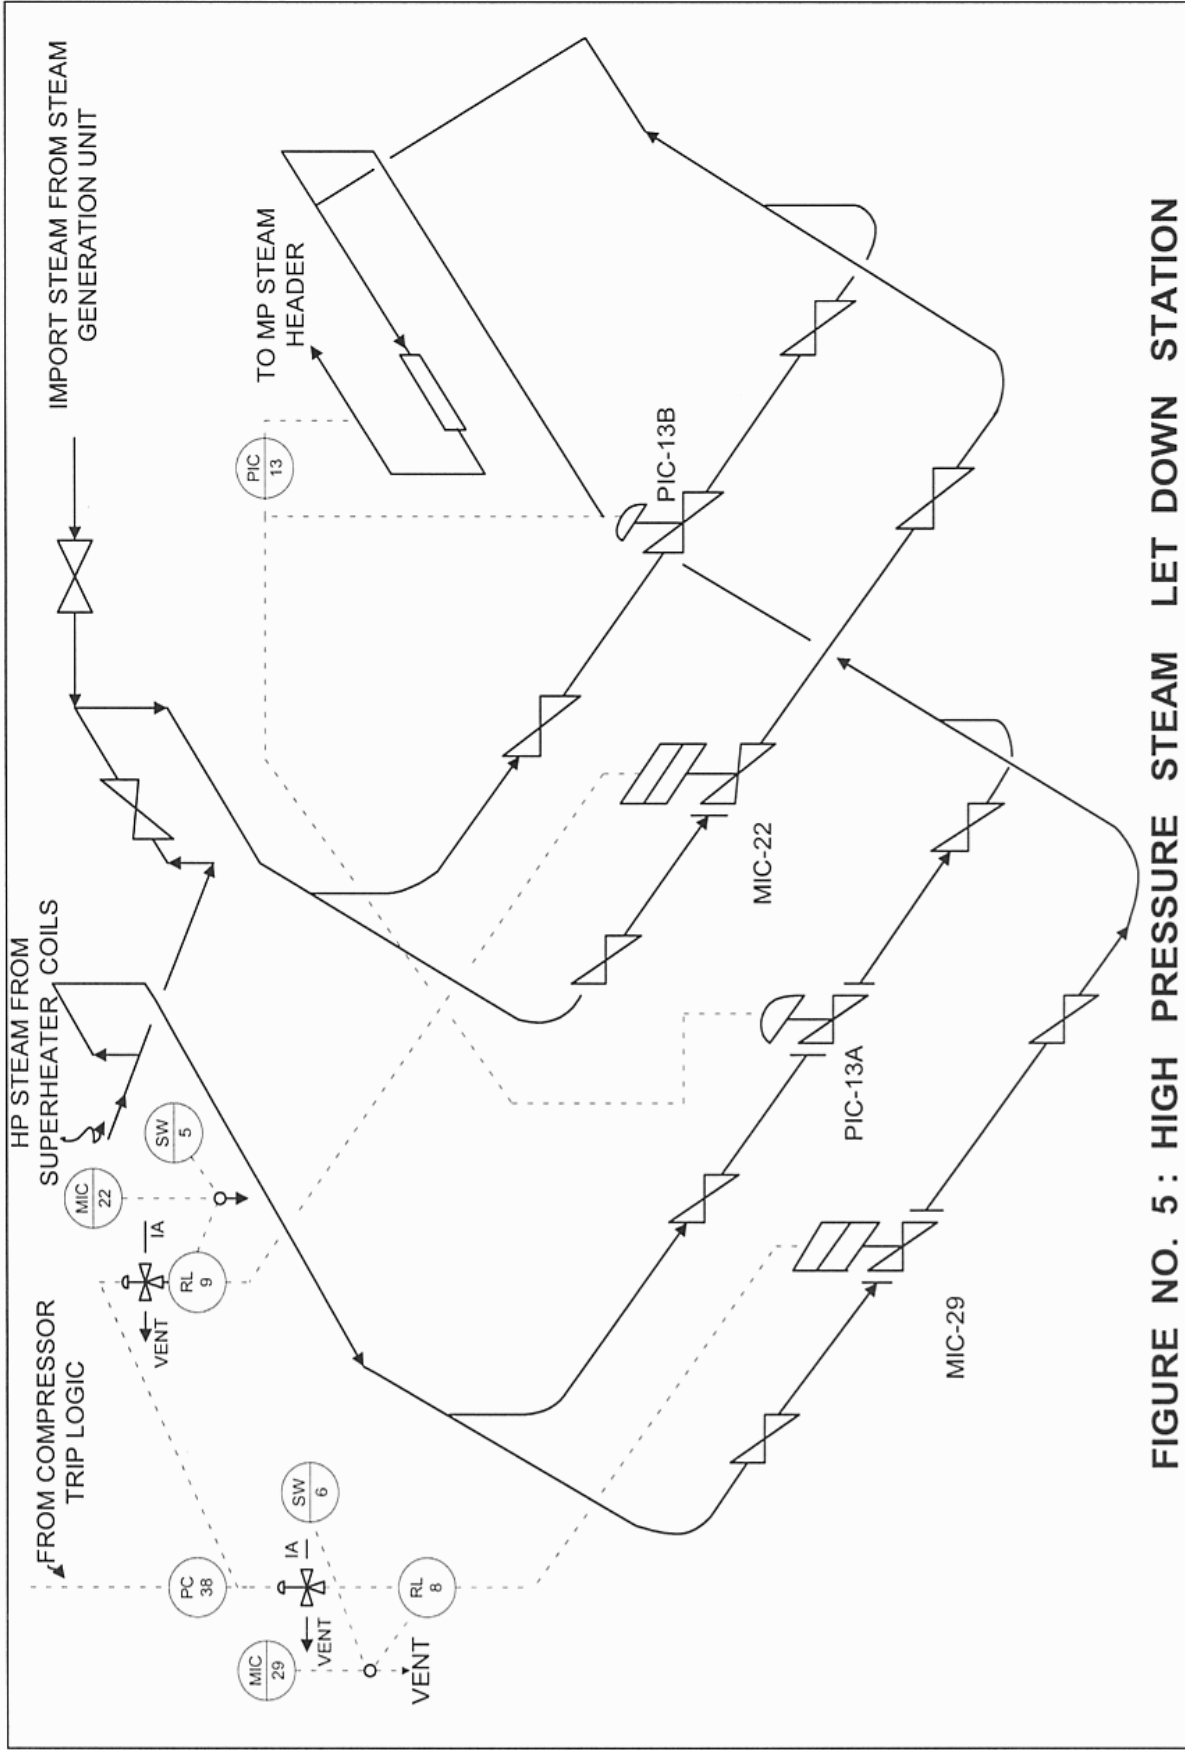
FIGURE NO. 5 : HIGH PRESSURE STEAM LET DOWN STATION

On 6 th Feb’1986 when synthesis gas compressor tripped the steam letdown station opened promptly but 12 mm tubing supplying hydraulic oil to MIC-22 snapped away leading to large scale leakage of oil on the floor. Since the steam let down station operates at high temperature the oil vaporized and instantly caught fire.

The oil supply tubing to the hydraulic actuator of MIC-22 valve snapped away from the ferrule joint when steam let down valves opened and this snapping away of tubing from the ferrule may be due to minor vibrations caused due to sudden flow of steam through the valves. All the four valves have small bypass valve with restriction orifice/isolation valves for keeping the lines in warmed up condition. There are chances that during the time of accident the station was not in properly warmed up condition and hammering might have taken place.

2. Two steam let down valves MIC-22 and 29 actuators were replaced from Hydraulic to Pneumatic type and all hydraulic oil lines leading to the station sealed off. The opening time for valves with hydraulic actuator was 1 second and after changing to pneumatic actuators opening time increased to 3 seconds but during our initial operation and based on our experience it was found that there were no disturbances in the MP steam system with steam let down station opening of time of 3 seconds.

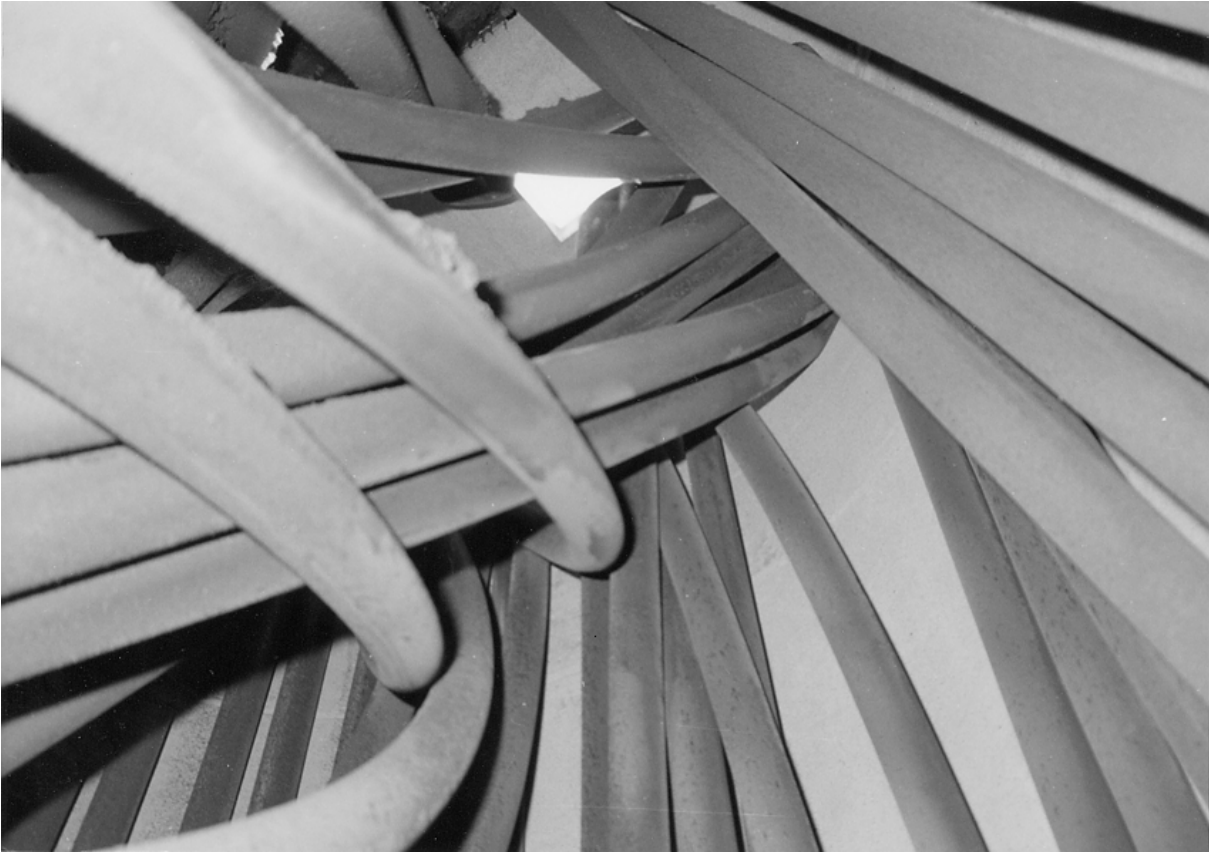
1. Spacers were installed in the gas lines and system purged out and furnace was accessible next morning. It was found that almost all the vertical radiant tubes were bent and entangled (Photo 1), convection section tubes and fins had melted out and burnt, even the HK-40 tube support plate for convection coil was partially burnt out. (Photo 2)

PHOTOGRAPH N°1 : TUBES IN RADIANT SECTION OF 103-B FOUND ENTANGLED DUE TO OVERHEATING

1. All the four radiant and convection coils, were replaced, damaged refractory in the radiant and convection zone was redone, repairs of instrument and electrical items was carried out and foundation and shell of heater was repaired.

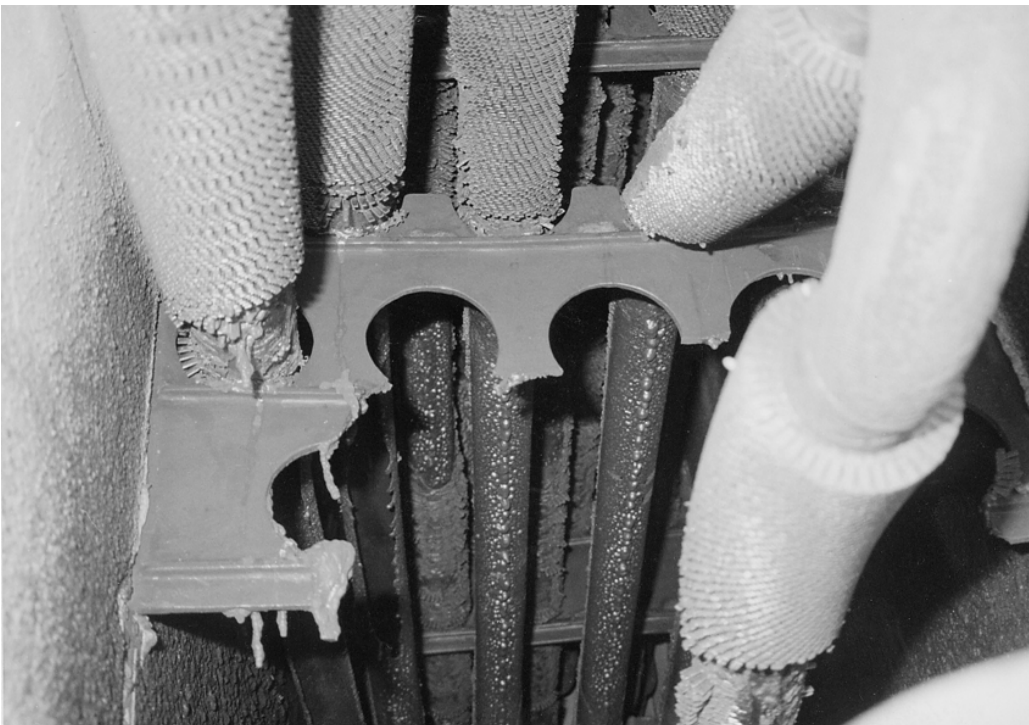
PHOTOGRAPH N°2 : TUBES IN CONVECTION SECTION OF 103-B FOUND MELTED, HK-40 TUBESHEET FOUND MELTED DUE TO OVERHEATING

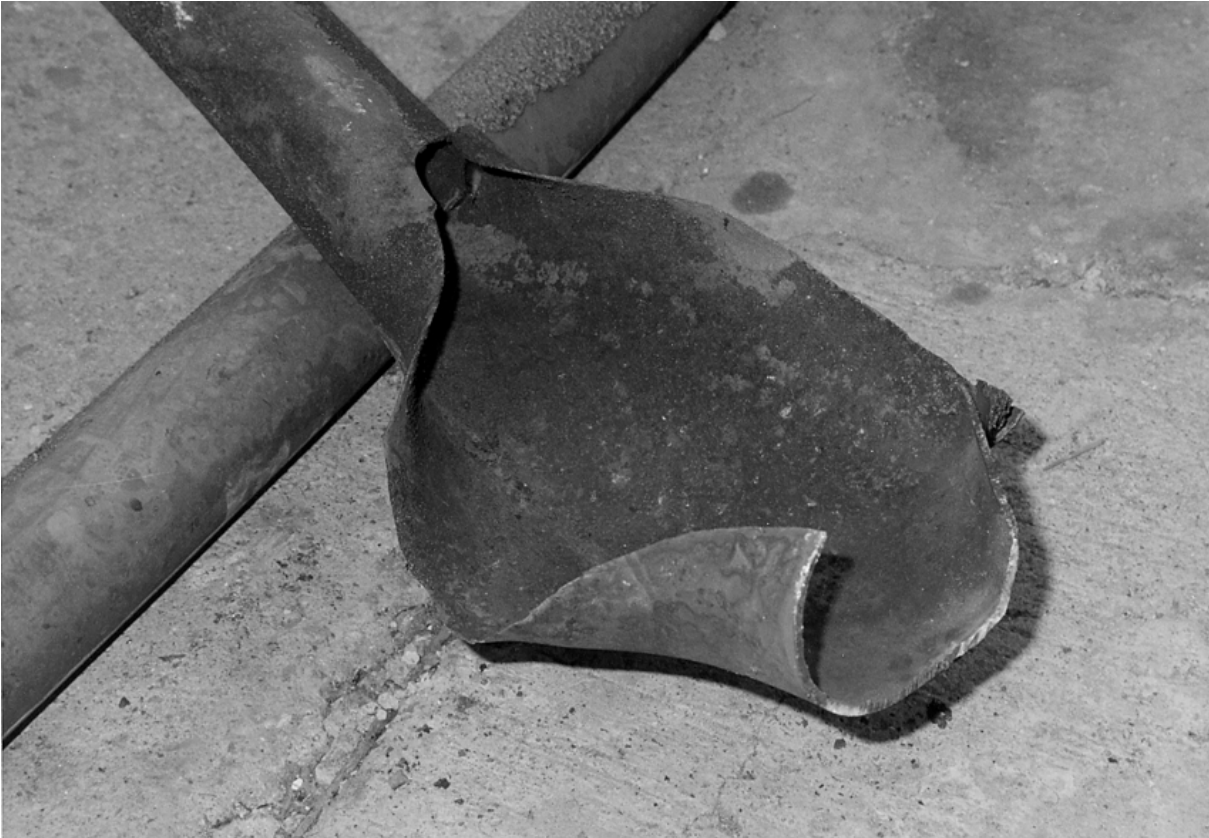
2. One tube in the radiant section was found to be burst open with length of rupture about 2 feet. (Photo 3)
3. The refractory in the area close to burst tube was found fallen and had loosened, resulting in exposure of shell of the furnace to heat and consequent bulging of the same.

The big fire and subsequent damage occurred due to bursting of one of the tubes in radiant section. This tube had thinned down at the burst open portion probably due to large radial expansion at that place caused by overheating of the tube. The overheating of tube can take place because of (a) dislocation of the radiant tube from top support and tilted portion coming closer to the burner flame (b) flames of the burner touching the radiant tube due to mal operation of the burner (c) another tube near the burst tube might have a small leak and flame directly touching the burst tube (d) overheating of the tube due to low flow of feed gas through the coil.

PHOTOGRAPH N° 3 : ONE TUBE IN RADIANT SECTION OF 103-B FOUND BURST OPEN

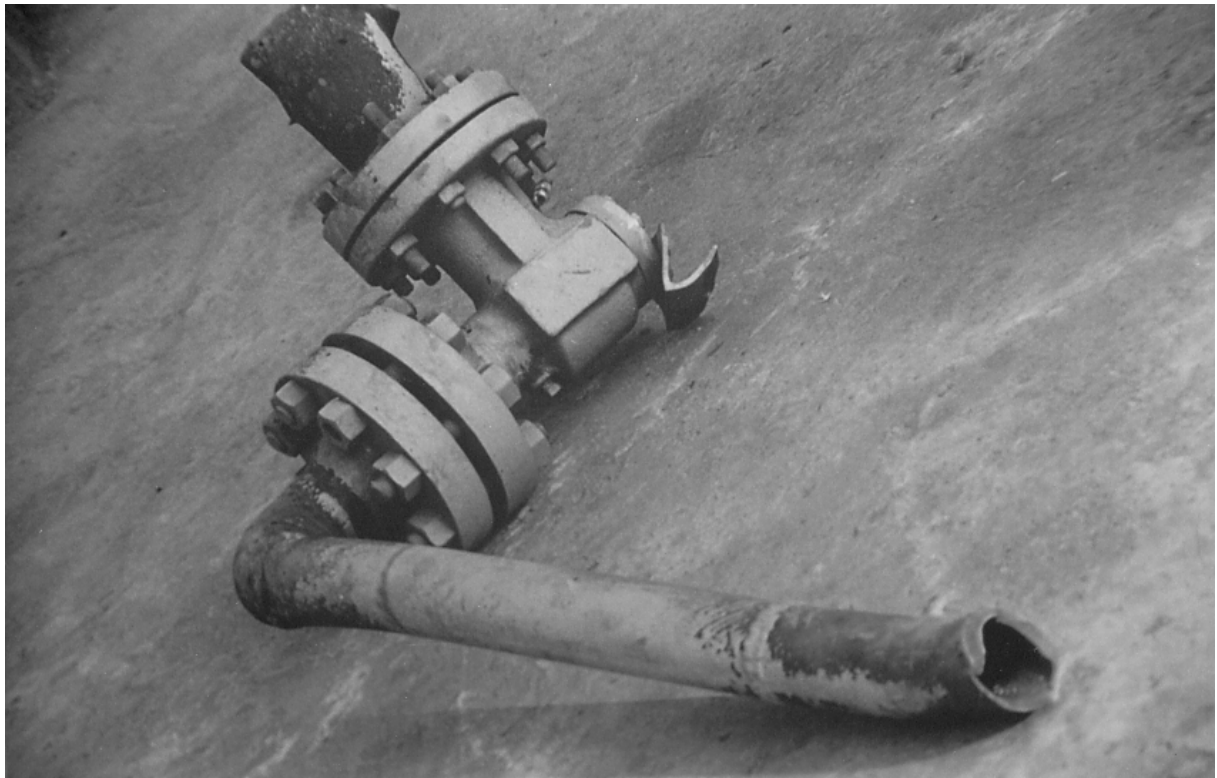
1. The pilot operated relief valve RV-156-C was uprooted from its inlet position (Photo 4), the tail pipe was knocked out of position and was found sheared and blown open (Photo 5 and 6). Due to explosion the relief valve was blown away to the nearby pipe rack. Pilot valve was found detached and lying on the ground.
2. Due to fire nearby exchangers were exposed to heat and became red hot and subjected to water spray also during fire fighting.
3. Cold insulation of vessels/exchangers in nearby area had burnt.
4. Power cables, lighting cables, instruments/tubes, trays and motorized actuators were found burnt.

PHOTOGRAPH N°4 : RV-156-C SHEARED OFF FROM MAIN PIPE AND THROWN AWAY

4. Location of RV-156-C has been changed and kept on pipe rack with self draining arrangement and with proper support. New RV with “K” orifice has been installed instead of “J” type orifice. Supports of similar RV’s have been strengthened.

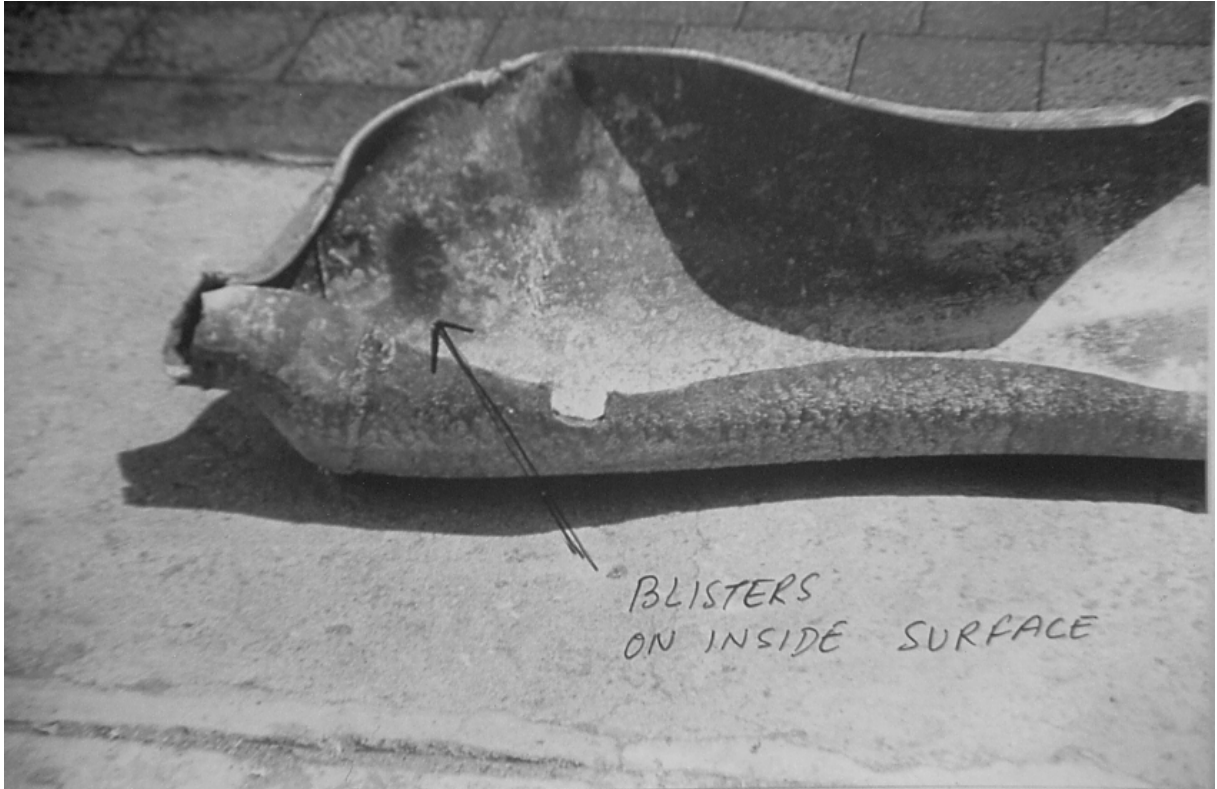
PHOTOGRAPH N°5 : SHEARED OFF TAIL PIPE OF RV-156-C

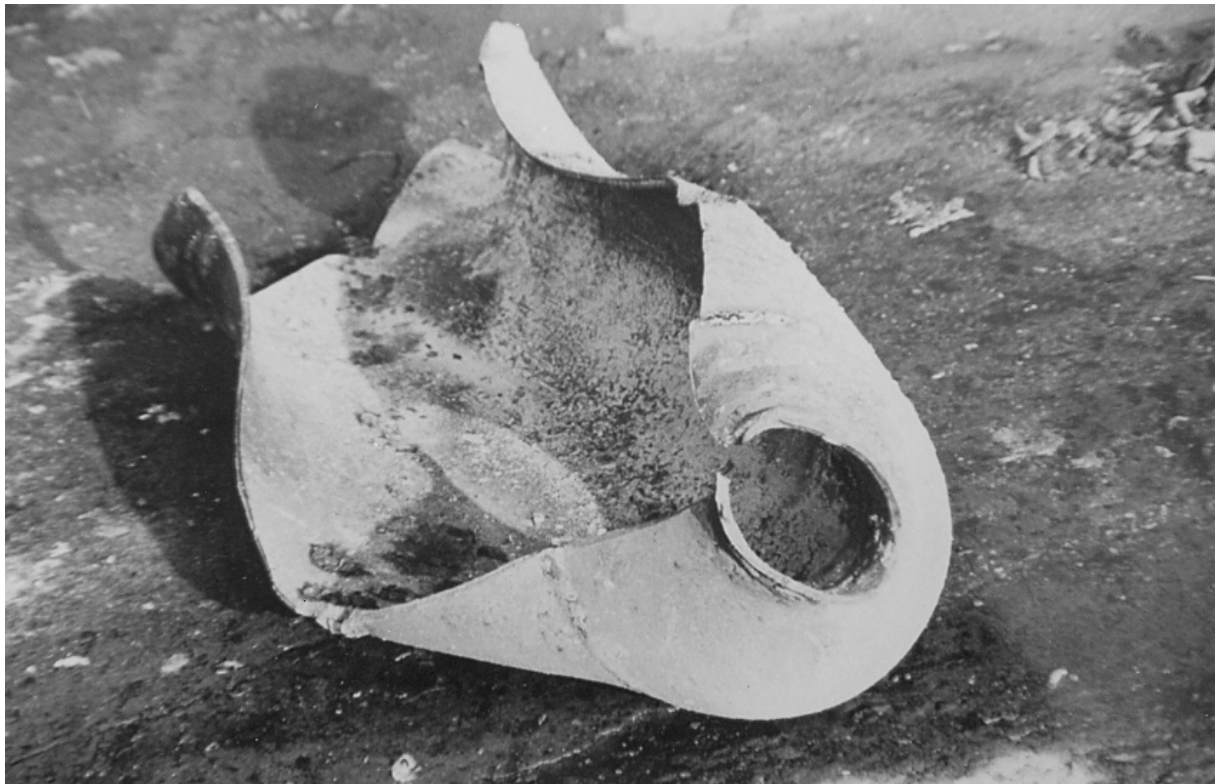
PHOTOGRAPH N°6 : SHEARED OFF TAIL PIPE OF RV-156-C

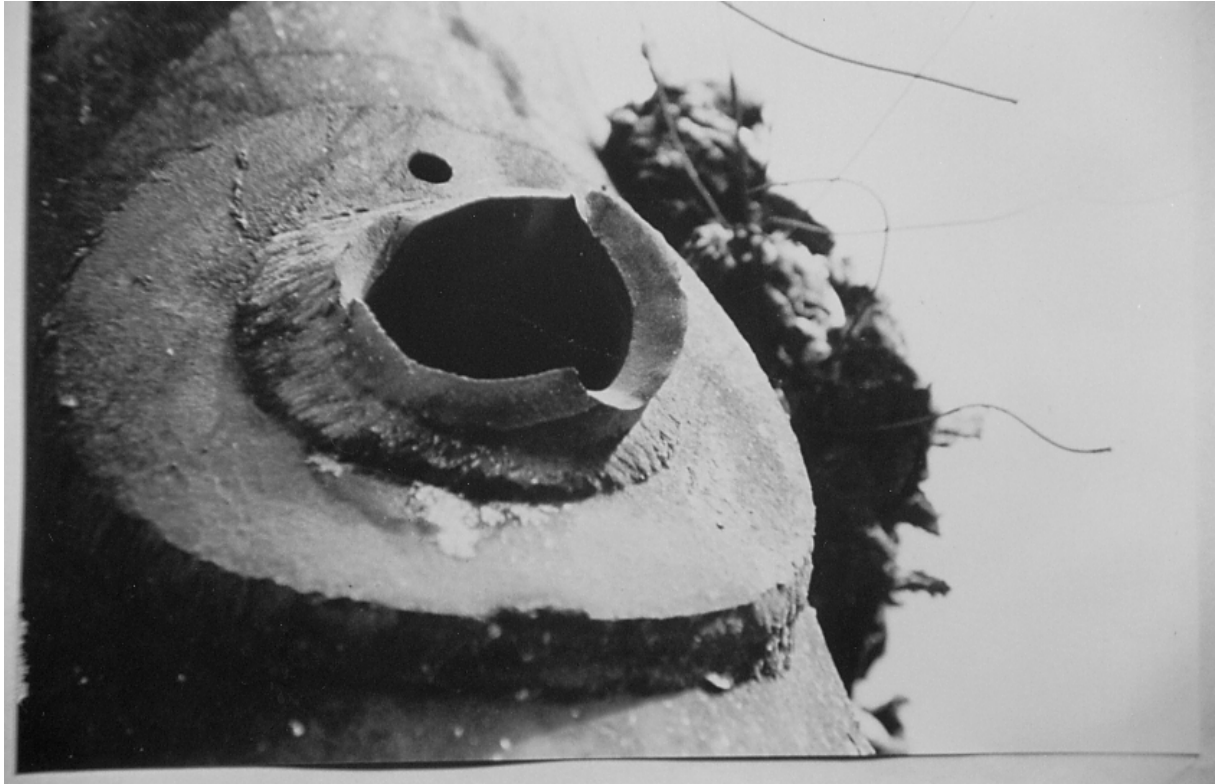
1. RV-156-C inlet lead pipe (3" NB Sch.140) was sheared off from parent pipe (10" NB Sch. XX) (Photo 7)
2. The failure took place at the Haz of welding, whereas there was no apparent damage to the parent pipe.
3. Sheared edges of the branch pipe clearly indicates reverse slant fracture which is usually associated with internal explosion. Tail pipe of RV was sheared off and ripped open and vertical support on exhaust pipe near RV-156C was pulled out of foundation.

PHOTOGRAPH N°7 : RV-156-C INLET PIPE SHEARED OFF FROM MAIN 100" PIPE
