# IFA Technical Conference

Chennai, India

# FAILURE AND REPAIR OF THE SECONDARY REFORMER – AN EXPERIENCE (a)

V. K. Bali\*, Indian Farmers Fertiliser Cooperative Limited (IFFCO), India

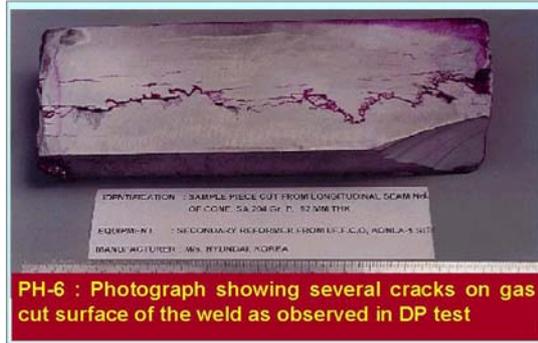
### Sample Piece Cut From Longitudinal Seam: L-1

Besides in-situ metallography, the samples of defective material were taken for metallurgical examination. Photographs PH-6 and PH-7 show several cracks on the sample piece cut from the weld and the HAZ of longitudinal seam L-1.

Visual examination of the fracture surface of the samples showed brown to dark brown color and brittle type of failure. The direction of fracture observed on sample removed from inside surface of longitudinal seam showed that the cracks had started from inner surface of cone and propagated towards the outer surface. Also, there were radial marks starting inside surface which are characteristic of brittle fracture. After the brittle fracture, some quasi-cleavage type of fracture was observed. Metallography examination revealed that cracks had started from heat affected zone at the toe of the weld and propagated into base material. The cracks are fine and transgranular in nature indicative of hydrogen assisted cracking.

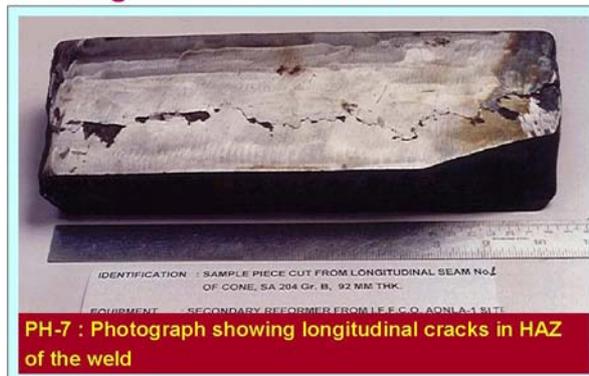
### Sample Piece Cut From Longitudinal Seam: L-1

Fractography of the sample using Scanning Electron Microscope was made to study the nature of cracking. The fractographs of the sample indicated that the main cracking which resulted in failure was of brittle mode and the cracks were intergranular in nature indicating towards hydrogen embrittlement as cause of the failure.

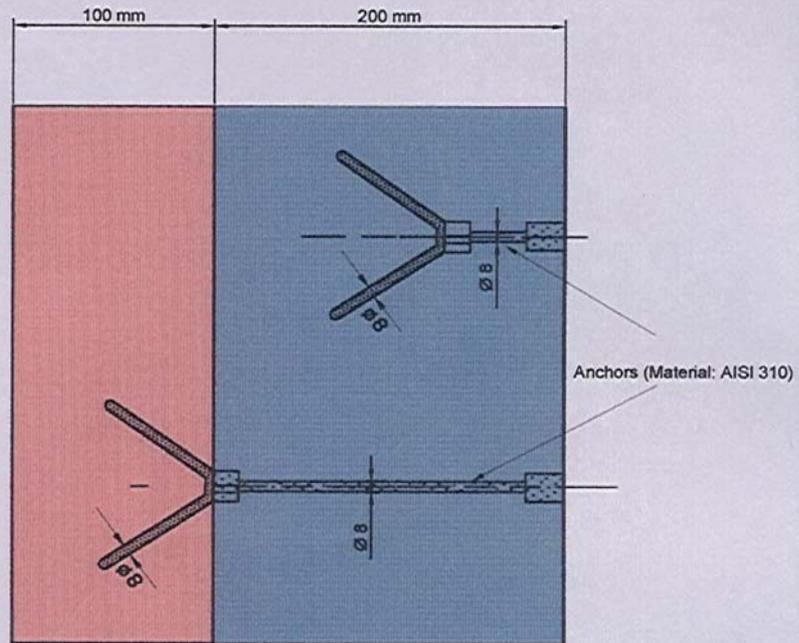
Figure-3

The first layer in contact with secondary reformer vessel is 200 mm thick insulating castable refractory (50-60% alumina). The next layer, which is in contact with insulating layer on one side and the high temperature process gas on the other side, is high alumina castable refractory (94% alumina). All these refractory are held together by stainless steel anchors which are welded to the vessel (**Refer Figure 3**).

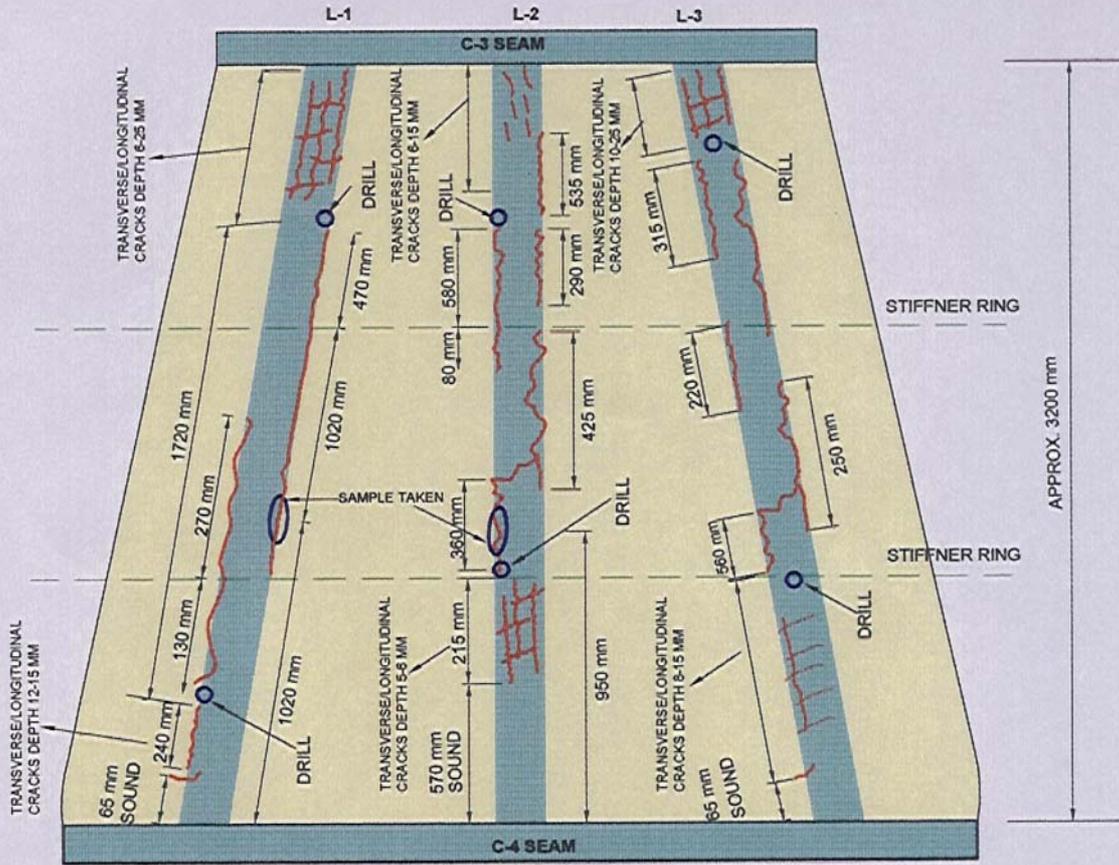
Figure-7

<b>Weld seam No. L-1</b>
<ul style="list-style-type: none"> <li>1650 mm long crack at weld edge with depth varying from 10 mm to 92 mm from inside.</li> </ul>
<b>Weld seam No.L-2</b>
<ul style="list-style-type: none"> <li>1350 mm long crack at weld edge with depth varying from 12 mm to 62 mm from inside.</li> </ul>
<b>Weld seam No. L-3</b>
<ul style="list-style-type: none"> <li>2360 mm long crack at weld edge with depth varying from 12 mm to 62 mm from inside.</li> </ul>
<b>Weld seam No.L-4</b>
<ul style="list-style-type: none"> <li>A 65 mm long crack observed in UT at a distance of 290 mm from the lower edge of the weld seam. The same was confirmed by DP/MPI from inside. The depth of the crack was 6 mm to 7 mm.</li> </ul>
<b>Weld seam C-3</b>
<ul style="list-style-type: none"> <li>39 Nos transverse micro cracks were observed during DP test from inside on the weld and Heat Affected Zone. Depth of cracks was 5 to 6 mm.</li> </ul>

### LOCATION OF CRACKS ON L- SEAMS

- Depth of transverse cracks observed in U.T in the range of 6-8 mm .
- Depth of longitudinal cracks observed in U.T in the range of 10-15 mm & at few locations 25 mm .
