# IFA Technical Conference

# SHAFT OIL BARRIER SEALS CAN CAUSE HIGH VIBRATION. DO YOU KNOW ? (a)

(A Case Study of High Vibrations in Syn Gas Compressor, its Diagnosis and Correction)

Arun Kumar National Fertilisers Limited, Panipat Unit, India

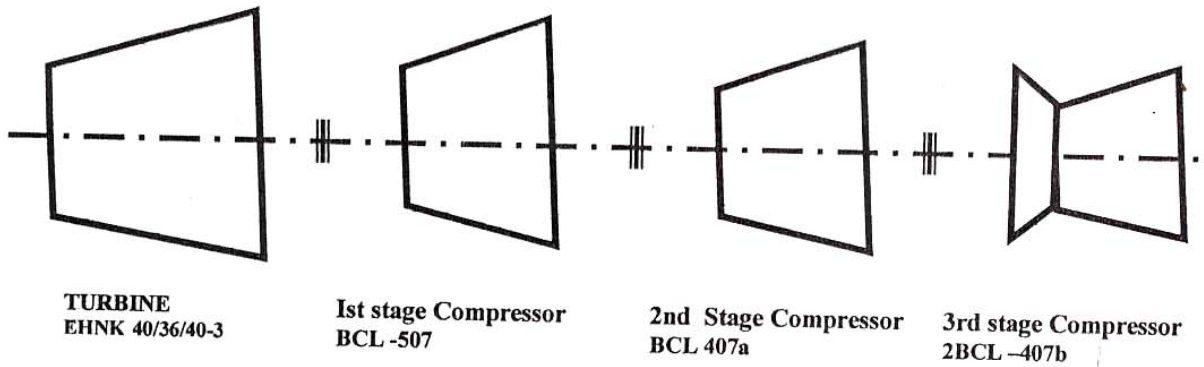
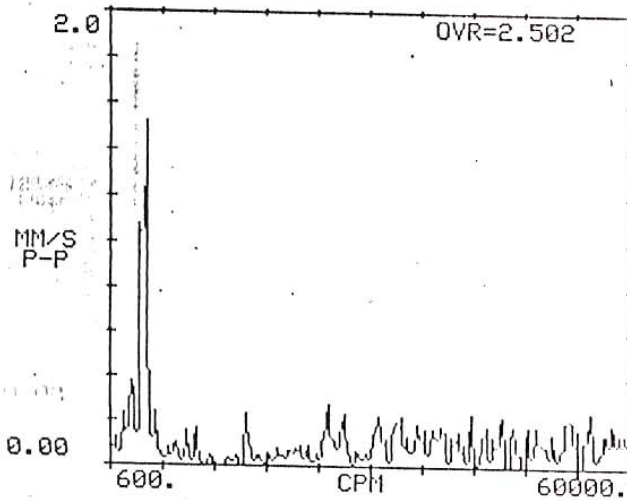
## ANNEXURE - I

The vibration signatures were taken (by instrument CSI, model: 1900). Peak component was occurring at 0.42 to 0.45 times the RPM. Kindly refer Annexure I, for vibration signatures. Generally such low frequency vibrations, below frequency of 1 x RPM (0.42 to 0.45 times RPM) are associated with oil whirl phenomenon. It was felt that the problem was of Oil whirl occurring at journal bearings. Hence the oil pressure to journal bearings (both ends) were changed along with temperature as a remedy for problem of oil whirl, but no change in vibrations was observed. Hence chances of oil whirl appearing in journal bearings were eliminated.

SIGNATURES OF SHAFT VIBRATION (2<sup>nd</sup> Stage)

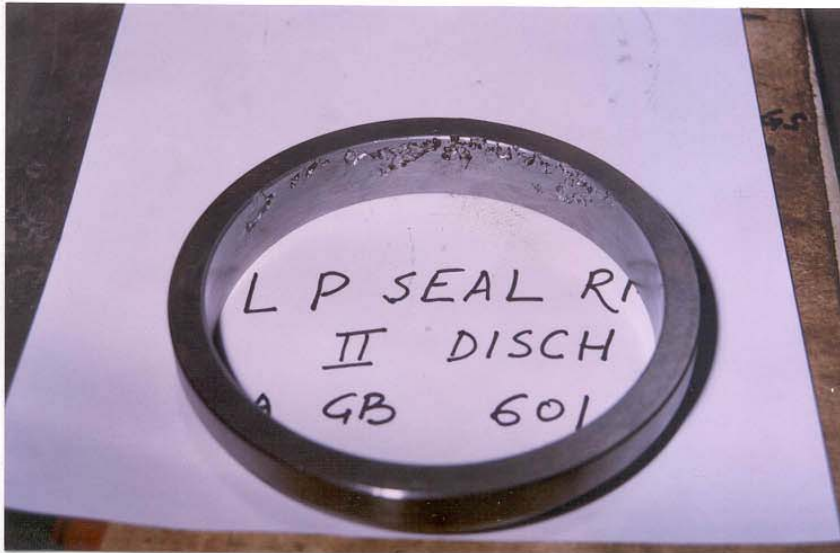
ANNEXURE-III

- Suction side journal bearing pads had rubbing. Removal of babit material at one edge was observed (refer Annexure III).
- The discharge and suction end oil barrier seal rings were found to be rubbed and deep pitting was found on the babit metal (refer Annexure III)
- The edge of the slot on the leaf spring was found digging inside its resting face on HP seal ring.

**OIL BARRIER SHAFT SEAL RINGS**  
(Showing rubbing & deep pitting)

To prevent the restricting of floating action of HP seal ring, all concerned areas were taken care of as follows: a)The journal bearings were replaced with new bearings with lower clearance. b) The new HP seal ring with higher clearance of 0.09mm to 0.1mm was fixed. A chamfer of 45 degrees was provided at oil inlet ends of HP seal ring. c)The assembly of seal rings were made with leaf spring positioning in such a way that slot on leaf spring did not rest on face of seal ring,(i.e., it was set in air). Kindly refer Annexure IV for correct and incorrect position of leaf spring.

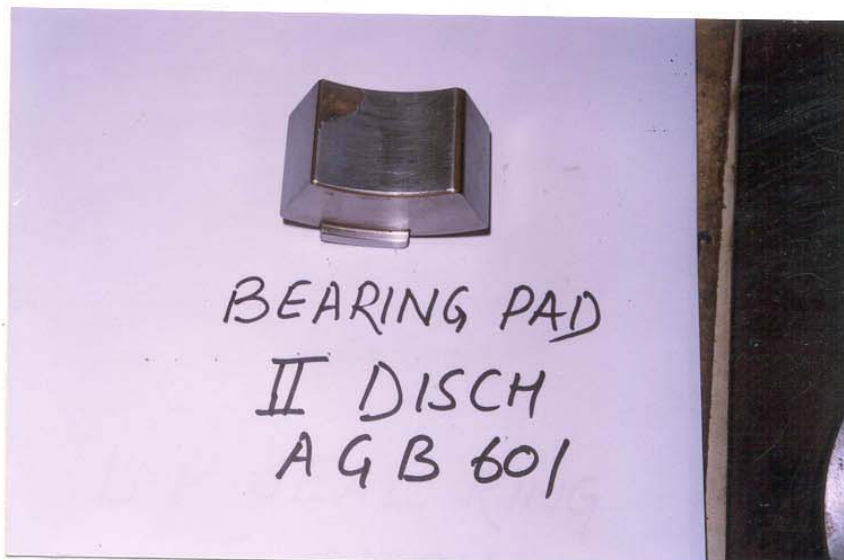
**DAMAGED JOURNAL BEARING PAD**  
(Removed Babbit metal at corner)

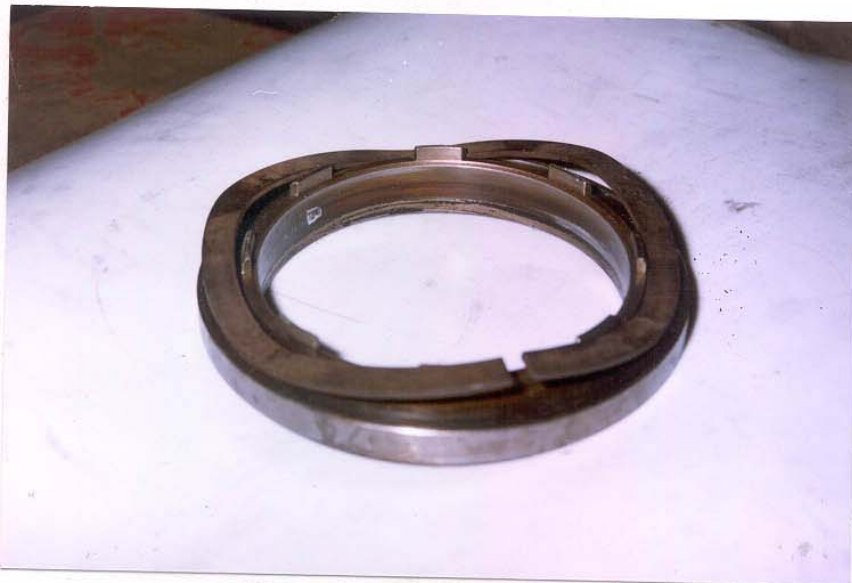
**SEAL ASSEMBLY IN RIGHT WAY**  
(Edge of the Leaf spring NOT resting on seal ring face)

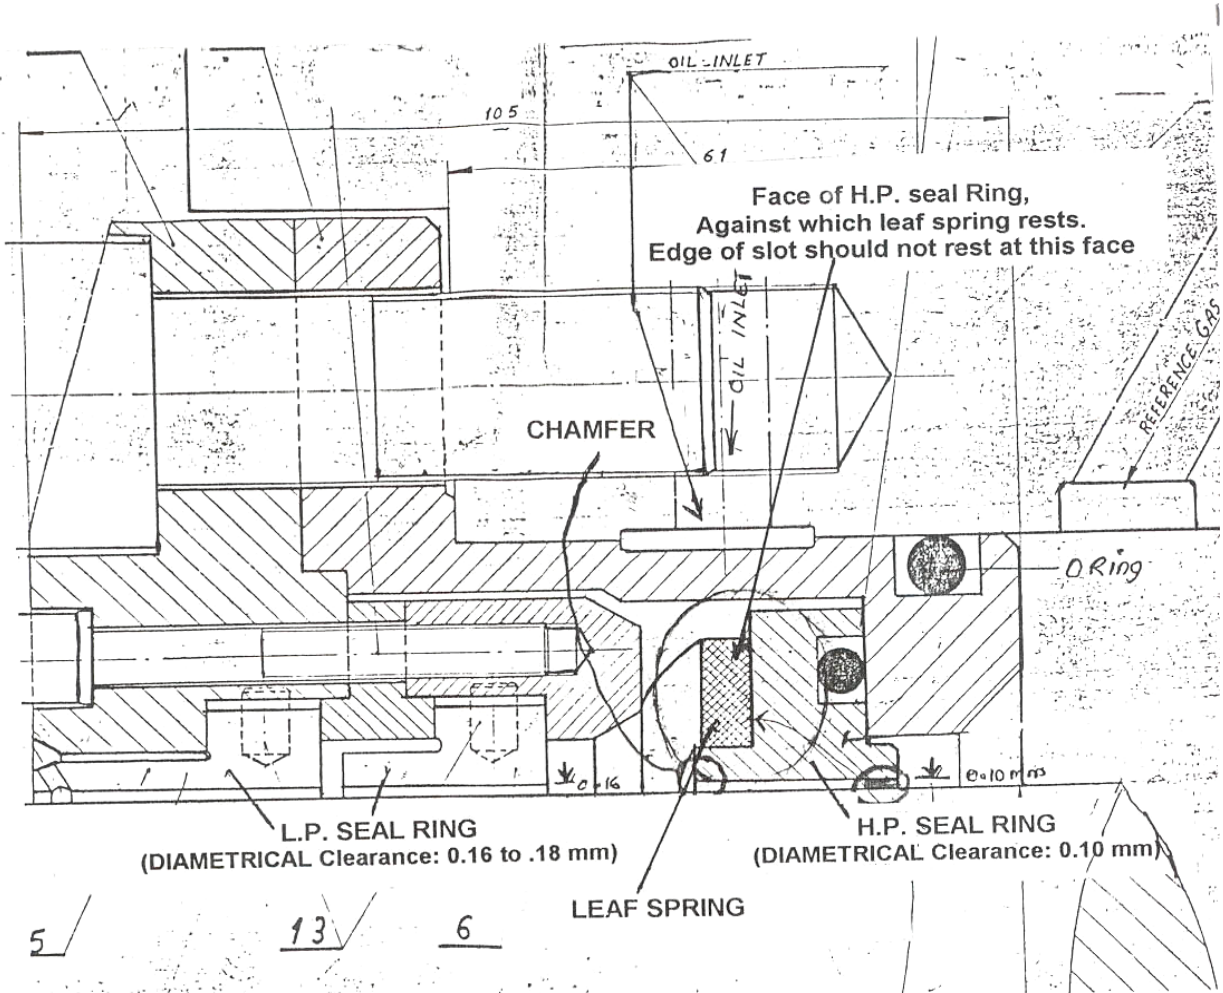
**OIL BARRIER SEAL ASSEMBLY  
(MODIFICATIONS FOR OIL WHIRL AVOIDANCE)**
