Technical Committee Meeting

A CASE STUDY ON ROTOR DAMAGE DUE TO ELECTROMAGNETIC SHAFT CURRENTS AND SUBSEQUENT COUPLING INSTALLATION PROBLEMS FACED ON SYNTHESIS GAS COMPRESSOR OF AN AMMONIA PLANT

by: K.L.Singh and K.J.Patel IFFCO, Kalol, India

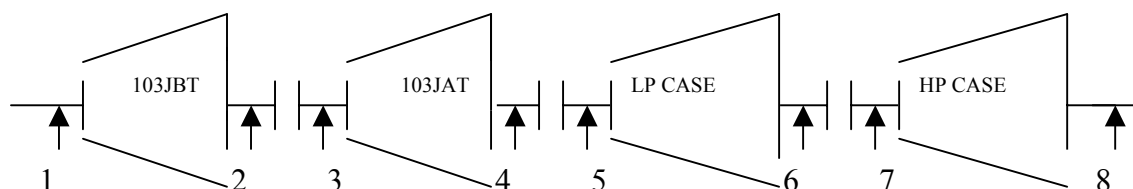
Figure 1: Machine Train Diagram

The synthesis gas compressor train consists of a barrel type LP and HP compressor cases driven by two turbines running in tandem, one out of which is a back pressure turbine and the other one is a condensing turbine. The machine train diagram is shown at Figure 1.

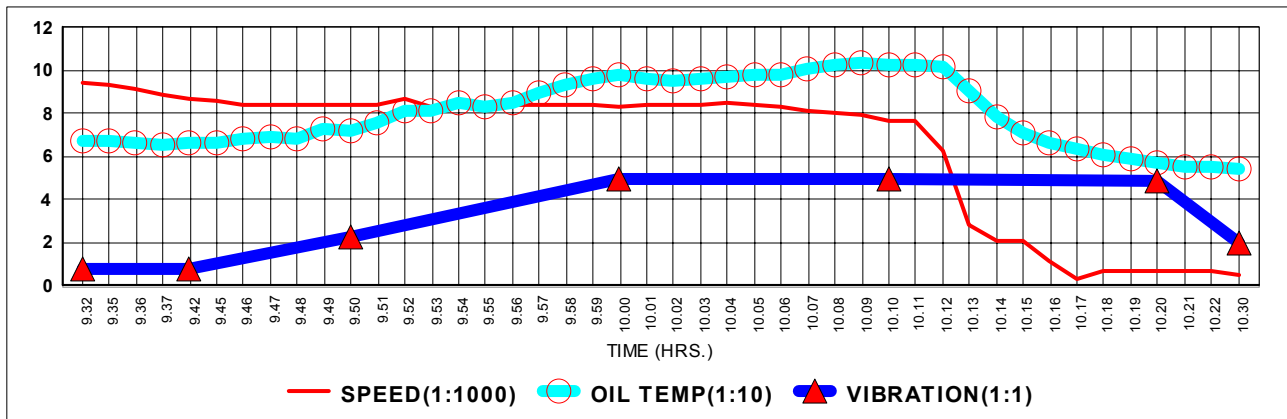
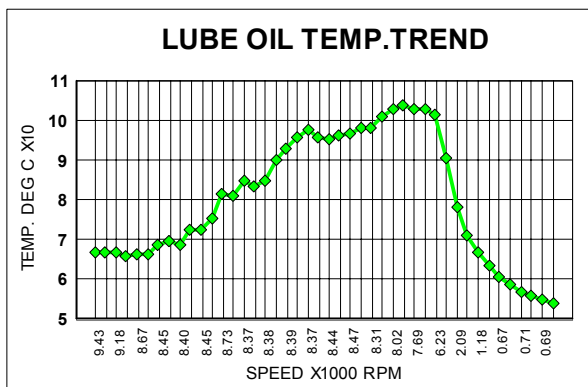
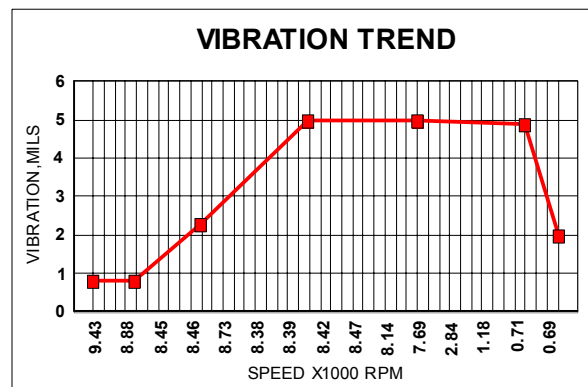
Table-1: Speed, vibration and lube oil temperature data.

The three critical parameters viz. speed, lube oil temperature and the vibration levels on the steam exhaust end bearing, just before the incident and during the process of shutdown were recorded and these are given at the Table-1 below. Graph 1 shows the multiple variable trends for the parameters viz. Speed, vibration amplitudes and lube oil temperatures. The Graph 2 (Speed vs. Oil Temperature) and Graph 3 (Speed vs. Vibration) show the individual trends.

Detailed survey of all the possible reasons for the failure was made. The failure of the bearing was not due to gradual deterioration but the catastrophic failure of the bearing was evident from the vibration data and trend shown in the Table 1 and Graph 1 respectively. Just before the incident, vibration levels were 0.8 mils on non-contact surveillance system. The rise in bearing drain oil temperature took place very rapidly. At 9.48 AM, it was normal i.e. 68.8 deg C while within the time gap of only four minutes, temperature reached 81.6 deg C i.e. there was a rise of 13 deg C in drain oil temperature. The metal temperatures are predicted to have reached very high levels beyond the melting point of white metal. The reason for keeping the turbine running for quite some time was evident from the fact that the temperature gauge on the pipeline in the field was being changed to ascertain the correctness of the reading. The time gap between 9.52 AM to 10.05 AM was long enough to show the temperature reading of 98.2 deg C. Even after stopping the compressor unit, the temperature continuously went up and reached the highest level of 103.9 deg C at 10.09 AM.

The trend of the vibration levels is shown at Graph 1. It is revealed from the data that the shaft vibration levels were just 0.8 mil till 9.42 am which increased to 2.27 mils at 09.50 am. After two minutes, at 9.52 am, bearing drain oil temperature crossed the alarm levels and shot up to 81.6 deg C from a normal level of 66.3 deg C recorded at 9.42 am i.e. rise in drain oil temperature by 15.3 deg C within a span of 10 minutes.

This confirms spontaneous failure of the bearing, which is a common phenomenon for the failure due to high magnetism levels in turbo machinery. Also there were spikes seen on the time wave form as well as on the unfiltered orbit as if there was the presence of the electrical run out just before the incident which are indicative of the flow of magnetic currents through the shaft near the probe area.

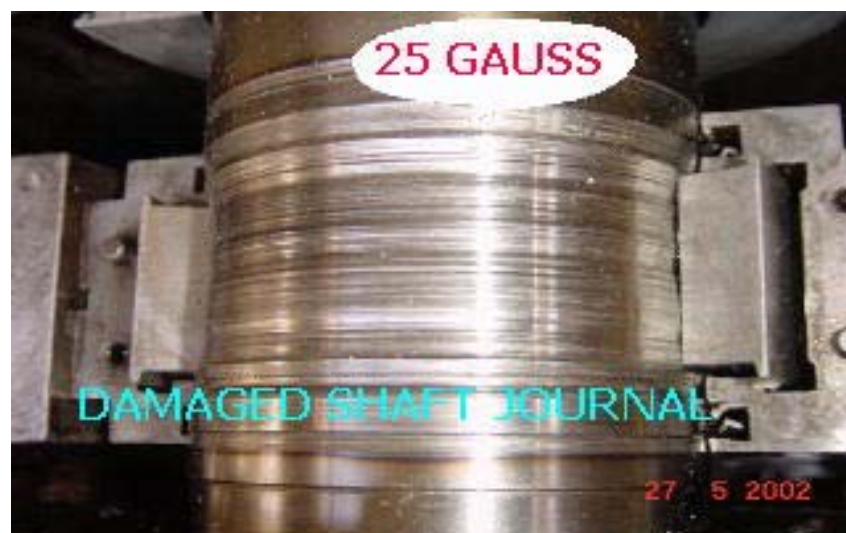
Photograph 1 Damaged Shaft Journal

The turbine bearings were inspected immediately on shutdown. The exhaust end bearing was found badly damaged causing total loss of white metal lining. The shaft surface on the journal area was observed to have 1 mm to 1.5 mm deep scores due to heavy friction. The bearing at the other end showed little rubbing marks.

1. The residual magnetism levels were checked on the failed shaft journal on the exhaust end. The magnetic field strength of 25 Gauss max. was recorded on the journal after disassembly of the rotor. The photograph below shows the measured readings on the rotor at different areas. This level is very high as compared to the normally permissible levels of 3 to 4 gauss on the shaft journals, which is a close clearance zone of the high speed turbine shaft.

All the above symptoms lead to the conclusion that the failure was a result of excessive magnetically induced currents. It is worth mentioning that the level of magnetism was found to be concentrated on only the exhaust end bearing journal/casing and there was no sign of appreciable amount of residual magnetism on the other parts of the rotor as well as casing.

It was a challenging task to undertake degaussing of the bearing housing which was the part of the huge casing. Portable demagnetizing equipment was used to undertake the degaussing. The magnetized surface was scanned with electromagnetic yoke (normally used for the purpose of magnetic particle inspection) while keeping the demagnetizing current 'ON'. The instrument got the facility to perform demagnetizing with AC currents producing reversing fields. Since the direction of the magnetic field was of complex nature showing irregular distribution of the field polarity, about six scans were required to be performed to bring down the level from 25 Gauss to 5.8 Gauss. Permissible magnetism levels are given at Table-2 below for reference.

1. During all inspection opportunities, it should be made a practice to inspect the bearings, journals and other accessible components for the residual magnetism levels. If these levels are found beyond the above referred maximum permissible levels, it is highly recommended to perform degaussing using the suitable instrumentation and expertise.

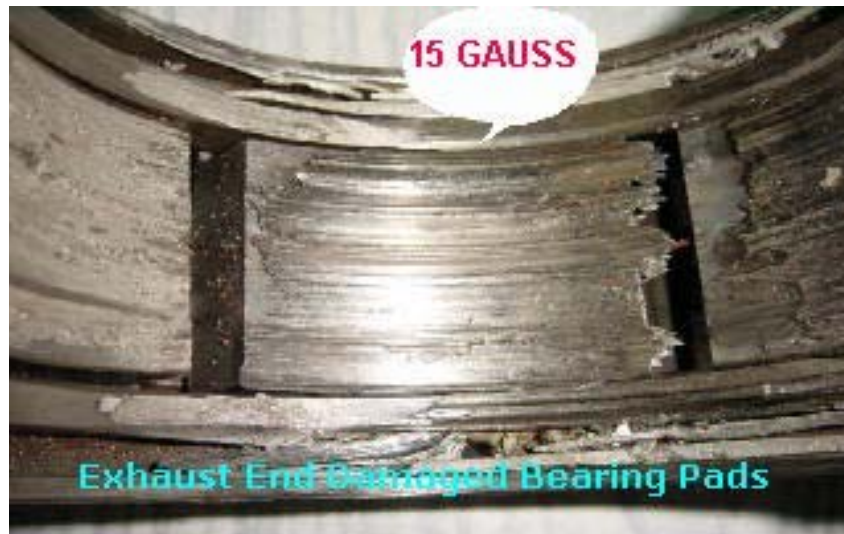
Photograph 2 Damaged Bearing Pads

2. On the damaged white metal lined bearing pads (from where white metal lining was badly rubbed out and barely any amount of white metal could be visible on them) , max. strength of the magnetic field density was 15 gauss. The photograph below shows the readings.

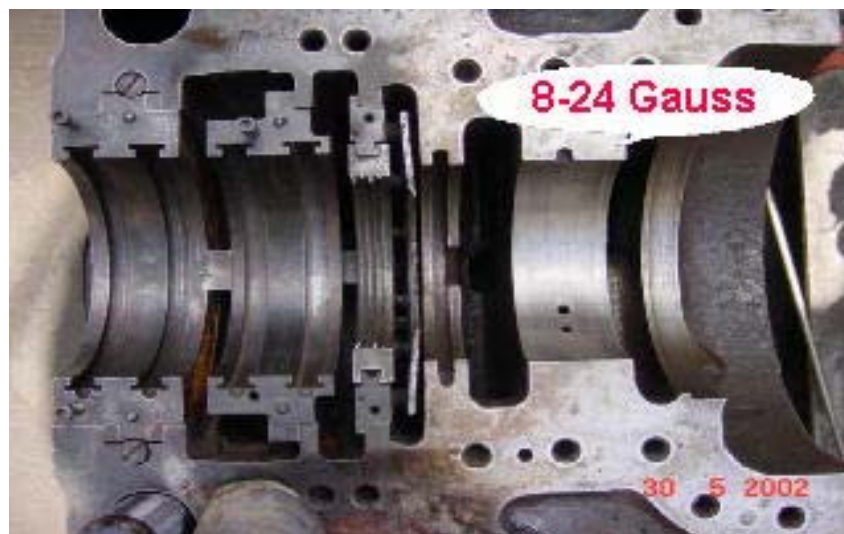
Photograph-3 Journal Bearing Shell Casing

3. The casing, on which the bearing shell was fitted, was also checked for the residual magnetism levels. The levels were recorded as high as 24 Gauss. Photograph 3 shows the readings.

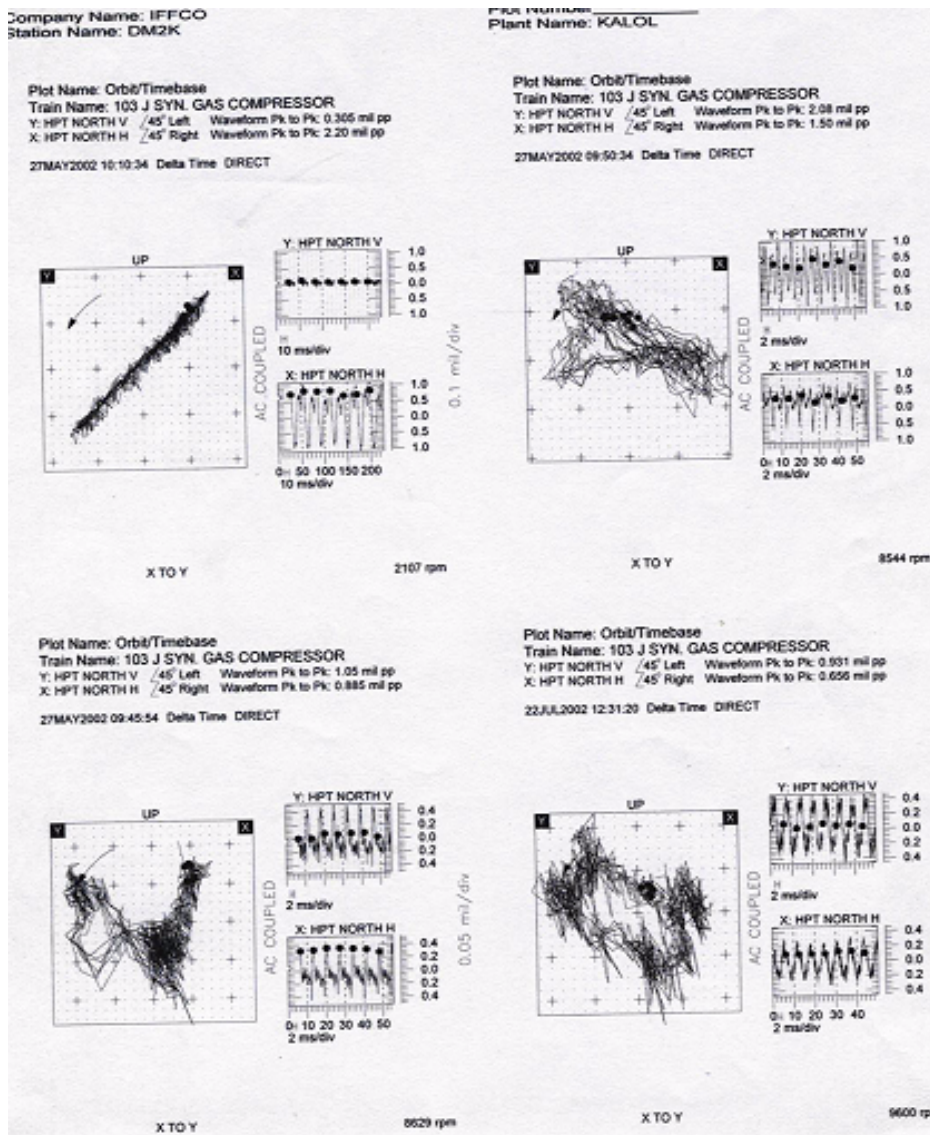
Figure 2 Vibration data viz. Orbit and waveform plots prior to, during and after failure

Figure 2 shows the unfiltered orbit and wave form shapes at different speeds of the unit during the failure (27.5.2002) and during the normal plant operation (22.7.2002).

4. 7200 Series vibration monitoring system is to be replaced by advanced vibration surveillance system, 3300 Series of Bently Nevada and the shaft vibration levels will be included in the trip logic to safeguard the machine against high radial vibrations.

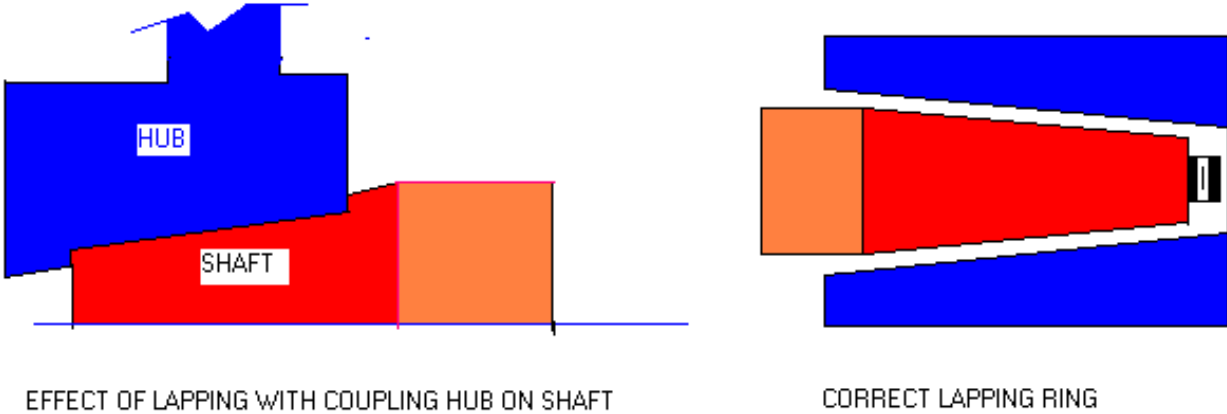
Figure 3 Result of lapping the shaft with the coupling hub

After lapping operation and achieving the better contact area, the coupling hub was again taken up for installation. The drive required after expansion, using the hydraulic coupling installation device, was still not available. As against 0.400 inch drive required, only negligible drive could be achieved even with very high installation pressures on the hydraulic tool. It was concluded that the reason for the difficulty in the installation of the coupling hub was the improper lapping practice.

Figure 3 below shows the condition when the coupling hub itself was used to lap the taper surface on the shaft for removal of minor high spots. The localized steps created on the shaft as well as on the hub bore prevented the hub to get the required drive. Even micro step cut during lapping by coupling was so deep that the pressure exerted by the hydraulic installation device was insufficient to drive the coupling hub on the shaft with specified interference fit.

In order to remove the steps created by lapping with the coupling itself, suitable lapping tools (ring and plug tools) of cast iron were prepared to lap and match the taper of the shaft and the hub. These lapping tools were checked for the perfect match and then were used to lap the tapered surface of the coupling seat area on the shaft as well as for lapping the tapered surface of the coupling hub bore. It was ensured that the tool length covers the entire tapered length of the hub and shaft so that no step shall be cutting during the process of lapping. This procedure resulted in the successful installation of the coupling.
