IFA Technical Conference

**Beijing, China
20-23 April 2004**

FALL IN EFFICIENCY IN SYNTHESIS GAS COMPRESSOR DUE TO 'O' RING EXTRUSION (A CASE STUDY)

Arun Kumar
National Fertilizers Limited, India

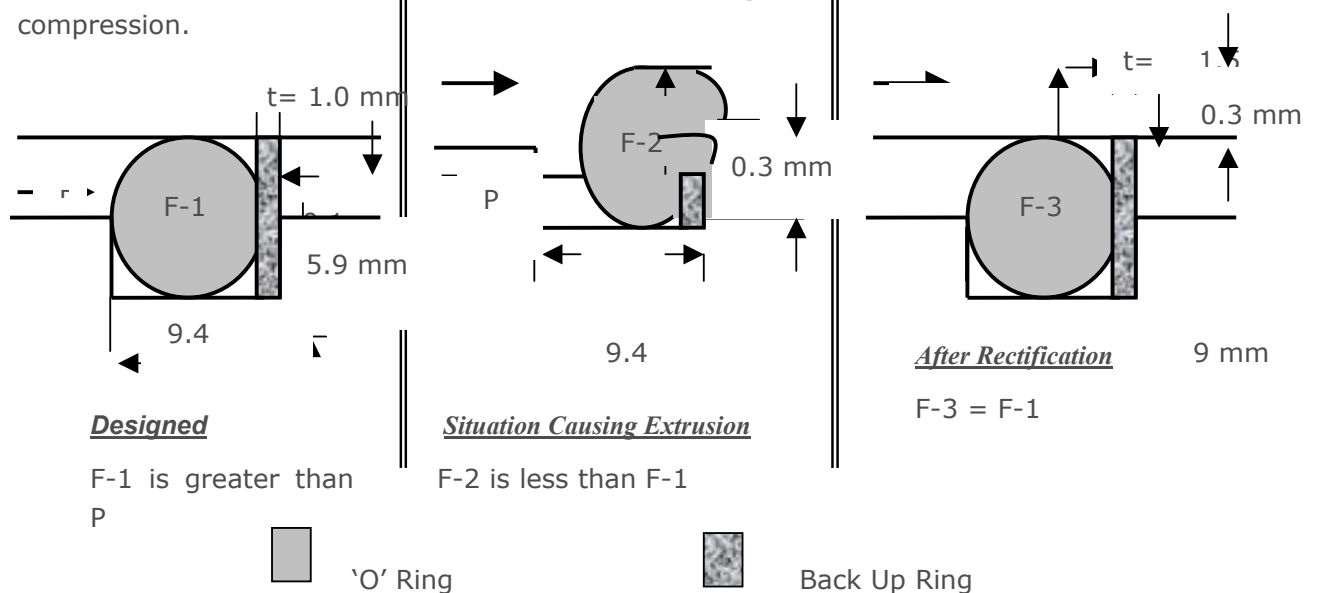
Hence in such situation, the pressure of gas from high-pressure side can easily extrude such 'O' ring and finds its way for bypassing towards low-pressure side. The actual compression or nip in 'O' ring should be 15% to 30% depending upon pressure to be

But due to increase in clearance to 0.6mm the 'O' ring could become 6.2mm after the compression.

We wisely increased the nip or compression of 'O' ring by providing extra back up ring, due to which the sealing force generated was more than the pressure to be sealed and hence was able to provide successful sealing without any extrusion.

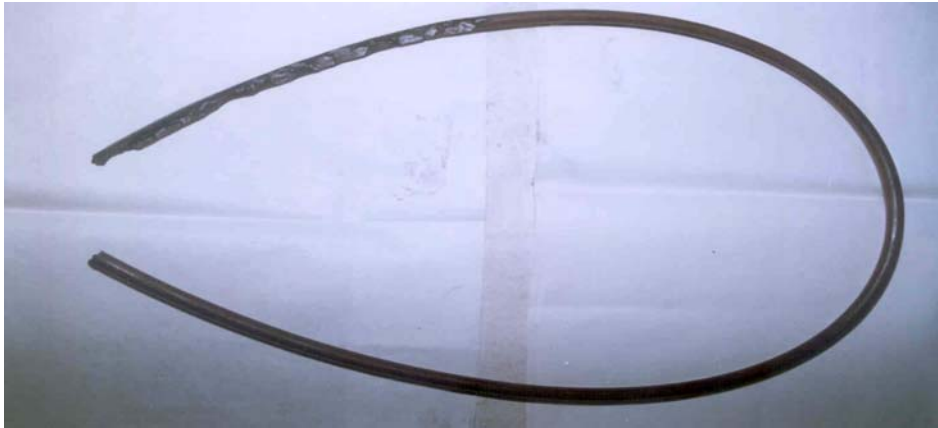
EXHIBIT 2

The job of overhauling was taken up on 22.2.2003. A shutdown of plant was taken. The casing was removed, opened, and diaphragm pack was taken out. On opening of casing, complete 'O' ring of diaphragm along with its back up ring was found missing. Only about 10 inches length of 'O' ring and its back up ring was left at bottom end. (Refer Exhibit 2 and 3 in Annexure-III).

As cause of problem was the extrusion of 'O' ring, which happened due to lack of nip or squeeze (compression) in 'O' ring. This was due to increase in diametrical clearance between casing bore and outer dia of diaphragm, because of damage/pitting on seating

area of casing bore. The clearance was 0.6 mm against maximum design value of 0.2 mm.

Damaged 'O' ring of diaphragm

Hence after technical deliberations, it was planned to rectify the problem by increasing the nip or compression in 'O' ring with extra thickness of back up ring (Teflon ring), along with the 'O' ring. Originally as per design we had back up ring of 1.0mm thickness. We provided one more back up ring with thickness of 0.5mm along with 1.0 mm back up ring (towards low pressure side). Two rounds of Teflon tape were provided below the 'O' ring. Refer sketch-3 and exhibit-5 in Annexure-IV.

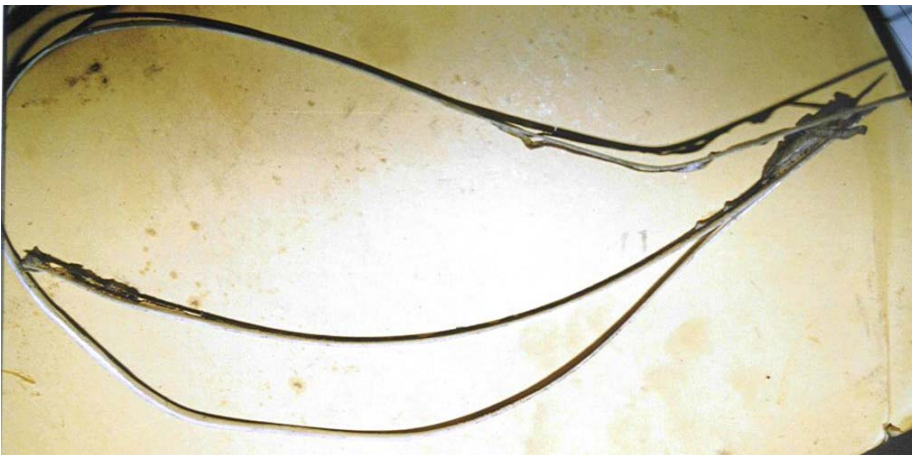
EXHIBIT 3

Damaged back up ring

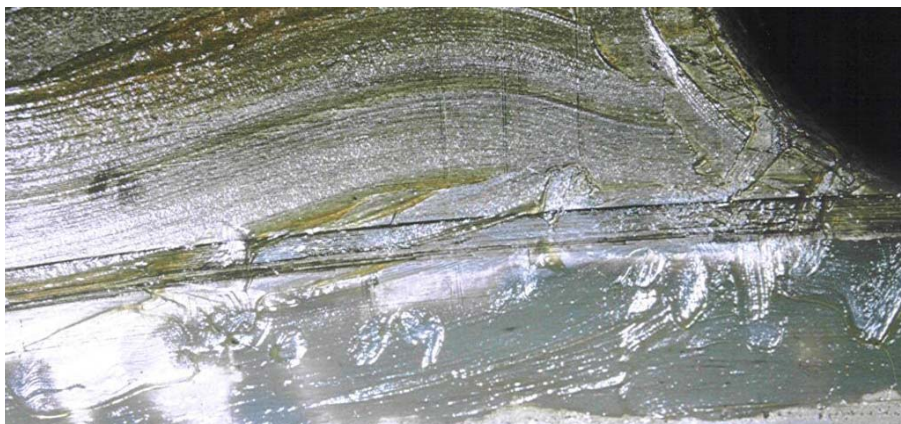
EXHIBIT-4

Lot of pitting was observed at seating area of 'O' ring on casing. (Refer exhibit – 4 in Annexure-III). The critical dimensions like bore of casing at 'O' ring seating and outside diameter of diaphragm at 'O' ring groove were measured.

Casing I.D.: 810.50 mm. Diaphragm O.D: 809.90 mm.

Width of 'O' ring groove: 9.4mm. Depth of groove: 5.9 mm

O ring thickness: 7 mm. Hence the diametrical clearance between Casing and Diaphragm: 0.6 mm

The problem of 'O' ring extrusion in subject case was due to lack of nip or compression in 'O' ring due to increased diametrical clearance between diaphragm pack and casing. This was due to damage / pitting in casing bore at 'O' ring sealing area. This pitting has been observed in number of sites in such compressors, which have been operating for longer time of more than 20 years and have floating type oil seal rings for end sealing of compressor. There is always small carry over of oil along with the gas even with good condition seals. With the time this oil gets stagnated in area adjacent to 'O' ring of diaphragm. This stagnated oil results into fretting corrosion, causing pitting in such area. Such pitting with the time destroys the 'O' ring seating area on casing, thus 'O' rings loses its nip. This lack of nip in 'O' ring no more can generate sealing force, which should be essentially more than the pressure to be sealed.

Pitting damage on casing at "O" ring seating

Though this provided solution to problem within a very short shutdown of machine but chance cannot be taken to continue with this unconventional repair for a very long time. Hence the permanent solution involving casing repair shall be done during planned Annual Turnaround of the plant.

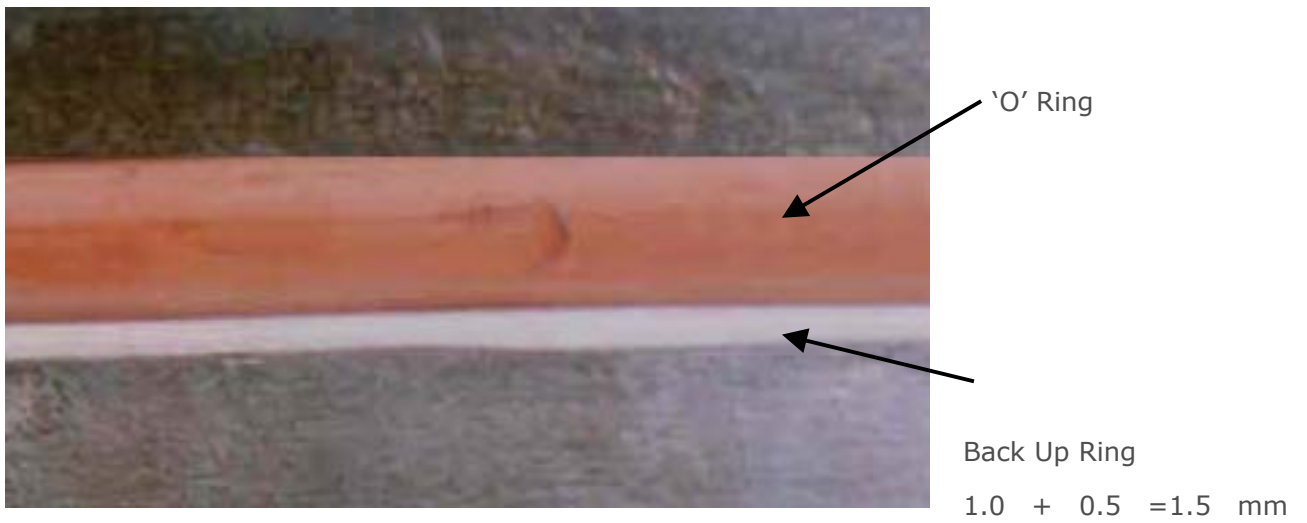
EXHIBIT 5

Fitting of New 'O' Ring and back up rings on Diaphragm
