IFA Technical Conference

MILLING PHENOMENON EXPERIENCED IN THE PRIMARY REFORMER OF AN AMMONIA PLANT AT NFCL – KAKINADA (a)

Ch Varahalu*, G Kameswara Rao** & V Sunder***,
Nagarjuna Fertilizers and Chemicals Ltd., India

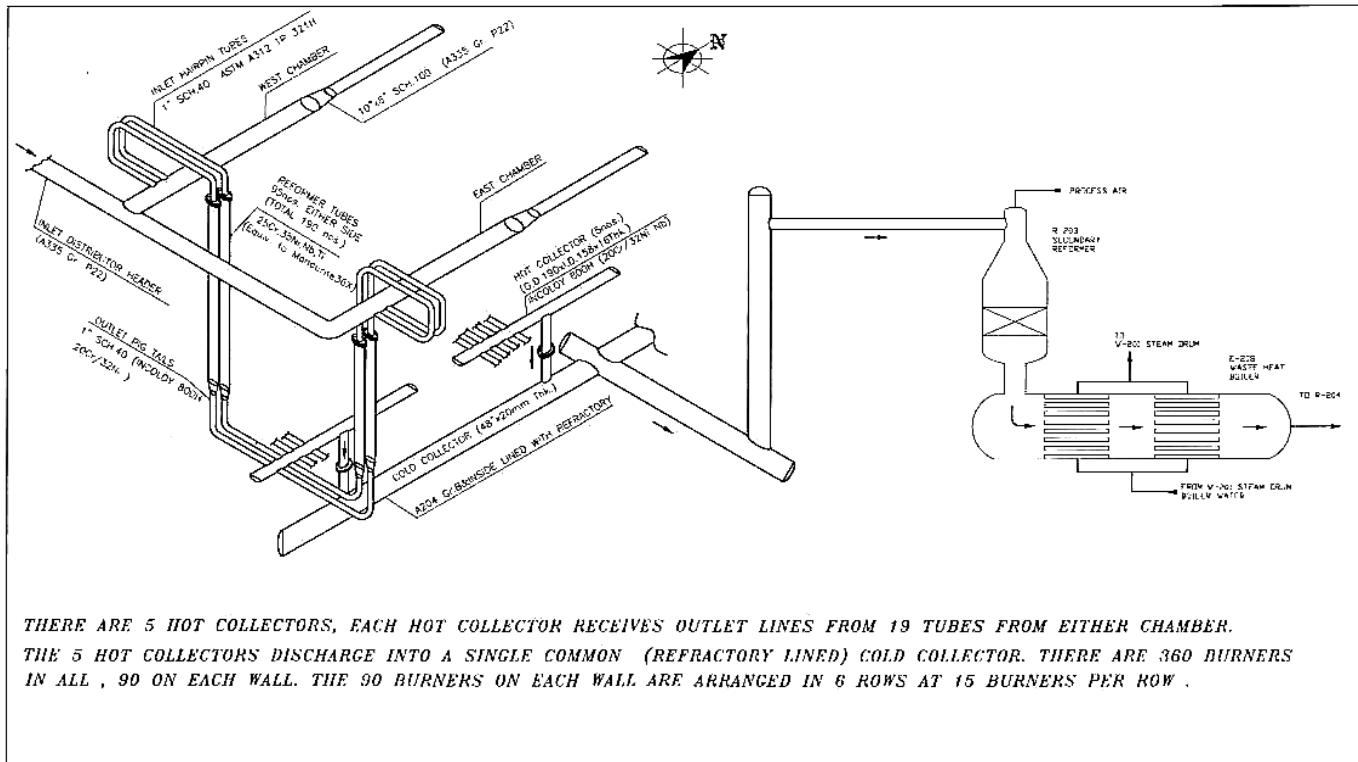
Figure 1

The inlet gas distribution system consists of a header and 95 inlet pigtailed for each chamber. The inlet pigtail is connected to the catalyst tube at the top by means a flange and gas enters the tube axially at the top. The outlet distribution system consists of five hot collectors to which a bank of 19 tubes from each chamber is connected by means outlet pigtailed. The hot collectors in turn deliver the process gas into a refractory lined common cold collector. Please refer to Fig.1 for a general arrangement of the system.

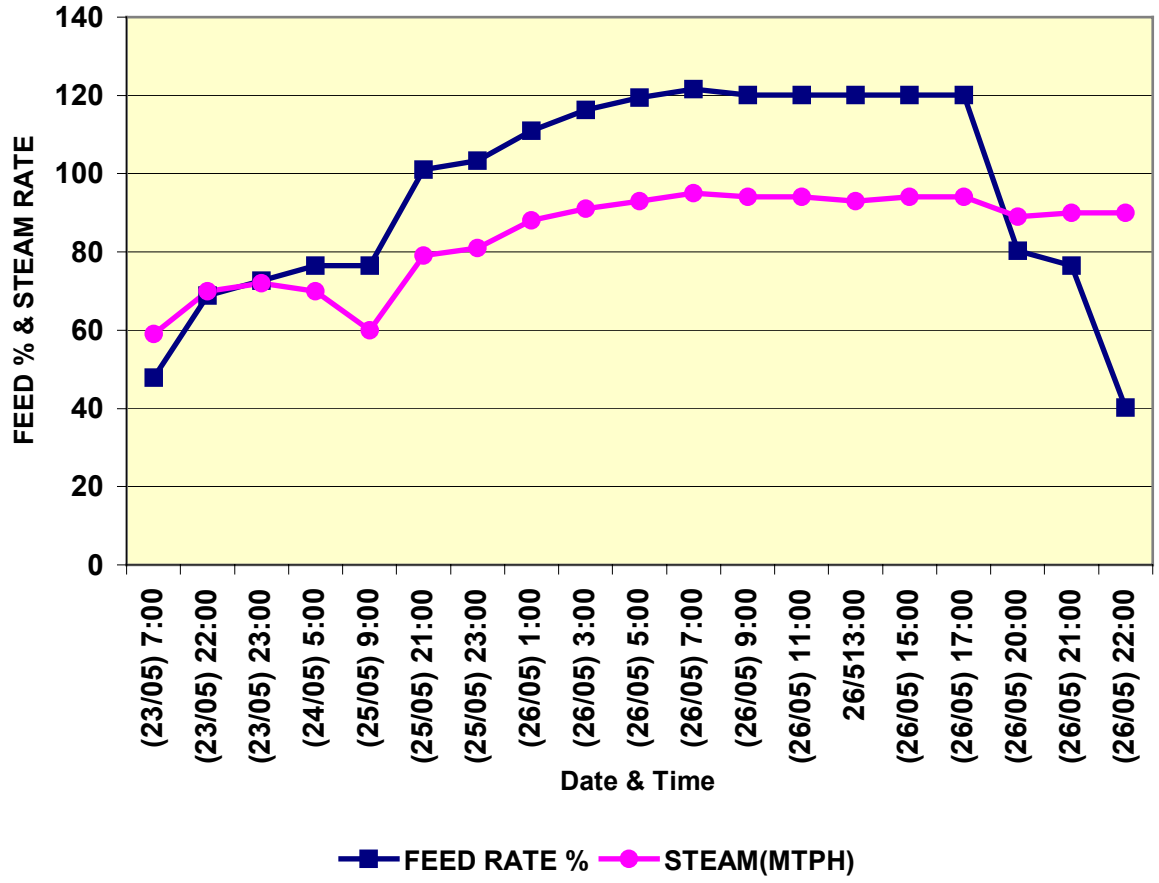
Figure 3 shows the profile of steam and feed gas flow to the primary reformer and Figure 4 shows the profile of the pressure drop across the primary reformer.

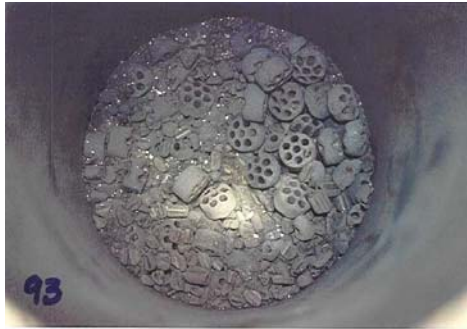
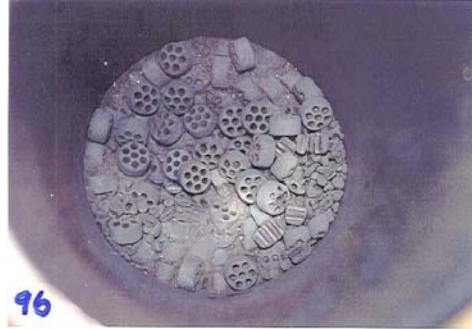
Figure 6A

First the manways of the cold collector were opened. All the refractory was found intact and no blockages were found in the gas path. Next, to look at the catalyst, the inlet flanges of a few reformer tubes were opened. The catalyst in these tubes was found to be broken into pieces, partly powdered and the catalyst mass up to a depth of about 150 mm was found to be crusted. Figure 5 shows the portion of the crushed catalyst. Figures 6 A, B and C show the appearance of the catalyst pellets at the top in side the tubes. Interestingly enough, some of the catalyst cylinders were found to have rounded edges and surface. In Figure 7, rounded edges of the catalyst pellets can be seen clearly. Subsequently inlet flanges of all the remaining tubes were opened and the same phenomenon was noticed in all the tubes. The condition of the catalyst beyond the depth of about 150 mm was, however, found to be normal in all the tubes. Haldor Topsoe were apprised of the events and as advised by them the catalyst was removed to a depth of 0.75 meter in all the tubes. Then the pressure drop across each tube was measured and found to be more or less matching with the original values obtained in May 2000 at the time of filling the fresh catalyst. Random catalyst samples at 0.75meter depth were collected from a few tubes and were analyzed for carbon deposition and sulphur pick up. Neither carbon nor sulphur was present in the samples. Catalyst samples were also collected at a depth of 1 meter and 2 meters from a few tubes. Here too no carbon or sulphur was found and the physical condition of the catalyst was found to be good. Further, two more tubes were fully unloaded to check the catalyst condition and the catalyst was found to be good.

Haldor Topsoe explained that a phenomenon called “catalyst milling” had occurred in the top layer of the catalyst, which was the reason for the high-pressure drop and there were a few reported instances of such occurrences in other plants. The phenomenon of milling is the breakage of catalyst into fine particles or powder and crusting, as a consequence of rapid swirling of catalyst due to impingement of high velocity gas on the catalyst surface.

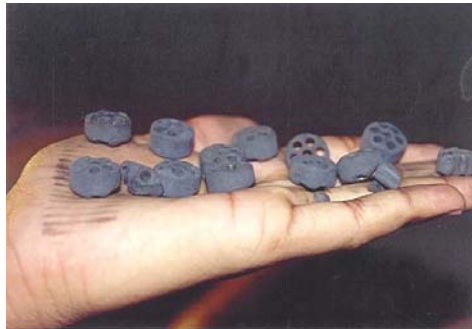
Figure 8

Haldor Topsoe advised us to top up all the 190 tubes with fresh catalyst leaving an outage of 0.40 meter (Figure 8) and also to increase the plant load gradually during the start up so as to avoid the possibility of catalyst milling.
