Technical Committee Meeting

Forum & Technical Field Visit

International Fertilizer Industry Association

Abu Dhabi, U.A.E.
30 September – 2 October 2003

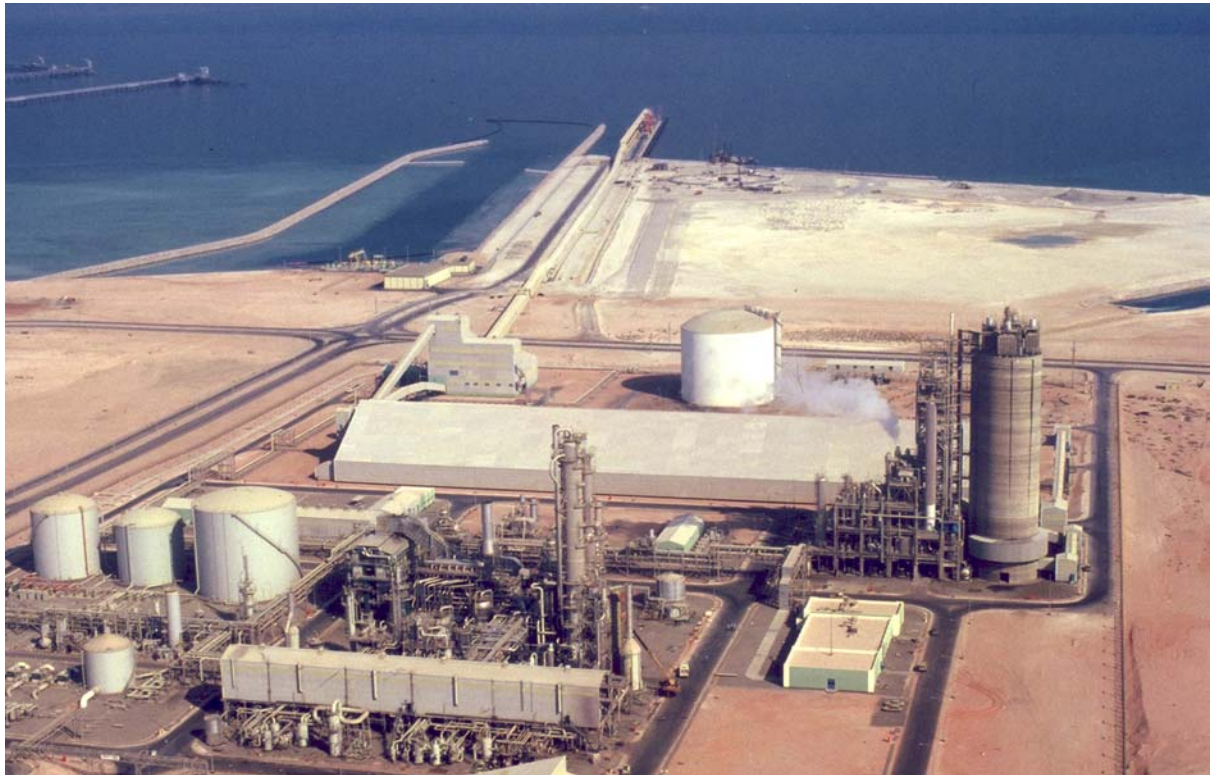
FERTIL's installations are located in the Ruwais Industrial Zone on the Arabian Gulf coast about 240 Km west of Abu Dhabi city. The complex comprises ammonia and urea processing plants with installed capacities of 1050 MTPD and 1500 MTPD respectively. The plants have fully integrated utility units with product handling and shipping facilities. The seawater, desalinated water and power are imported from ADNOC utilities plant.

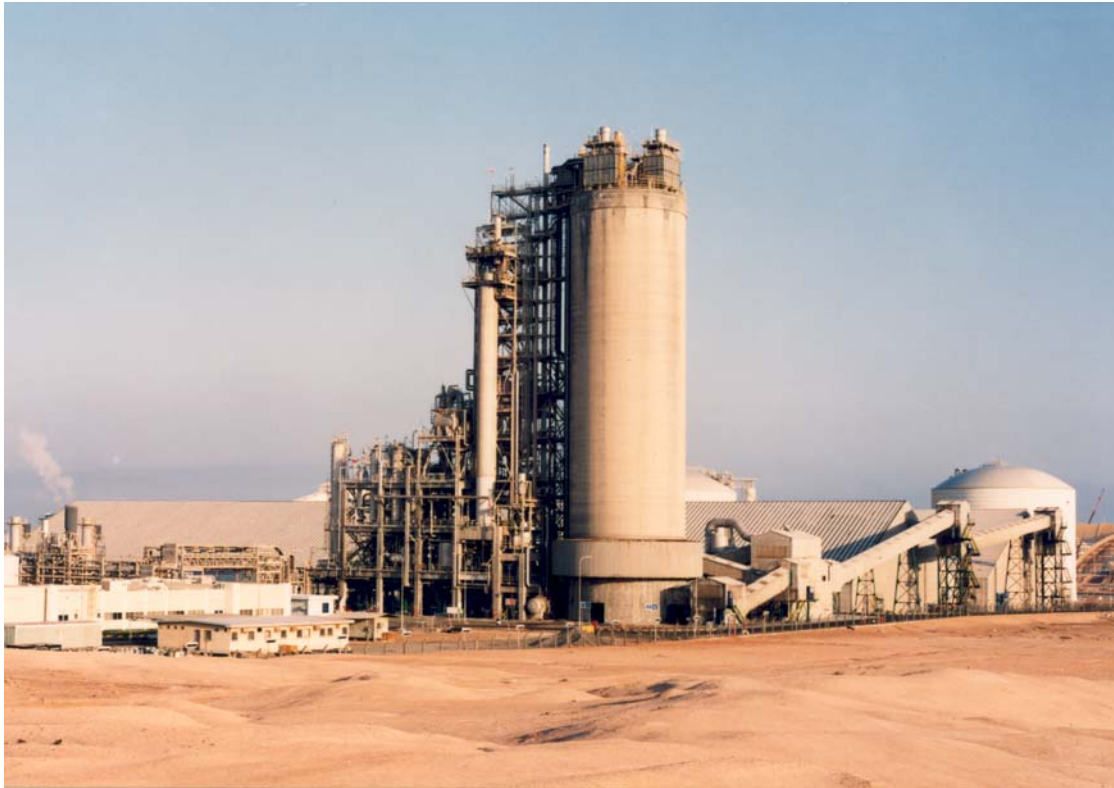
Prilled urea is stored in two Bulk stores, each having a storage capacity of 45,000 MT. These are equipped with a reclaimer and a conveyor system, which transports the product to bulk transport ships, or to the bagging plant for high-speed packing and then onward movement to FERTIL's jetty.

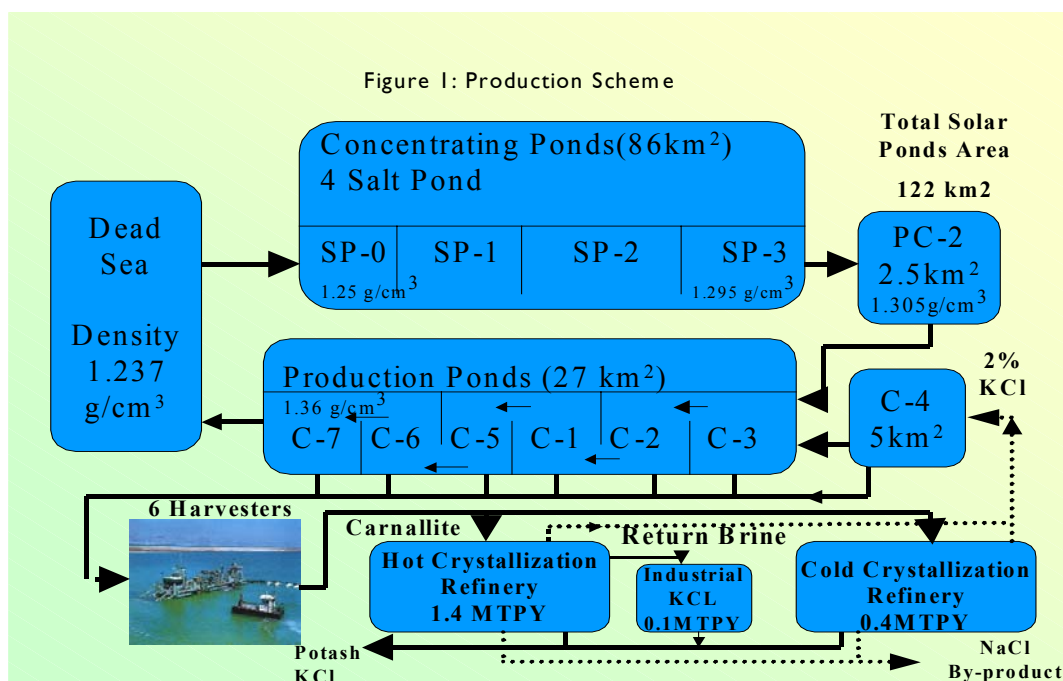
The Arab Potash Company operates one of the largest man-made solar pond system built on the land and is part of the Dead Sea, to prepare the raw material known as carnallite ($KCl \cdot MgCl_2 \cdot 6H_2O$), to feed two refineries to produce potash at the annual capacity of 2.0 MMTPY. Different processes are applied in order to produce high quality potash and these are: Hot leach and Cold leach (Figure 1).

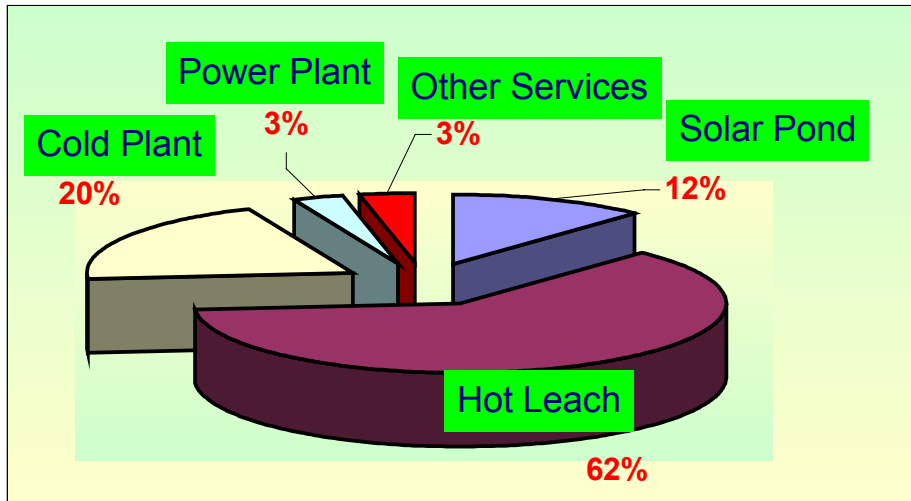
Figure 2: Distribution of Process Water Consumption in APC Facilities

Water is a major and essential element in potash production. To produce one ton of potash about five cubic meters of water is required. Potash refineries consume about 9-10 million m³/year. Process water is used mainly in decomposition of carnallite (Process nature requirements according to brine chemistry), dissolution of sodium chloride in crystallization unit, washing of the sylvinitic cake, cooling of pump seal and general purposes such as cleaning. This high consumption uses up mainly the good quality water on the account of farming and local community domestic uses (Figure 2).

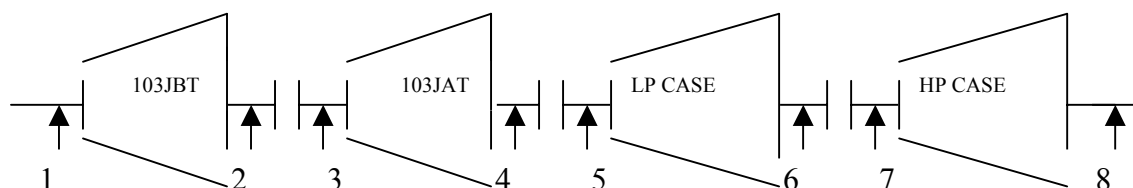
Figure 1: Machine Train Diagram

The synthesis gas compressor train consists of a barrel type LP and HP compressor cases driven by two turbines running in tandem, one out of which is a back pressure turbine and the other one is a condensing turbine. The machine train diagram is shown at Figure 1.

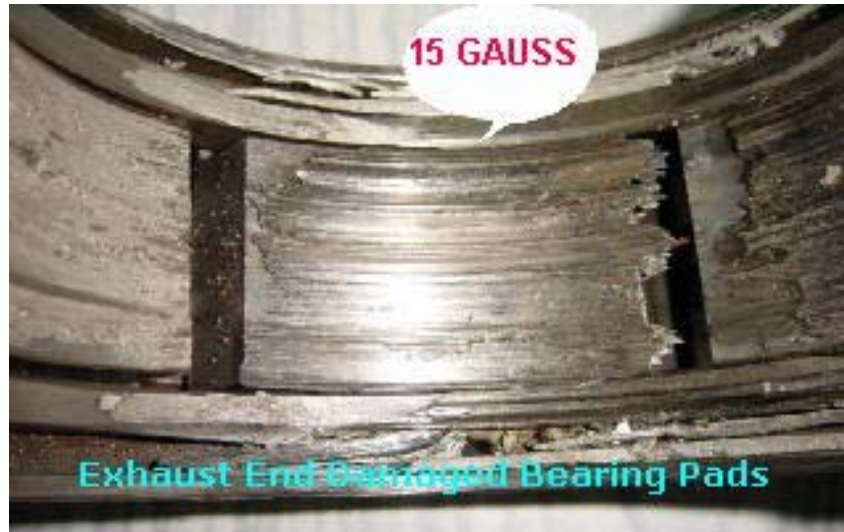
Photograph 2 Damaged Bearing Pads

2. On the damaged white metal lined bearing pads (from where white metal lining was badly rubbed out and barely any amount of white metal could be visible on them) , max. strength of the magnetic field density was 15 gauss. The photograph below shows the readings.

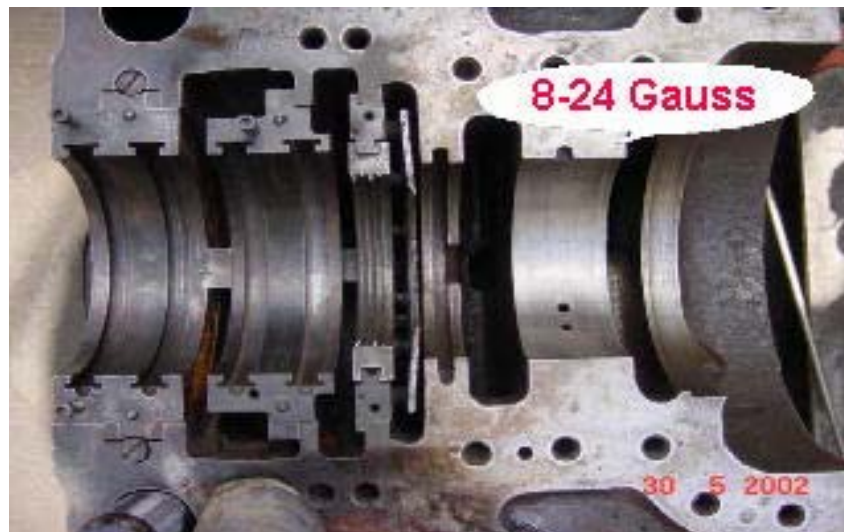
Photograph-3 Journal Bearing Shell Casing

3. The casing, on which the bearing shell was fitted, was also checked for the residual magnetism levels. The levels were recorded as high as 24 Gauss. Photograph 3 shows the readings.

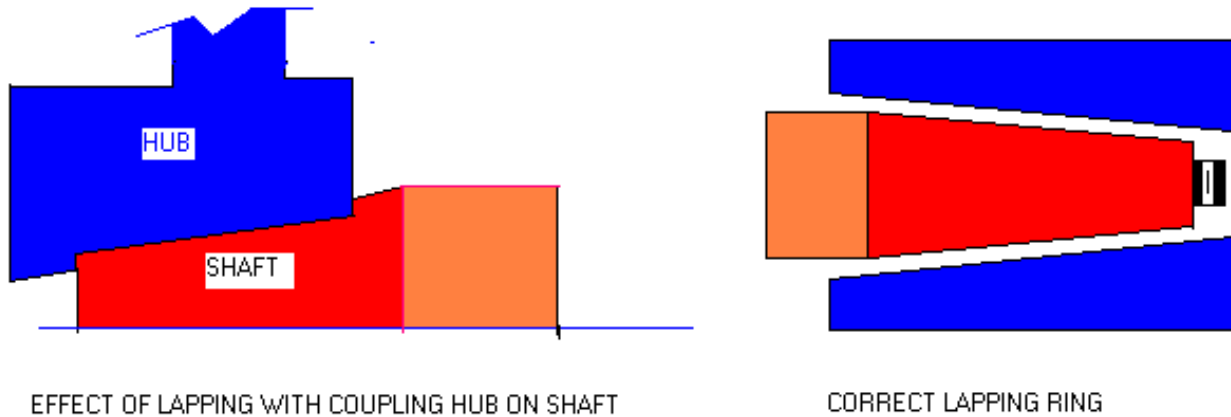
Figure 3 Result of lapping the shaft with the coupling hub

In order to remove the steps created by lapping with the coupling itself, suitable lapping tools (ring and plug tools) of cast iron were prepared to lap and match the taper of the shaft and the hub. These lapping tools were checked for the perfect match and then were used to lap the tapered surface of the coupling seat area on the shaft as well as for lapping the tapered surface of the coupling hub bore. It was ensured that the tool length covers the entire tapered length of the hub and shaft so that no step shall be cutting during the process of lapping. This procedure resulted in the successful installation of the coupling.

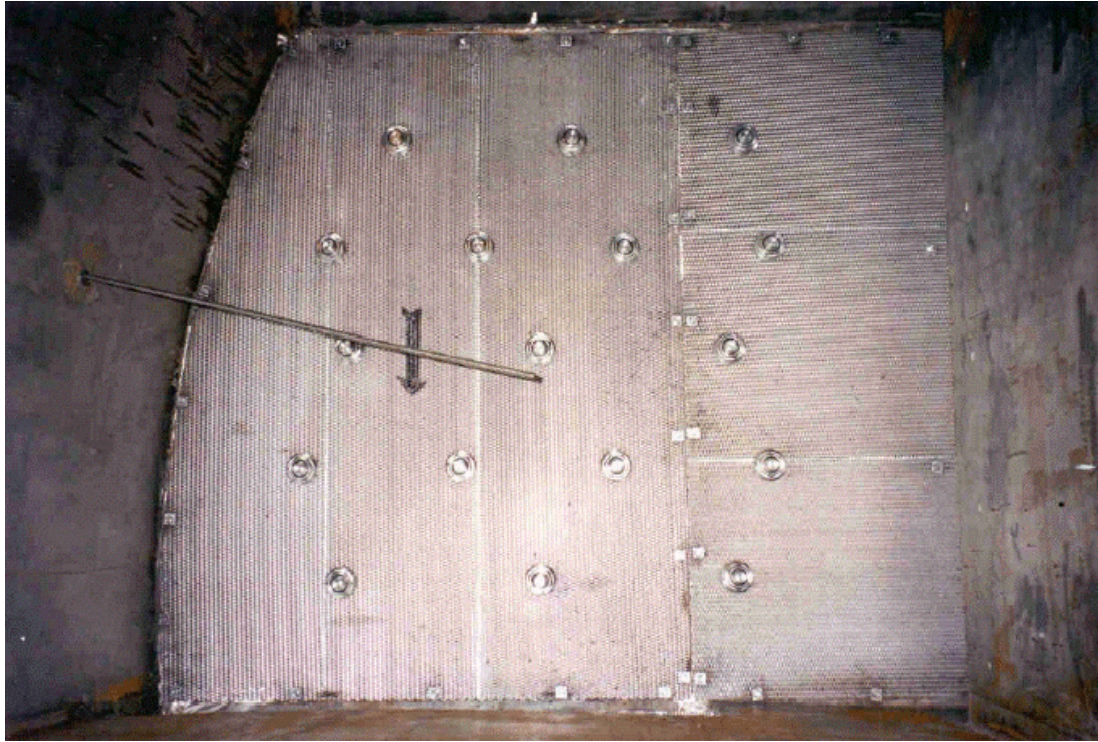
Figure 2: Internal fluid bed granulator

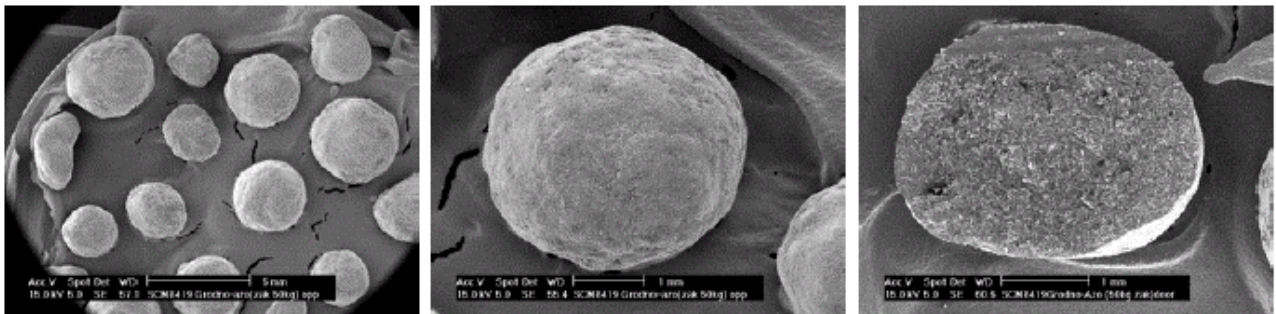
Figure 3: Grodno granular urea

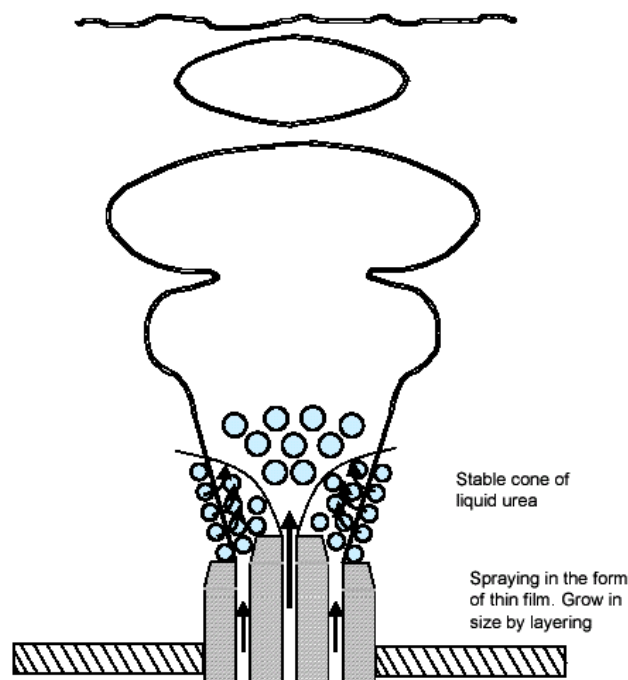
Figure 5: Cross section low pressure film sprayer

The 98.5 wt % urea solution is sprayed in the form of a thin film. Secondary air, supplied through an annulus surrounding the melt sprayer sucks the urea granules through this film. Each time a granule passes the liquid film it grows in size by layering.

The low pressure 'film' sprayer for urea fluid bed granulation was tested by DSM's Equipment Testing Department in a fully closed 200 kg/h granulation loop. This loop comprised all equipment normally encountered in a granulation loop, such as a granulator, granulate cooler, bucket elevator, screens, crusher, transport equipment, off-gas washing, fans, etc. These tests were very successful.

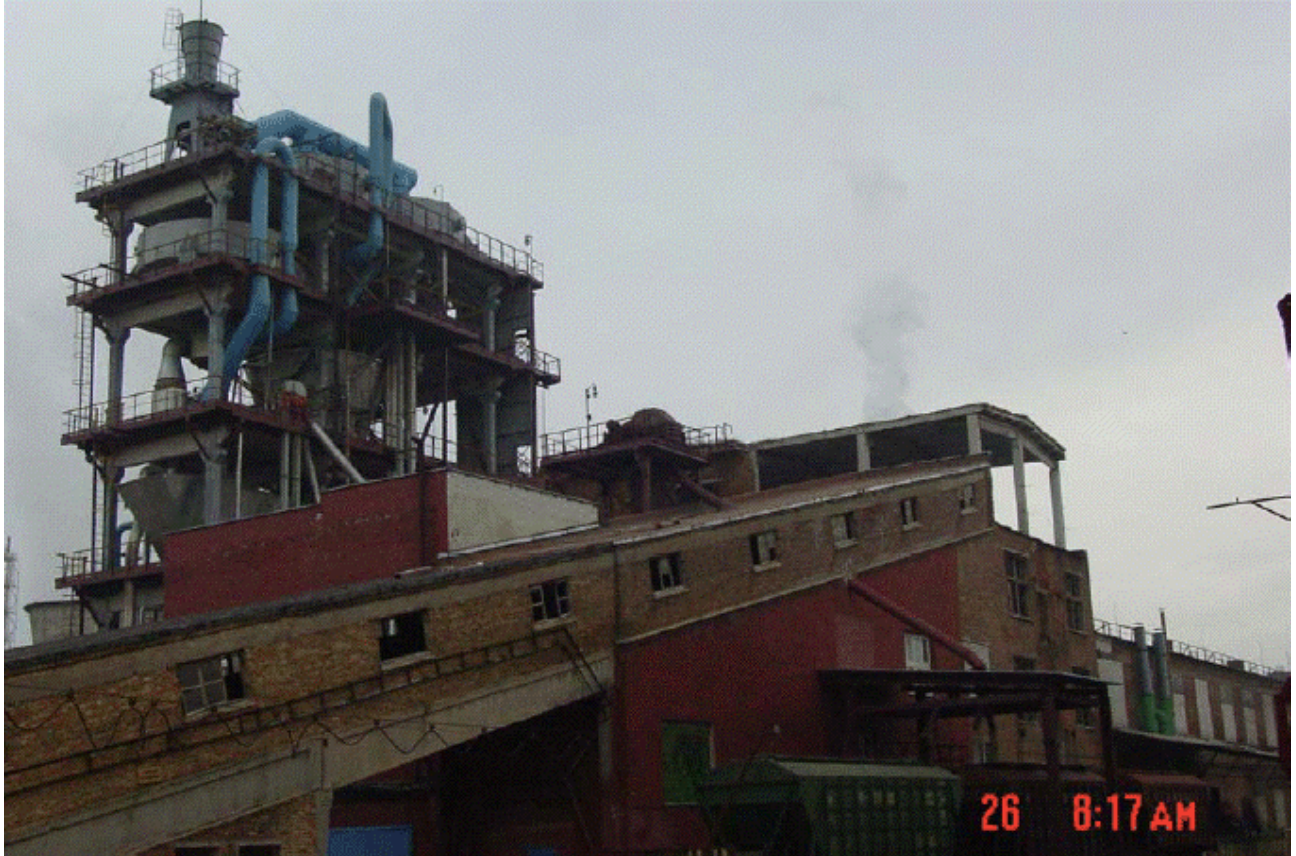
Figure 6: Overall view Grodno granulation with direct loading facility.

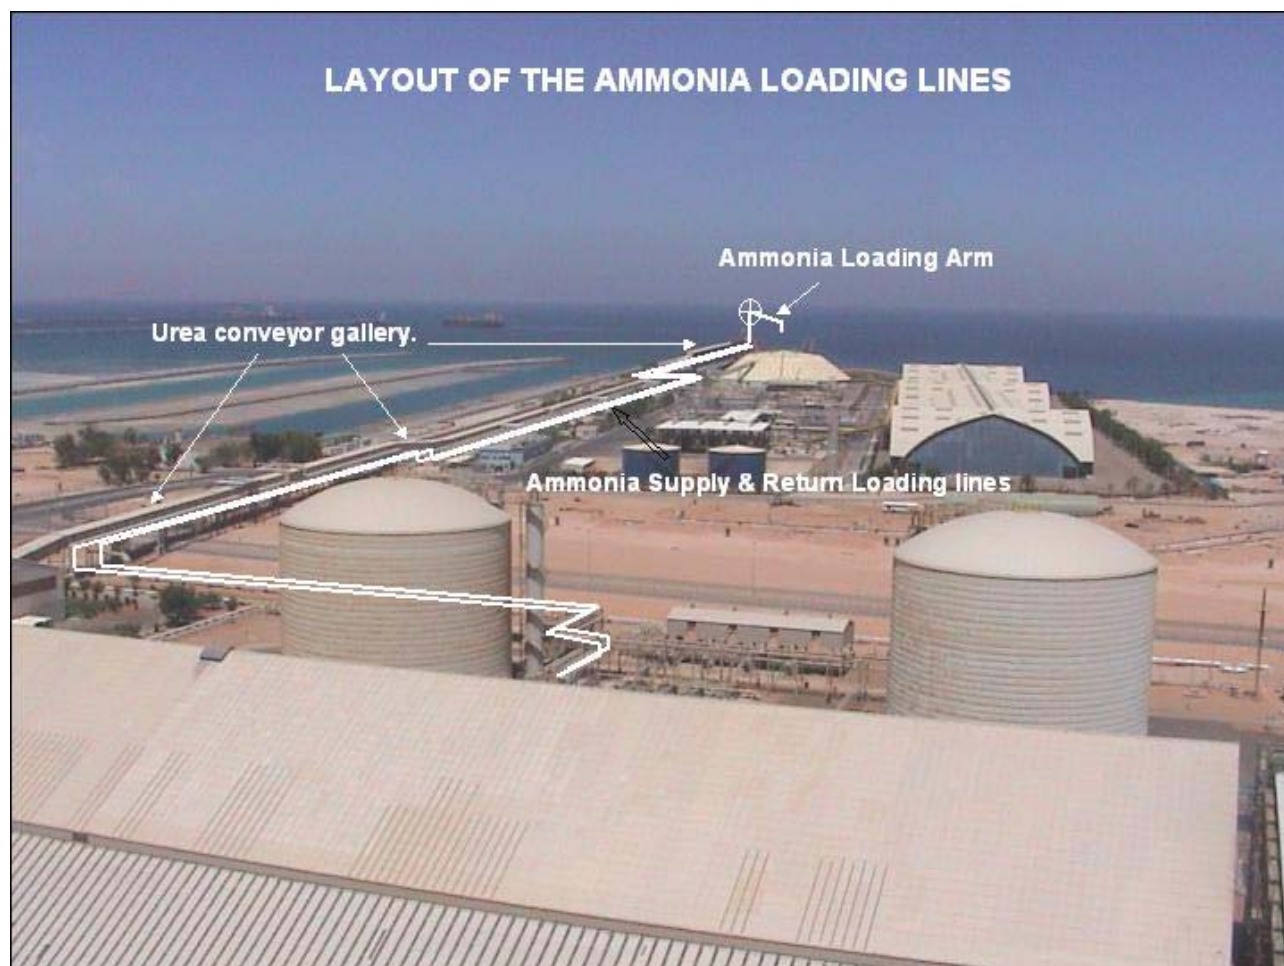
Liquid ammonia is stored in two atmospheric storage tanks each having 20,000 MT capacities. The tanks, of double wall-integrated design, are kept at atmospheric pressure by a refrigeration system. Liquid ammonia from the tanks is transferred by 500 T/H capacity pumps, through the 12" (30cm) diameter supply and return ammonia loading lines directly to the ship. The lines are approx. of 1900 meters length each and cold insulated by polyurethane foam and metal lagging.

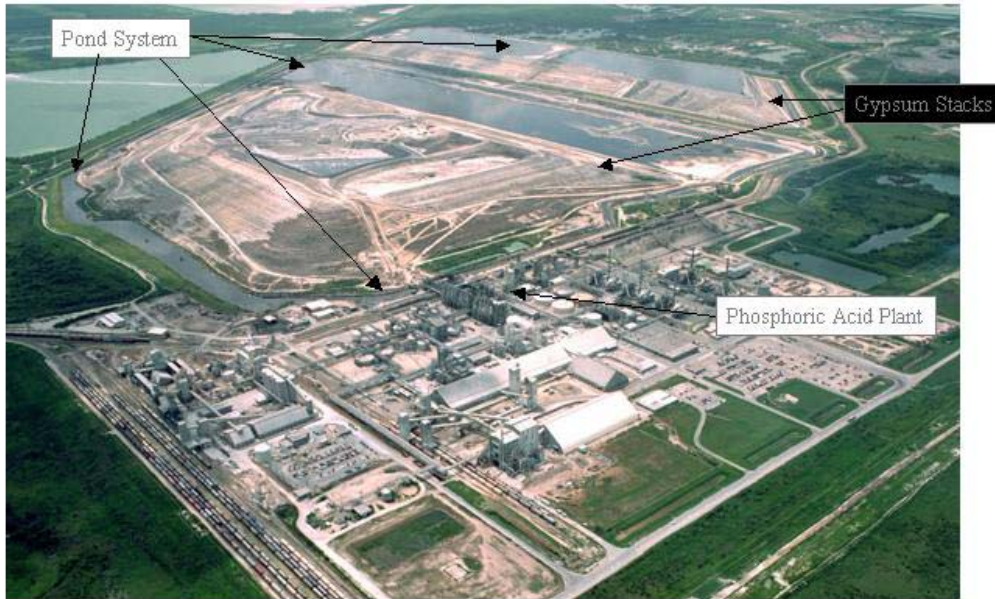
Pond Water – Source

Phosphoric Acid Process Origin of Pond Water

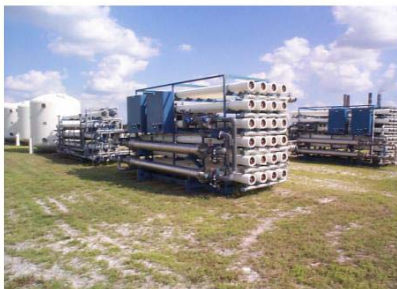
- **R.O. Pretreatment Technology**
- **R.O. Equipment**
 - Two 1st Stage R.O. Modules
 - Two 2nd Stage R.O. Modules
 - Multimedia Filter System
- **R.O. Equipment Modification**
- **Technical & Engineering Assistance, Continued Research**
