Abu Qir Fertilizers

Washing of Methanator Catalyst (Ammonia Plant III)

Abstract

Ammonia Plant III

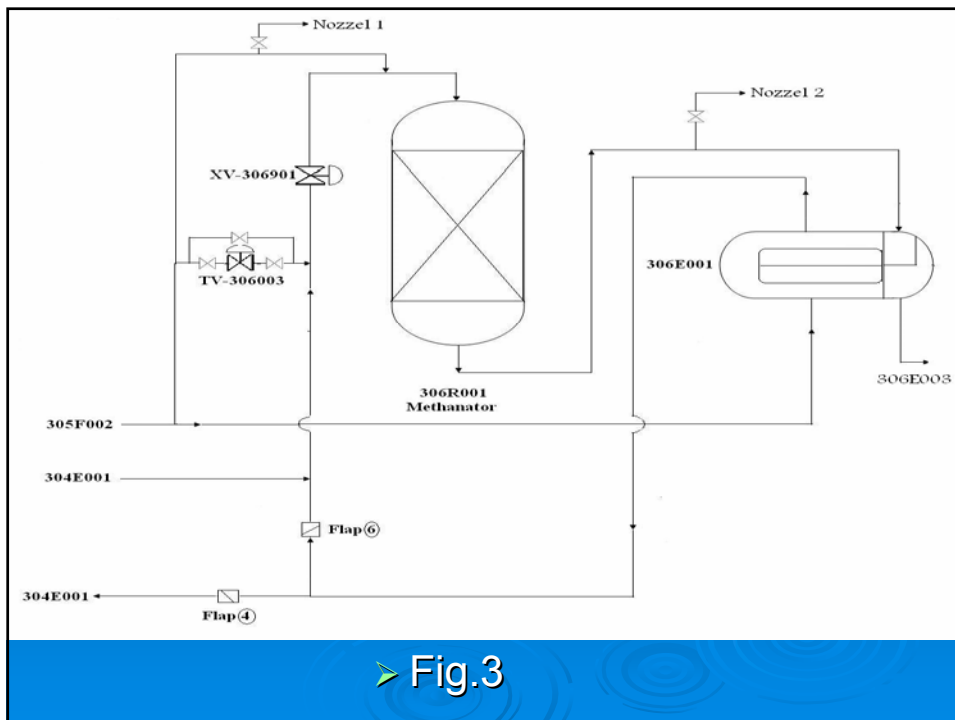
- Two nitrogen connections were erected to nozzles 1 & 2. "Fig. 3".
