# IFA Technical Conference

Chennai, India

# FAILURE AND REPAIR OF THE SECONDARY REFORMER – AN EXPERIENCE (a)

V. K. Bali\*, Indian Farmers Fertiliser Cooperative Limited (IFFCO), India

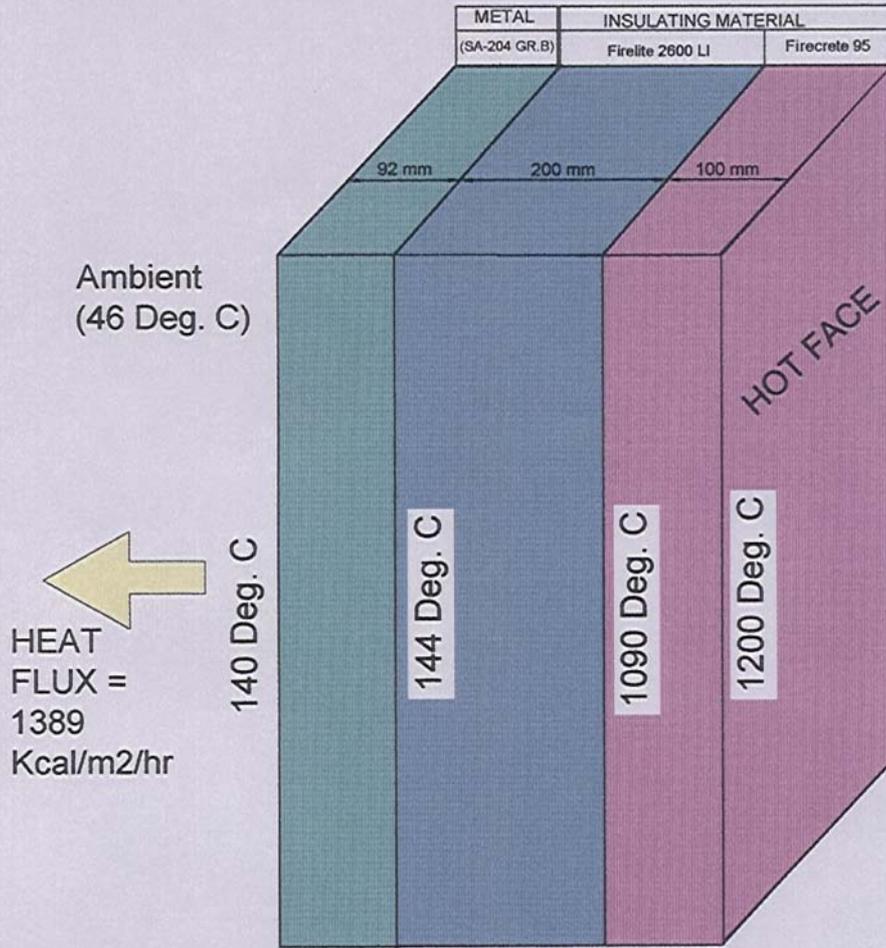
Figure-2

The secondary reformer for the plant was supplied in 1986 by Hyundai Heavy Industries, South Korea. The reformer operates under the most severe conditions of the process having a pressure of 32 kg/cm<sup>2</sup> (design shell pressure 38 kg/cm<sup>2</sup>) and extreme temperature reaching to 1200 deg. C. The normal shell temperature is about 160 deg. C. with design temp. of 350 deg. C. The shell of the reformer is made of low alloy steel CS SA204 Gr B (C-1/2 Mo) having a thickness of 80 mm and conical portion has a thickness of 92 mm. The thickness of neck portion and bottom dished end is 50 mm and 92 mm respectively. Due to high operating temperature. The shell is refractory lined from inside to minimise the heat loss and to keep the shell temperature less than 350 deg. C. Figure 1 shows the internal details of secondary reformer. Further, to warn against any possible refractory failure and high shell temperature, the shell is coated with Thermo Indicative Paint which changes colors at high shell temperature. Figure 2 shows the temperatures profile across the cross section of refractory and shell of secondary reformer.

**SECONDARY REFORMER:- SURFACE TEMPERATURES AT INTERFACES**

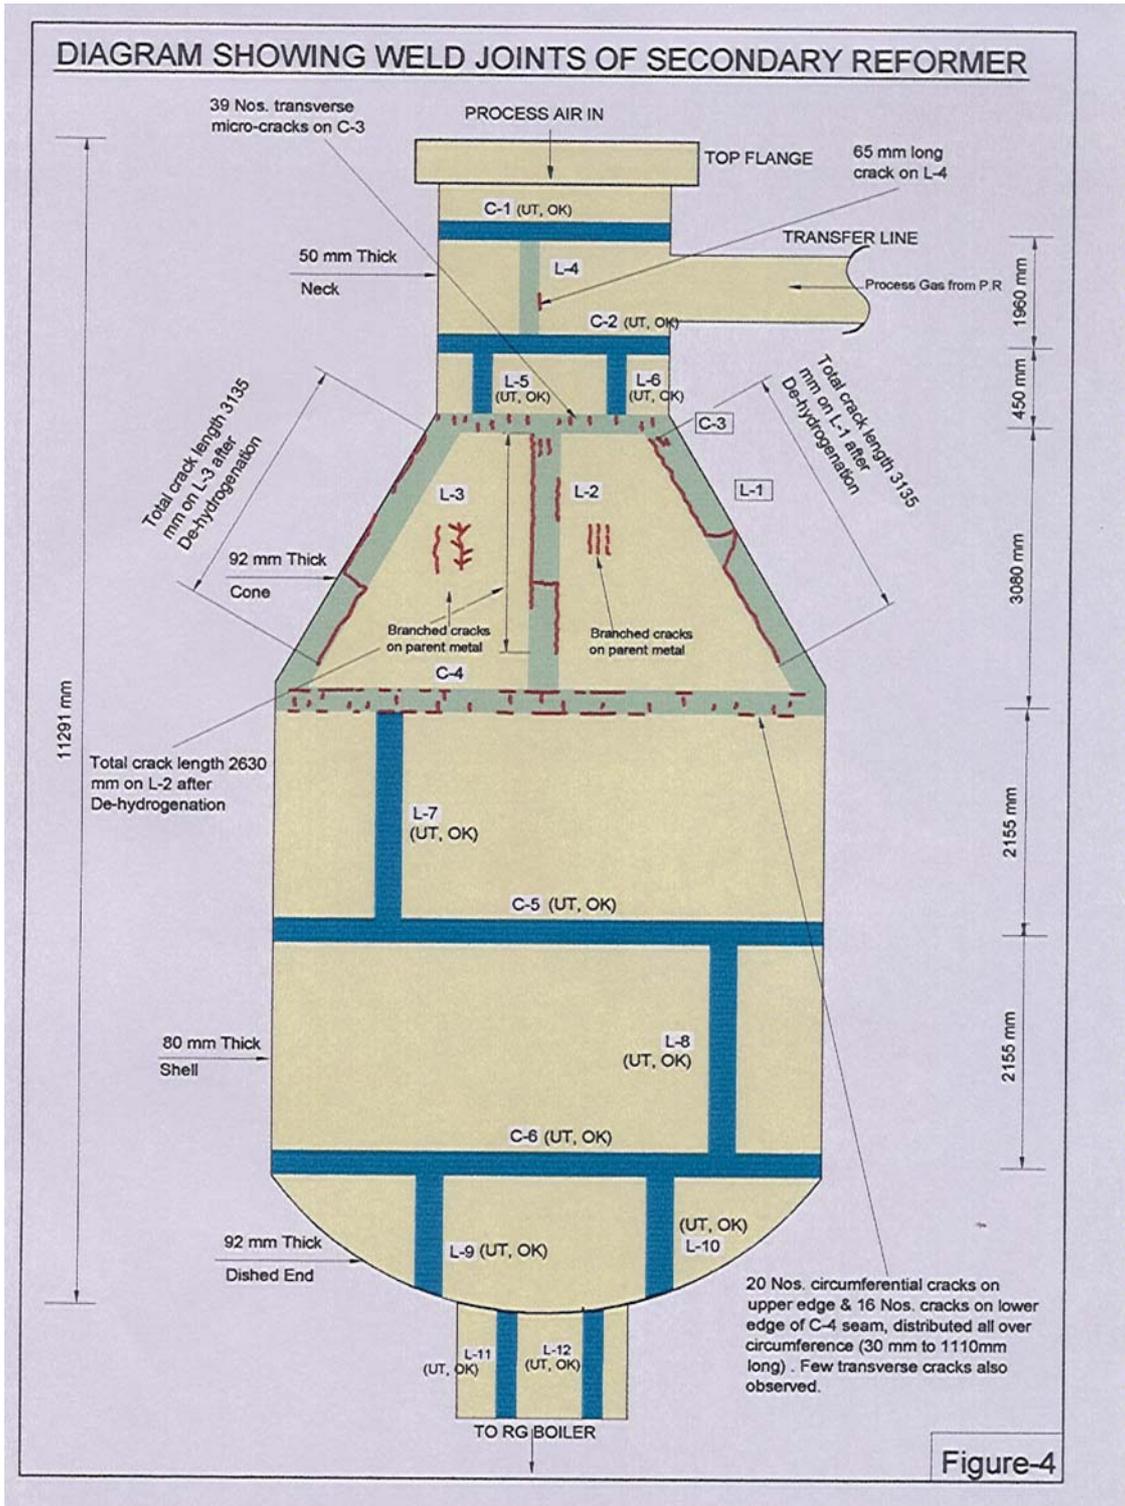
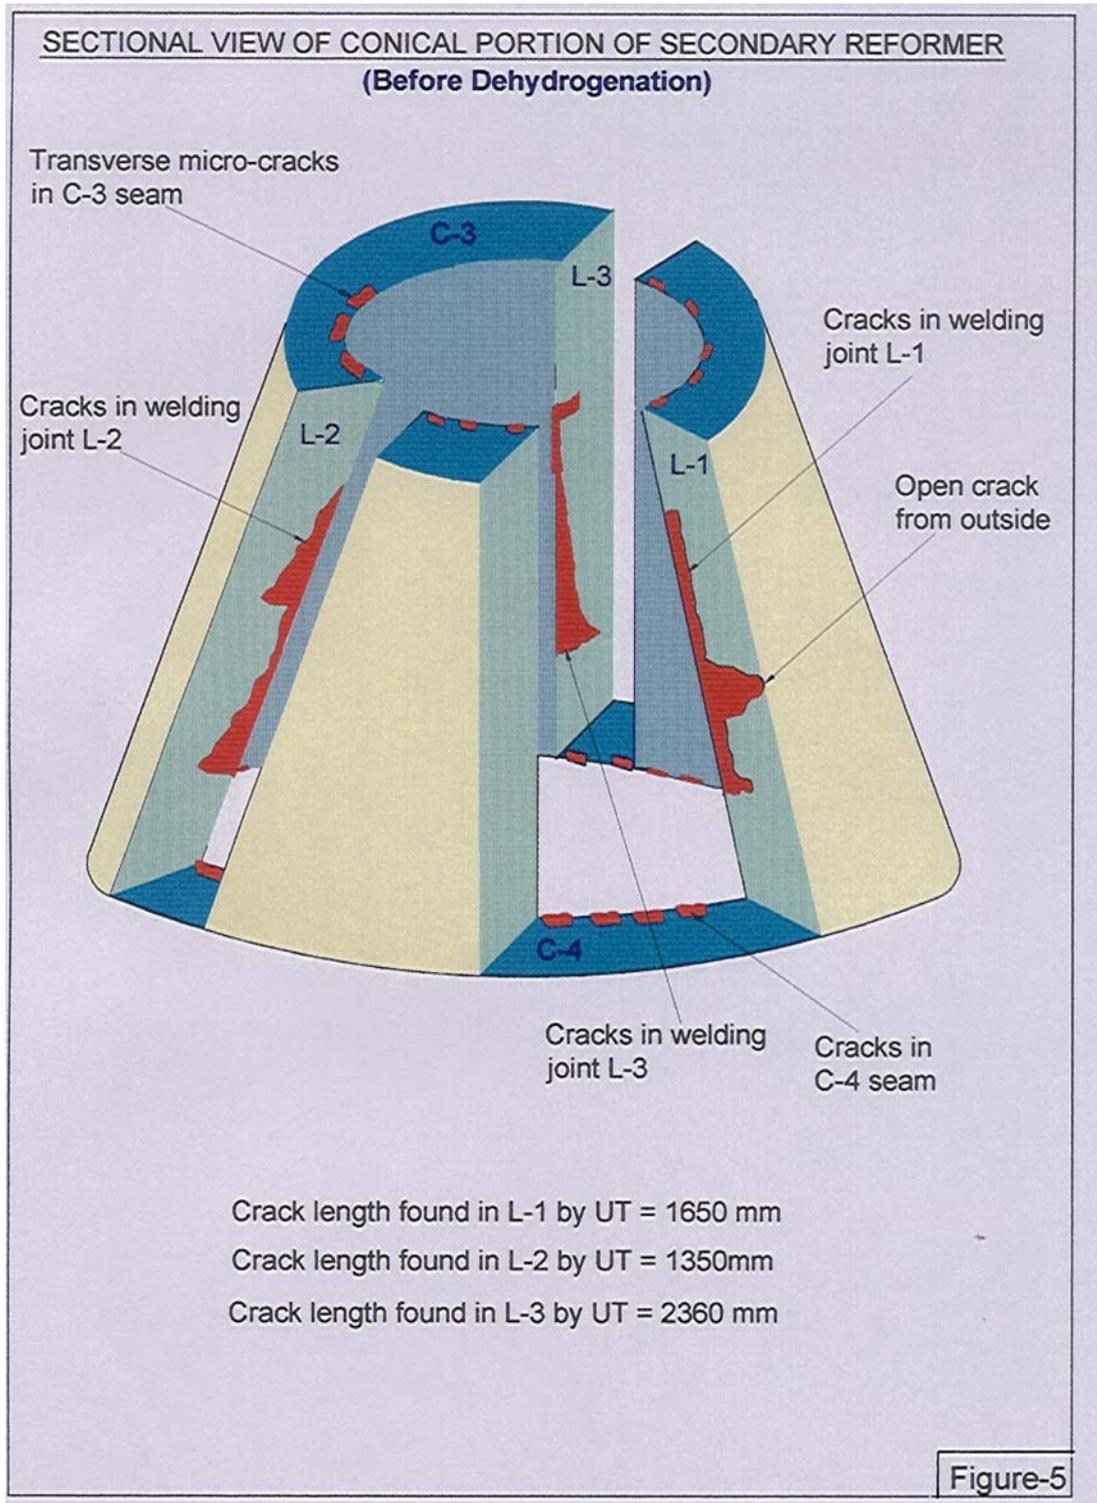
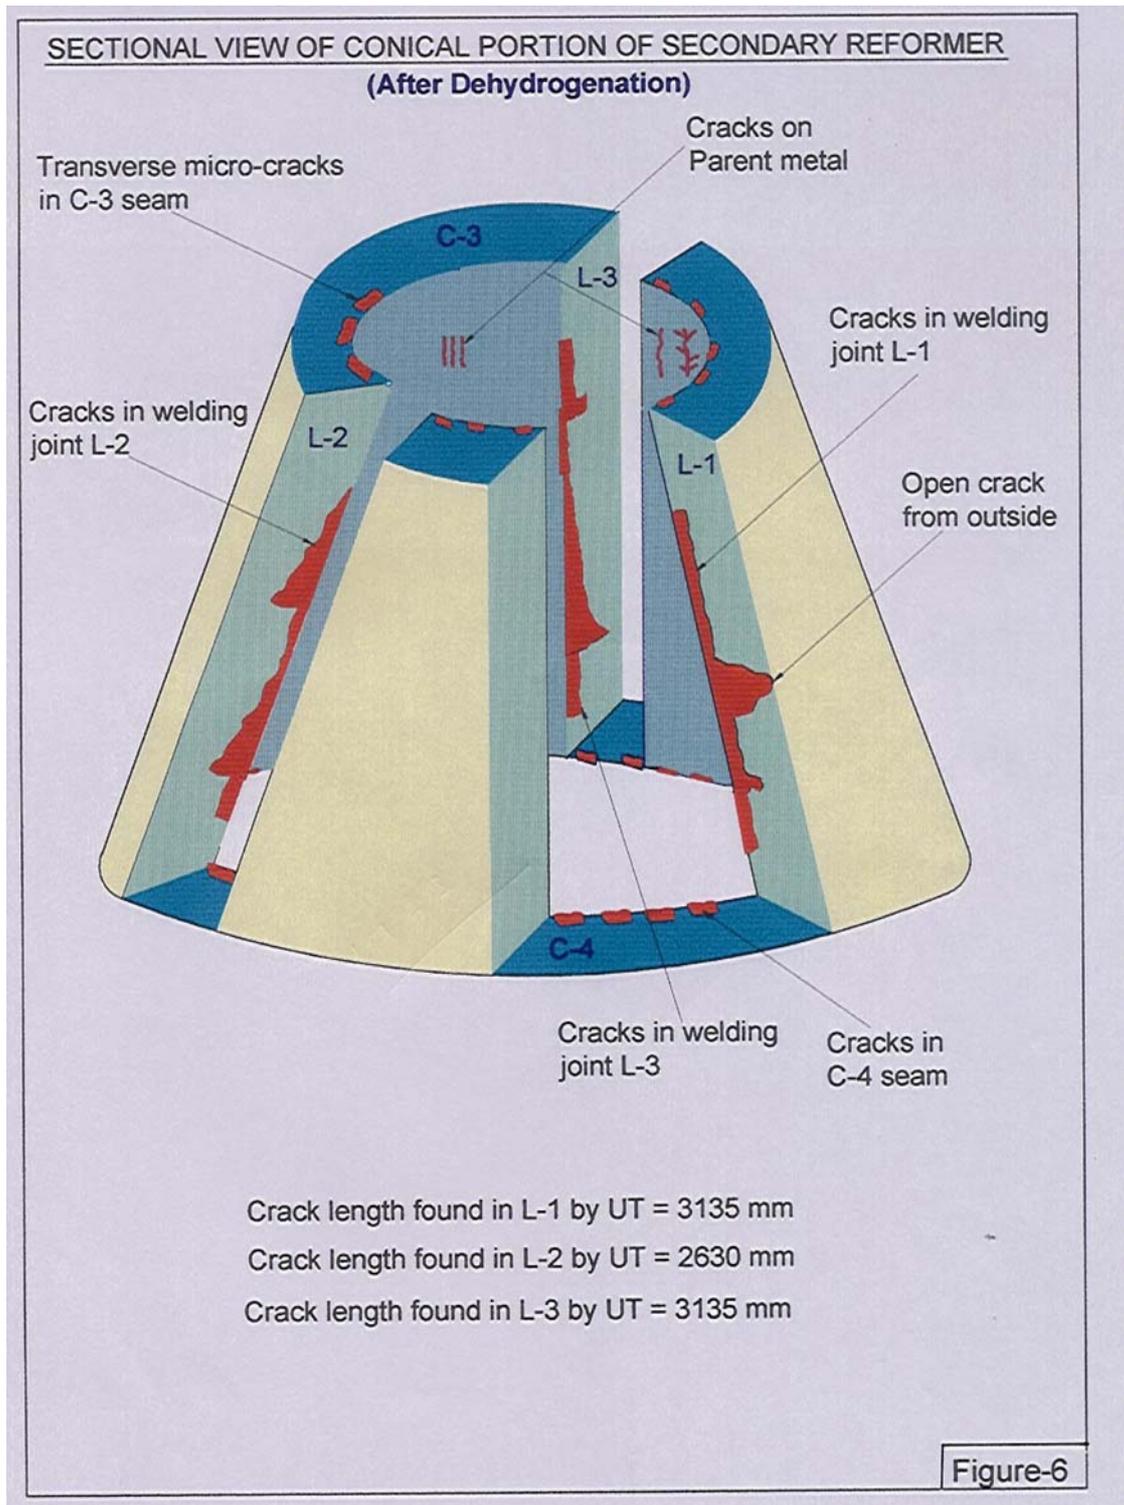
Dehydrogenation and stress relieving of long seams (L-1, L-2 and L-3) was carried out for improving the weldability of joints. Subsequent to dehydrogenation treatment (DHT) of long weld seams at 620 Deg C, the original cracks further increased to 3135 mm, 2630 mm and 3135 mm respectively out of total length of 3250 mm of each seam. Figures 5 and 6 depict sectional view of the cone indicating cracks on longitudinal seams before and after dehydrogenation. The number of transverse cracks on C-3 and C-4 weld seams increased. The length of circumferential cracks on the edges of the C-4 weld also increased as some of the adjacent cracks joined together and few new cracks developed. Also several clusters of branched cracks were observed on the cone parent metal as well. The concentration of cluster of cracks was more in the lower 'knuckle' portion of the cone about 680 mm height above the C-4 weld. Also cluster of transverse cracks were observed in a 200 mm wide band below the C-4 weld. Average depth of cracks was 6-25 mm. Figure 7 shows the cracks on longitudinal weld seams L-1, L-2 and L-3 and Figures 8, 9 and 10 show the cracks on circumferential seams C-3, C-4 and on the parent metal in the conical portion of secondary reformer.

### LOCATION OF CRACKS ON L- SEAMS

- Depth of transverse cracks observed in U.T in the range of 6-8 mm .
- Depth of longitudinal cracks observed in U.T in the range of 10-15 mm & at few locations 25 mm .
