# IFA Technical Conference

# SHAFT OIL BARRIER SEALS CAN CAUSE HIGH VIBRATION. DO YOU KNOW ? (a)

(A Case Study of High Vibrations in Syn Gas Compressor, its Diagnosis and Correction)

Arun Kumar National Fertilisers Limited, Panipat Unit, India

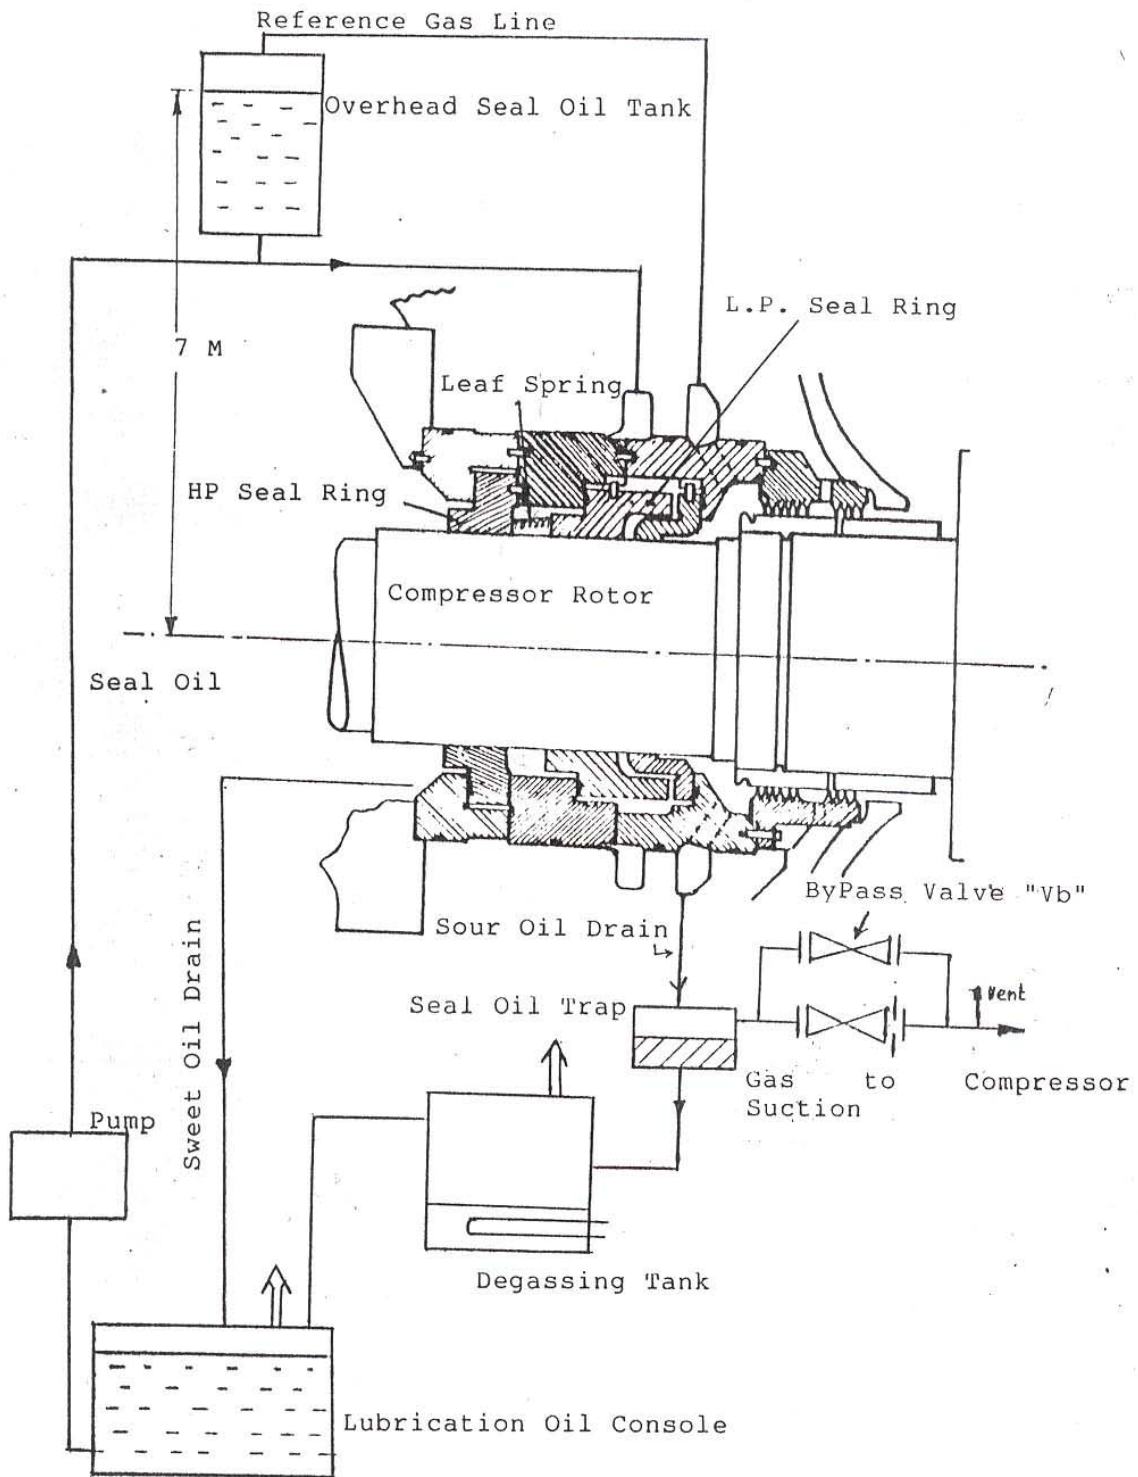
## ANNEXURE -II

As the chance of oil whirl in bearing was omitted, the probable area of concern could be floating oil barrier seal rings as well (either side). The oil whirl can occur on these close clearance seal rings also, when H.P. seal ring (with low clearance of 0.06mm to 0.08mm) starts acting as lightly loaded bearing. This can happen when floating action of seal ring is restricted. During the overhauling we had replaced the rotor with repaired one that was balanced and alignment of 2nd stage with 1st stage and 3rd stage was perfect, near to design values. This could have further decrease the preloading and resulting in enhancement of oil whirl phenomenon.

**OIL BARRIER TYPE SHAFT SEALING SYSTEM**
