IFA Technical Conference

**Beijing, China
20-23 April 2004**

FALL IN EFFICIENCY IN SYNTHESIS GAS COMPRESSOR DUE TO 'O' RING EXTRUSION (A CASE STUDY)

Arun Kumar
National Fertilizers Limited, India

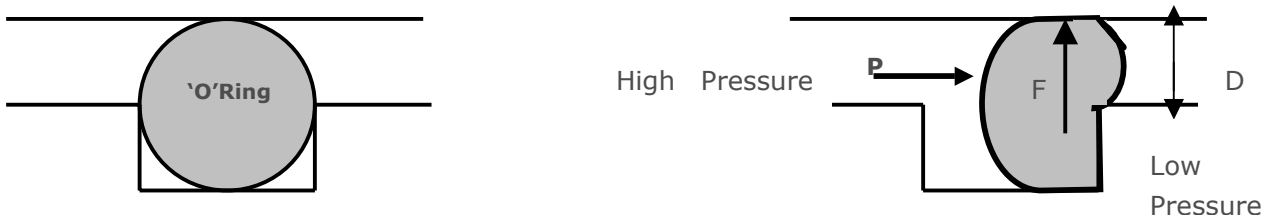
The problem of 'O' ring extrusion in subject case was due to lack of nip or compression in 'O' ring due to increased diametrical clearance between diaphragm pack and casing. This was due to damage / pitting in casing bore at 'O' ring sealing area. This pitting has been observed in number of sites in such compressors, which have been operating for longer time of more than 20 years and have floating type oil seal rings for end sealing of compressor. There is always small carry over of oil along with the gas even with good condition seals. With the time this oil gets stagnated in area adjacent to 'O' ring of diaphragm. This stagnated oil results into fretting corrosion, causing pitting in such area. Such pitting with the time destroys the 'O' ring seating area on casing, thus 'O' rings loses its nip. This lack of nip in 'O' ring no more can generate sealing force, which should be essentially more than the pressure to be sealed.

D :Diametrical clearance

P: Pressure to be sealed
