IFA Technical Conference

PHOSPHOGYPSUM STACK SYSTEMS, CLOSED AND LINED REPLACEMENTS AT CARGILL CROP NUTRITION

Ozzie Morris
Cargill Crop Nutrition, USA

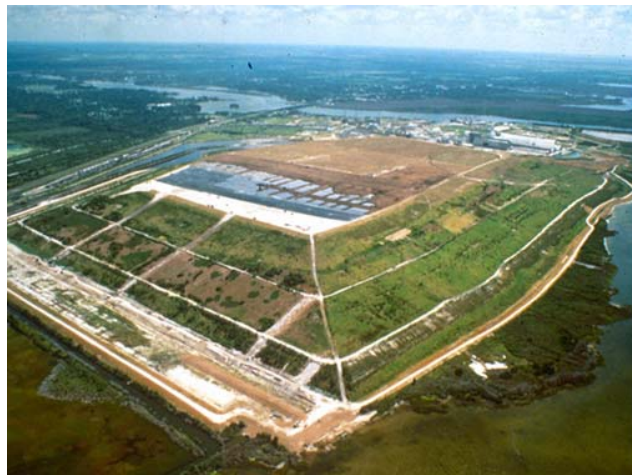
Riverview Closed Stack on Tampa Bay:

The original stack was successfully closed in 1990. The goals of the closure were to eliminate contaminated water from entering Tampa Bay, dry the stack for long-term care, control stormwater quality run-off and improve the esthetics of the stack. The closure included shaping of the stack after the water was removed, placing under-drains on the side slopes for directing the pour space water back to the facility operation, top-soiling the sides with 16 centimeters (cm) of soil, placing a geo-textile to protect the continuous 40-mil High Density Polyethylene (HDPE) liner which was placed on the 405,000 sq m top of the stack, and the placement of 46-cm of top soil on top of the liner. The whole stack was then grassed. The stack was shaped to allow stormwater to be directed to stormwater retention ponds located at the base of the stack. A hydraulic bearer was established between Tampa Bay and the stack to stop groundwater intrusion into the Bay. A slurry cut-off wall replaced the hydraulic bearer.

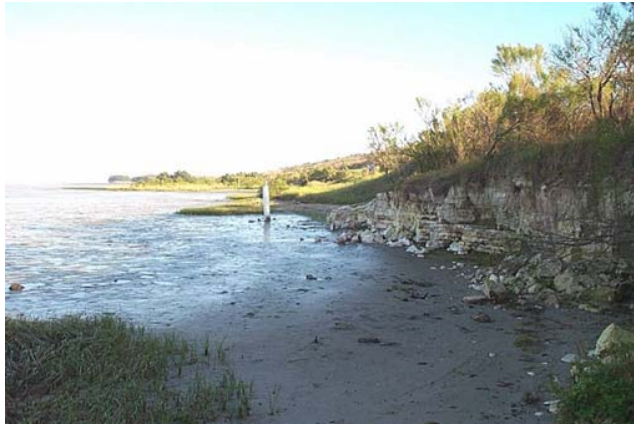
Riverview Shoreline Before Restoration:

As previously mentioned, the original stack had environmental impacts on Tampa Bay. The fluoride deposits were removed from the Bay by using motorized tracked equipment during low tides. Over 460 m of shoreline along the stack was re-graded and re-vegetated with indigenous plants for the ecosystem.

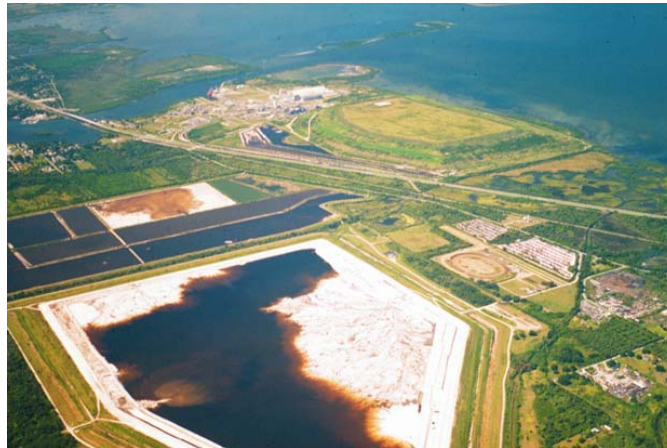
Riverview Existing Stack in Foreground & Closed Stack in Background:

The new stack was successfully constructed and ready for operation in January of 1990. That stack was designed with a 1.32 million sq m base and for an ultimate operation height of approximately of 61 m. The stack base is completely surrounded by a slurry cut off wall that ties into an existing clay confining layer that has a minimum thickness of 4.6 m. Inside this area, a 46 cm compacted clay liner formed with a vertical coefficient of permeability equal to or less than 1×10^{-8} cm/s. The clay liner is provided with a 31-cm. protective soil cover and an overlying under-drain system. The under-drain system is comprised of lateral drains placed approximately on 30-m. centers. The lateral drains consist of 15-cm. diameter, perforated, corrugated HDPE pipe set in a bed of non-reactive silica fine gravel, which, in turn is surrounded by an envelope of clean silica sand that acts as a filter for the gypsum. A 61-cm thick blanket of sand is also provided beneath the perimeter piping system and directed to a sump and pump station, from where it is returned to the process plant for re-use.

A network of groundwater monitoring wells surrounds the new stack measuring the performance of the liner. Grass is grown on the sides of the stack as the height

increases. The grass provides two purposes; first, to provide clean water run-off from the site and, second, to provide for a more pleasing aesthetic look of the stack.

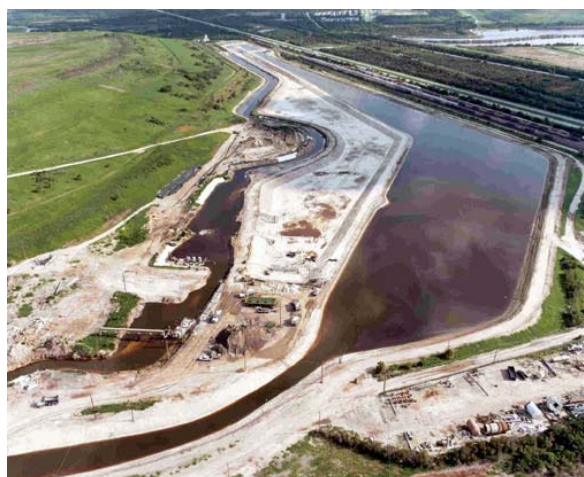
Riverview Process Pond Improvements:

In 2000, the Riverview Facility successfully completed the lining of a 130,000 sq m operating flow-through process pond. By the diversion of flows, the facility engineers, consultants and contractors were able to construct a composite liner system under an existing operating system. The project included the phased diversion, dewatering, and excavation of the site to allow the construction of a composite liner system. The composite liner system consisted of a 60-mil thick HDPE geo-membrane and a 31-cm. thick re-compacted gypsum layer with a hydraulic conductivity of 1×10^{-4} cm/sec. A passive gas venting system consisting of interconnected gravel-filled trenches lined with non-woven geo-textile was also constructed within the sub-grade directly below liner.

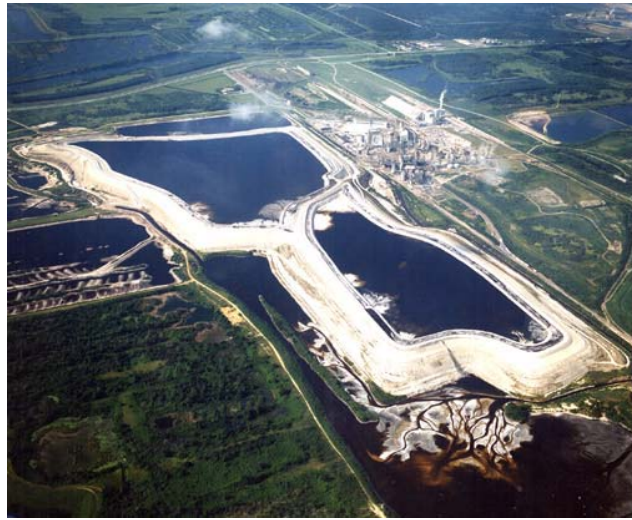
Bartow Facility:

The Bartow Facility has two operating stacks within the phosphogypsum system, North and South. The North stack is the oldest and has operated since 1954. It has a base of 1.21 million sq m and a height of 61 m. It is scheduled for complete closure by 2009. The long-term plan is to cover the stack with an 80-mil liner and utilize the top of the stack for water management. The sides will be grassed to facilitate clean stormwater run-off.

The South stack with process water recirculation system has a base area of over 1.9 million sq m. The average height is approximately 16 m. The interesting aspect for this facility is that the South stack is retrofitted to meet the present closure and new stack requirements under 62-673 of the Florida Administrative Code and meet the needs for gypsum storage for the facility for the next 25 years. The requirement is to line the top of the system to assure a maximum coefficient of permeability of 1×10^{-7} cm/s. In essence, the existing South stack is being closed under rule closure requirements at the same time the closure liner will meet the new stack requirements allowing the stack to rise an additional 60 m plus.

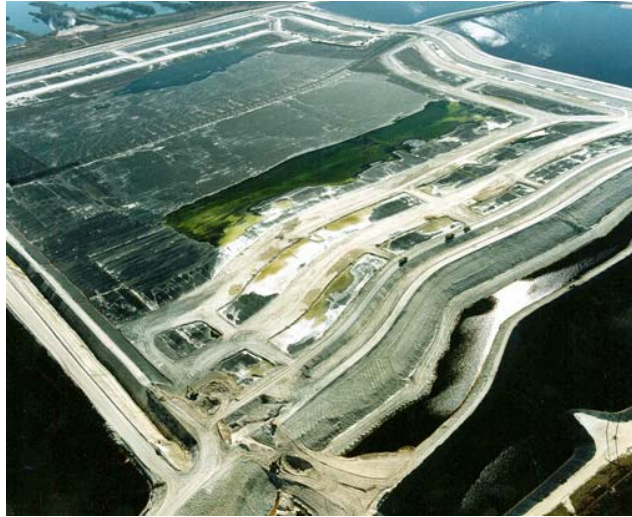
Bartow South Stack Retrofit:

The process involved dividing the stack into three phases. Two phases for this retrofitting project have been completed. The third phase is scheduled for completion in 2009. The side slopes of the existing South stack will be covered with soil and grassed.

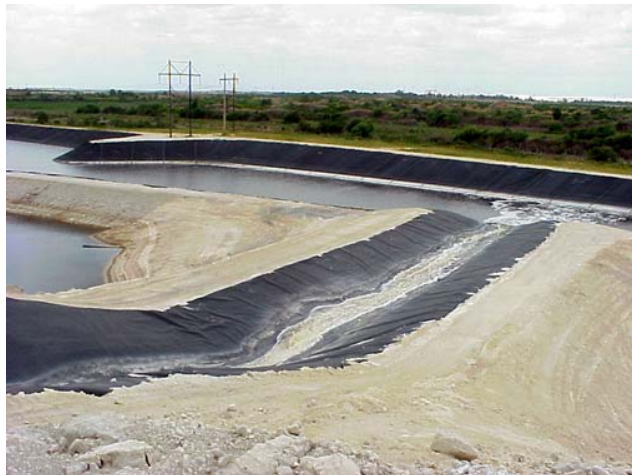
Bartow Process Pond Retrofit:

An existing surge pond on the West side of the South stack was retrofitted to meet the closure and liner requirements. This was accomplished by filling to approximate bottom level grade with gypsum in a manner to replace the excess water contained in the lower elevations. The pond was emptied, graded, lined with 60-mil HDPE and covered as required by rule.

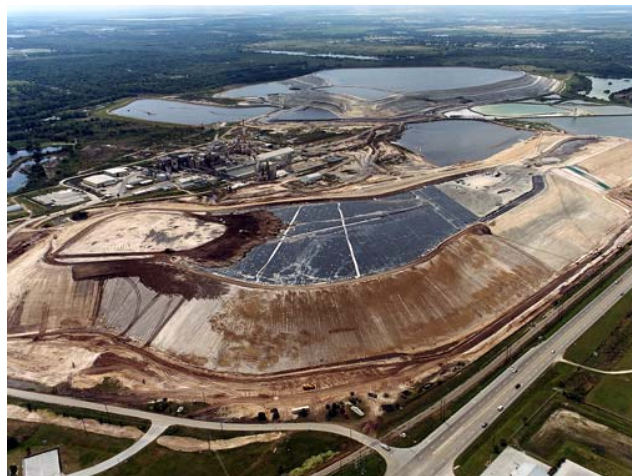
Mulberry North Stack Closure with South Stack in the Background:

Facility to the Bartow Facility by pipeline. The Mulberry Facility had two stacks, North and South. To date the North stack has been closed. The North stack had a base of approximately 405,000 sq m and a height of approximately 25 m. To close this site required approximately 186,000 sq m of liner, 200,000 cu m of soil, 21,000 kg of grass seed, labor and energy. The South Mulberry Stack is scheduled for closure by the end of the decade.

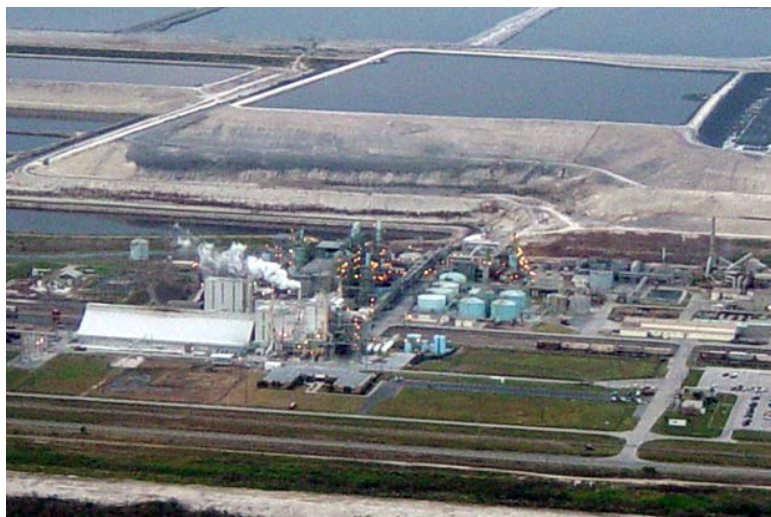
Green Bay Facility:

The Green Bay Facility has one active gypsum stack and one inactive gypsum stack that are in the final stages of closure. The closed gypsum stack began receiving gypsum in the late 1960s and the active gypsum stack was constructed in 2000-2001, meeting all of the requirements set forth by Chapter 62-673 of the FAC.

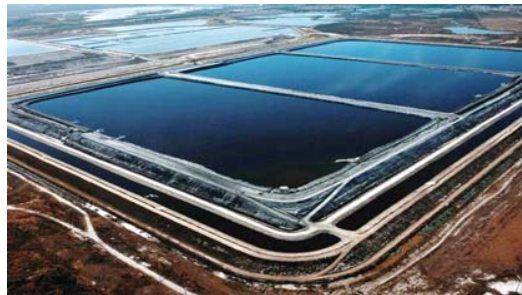
Green Bay New Stack:

The active gypsum stack has a base area of approximately 1.3 million sq m and will have a final height of 73 m. The stack is estimated to reach its final elevation in approximately 15 years. The stack was constructed on mined and partially reclaimed land with a 60-mil liner over top of the prepared cast spoil foundation. At the time of construction, the base liner was the largest continuously welded sheet of liner in the world. On top of the 60-mil liner there is a series of three concentric under-drains that aid in reducing the pore water pressure within the stack. As is typical in central Florida's phosphate industry, the drains consist of a 15-cm perforated, corrugated HDPE pipe completely enveloped in a bed of non-reactive silica gravel. On top of the drains is a minimum 61-cm compacted gypsum foundation serving as the second part of the required composite liner system. The gypsum required for the construction of the composite liner system was borrowed from the old gypsum stack at the Green Bay Facility.

The stack is raised using the upstream method of dike construction with a series of three step backs over its anticipated life to maintain an appropriate slope stability safety factor. The picture below shows active gypsum stack, currently with three operating cells, as it looked during the spring of 2003.

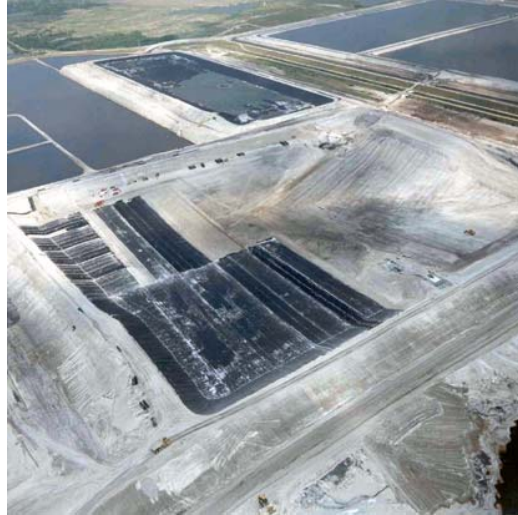
Green Bay Closed Stack Used for Water Storage:

The Green Bay inactive gypsum stack ceased receiving gypsum in early 2001 as a result of the new gypsum stack being activated. It was expanded several times during its 35-year history and ended with a base area of approximately 1.4 million sq m and a height of approximately 60 m. To facilitate the closure of the inactive stack, it was necessary to move 2.5 million cu m of soil and install 12,000 m of under-drains in the slope. In addition, closure of the stack required lining approximately 12,500 m of stormwater ditches with 40-mil liner and installing 600,000 sq m of 60-mil HDPE liner on the top of the stack. The lining of the top of the stack formed a series of three holding ponds capable of safely storing 3.75 billion liters of either unimpacted stormwater or acidic process water. The well-above average rainfall experienced in central Florida during 2002 and 2003 prompted the ponds to hold excess process water and impacted stormwater. During drier times, the process water can be drained from the ponds making them

capable of holding excess unimpacted stormwater. The picture below shows the lining of one of the three lined cells on top of the gypsum stack.

Upon the completion of the three lined cells on top of the stack, the side slopes were covered with approximately 15 cm of topsoil and grassed. The result is a vegetated slope surface that allows rainfall from the 800,000 sq m slope to be directed to a retention pond and subsequently discharged offsite. The closure of the side slopes and the creation of lined holding ponds on top of the stack has aided the Green Bay Facility in both improving the overall water balance and increasing the water management options during periods of increased rainfall.
